SERVICE CAMPAIGN BULLETIN

NTB16-120c

VOLUNTARY SERVICE CAMPAIGN 2013 – 2014 PATHFINDER; CVT

CAMPAIGN ID #: PC500

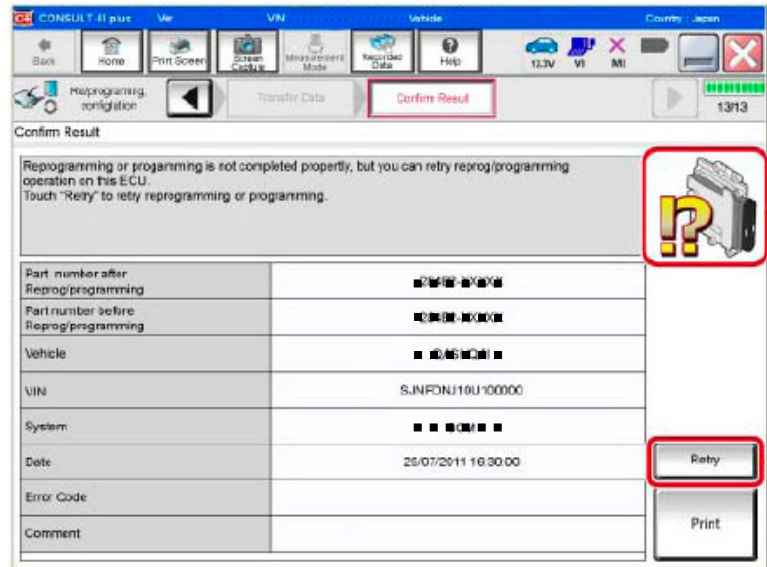
Figure 6

If reprogramming does not complete and the “!?” icon displays as shown in Figure 6:

- Check battery voltage (12.0–15.5 V).
- Ignition is ON, engine OFF.
- External Bluetooth® devices are OFF.
- All electrical loads are OFF.
- **Select retry and follow the on screen instructions.**
- “Retry” may not go through on first attempt and can be selected more than once.

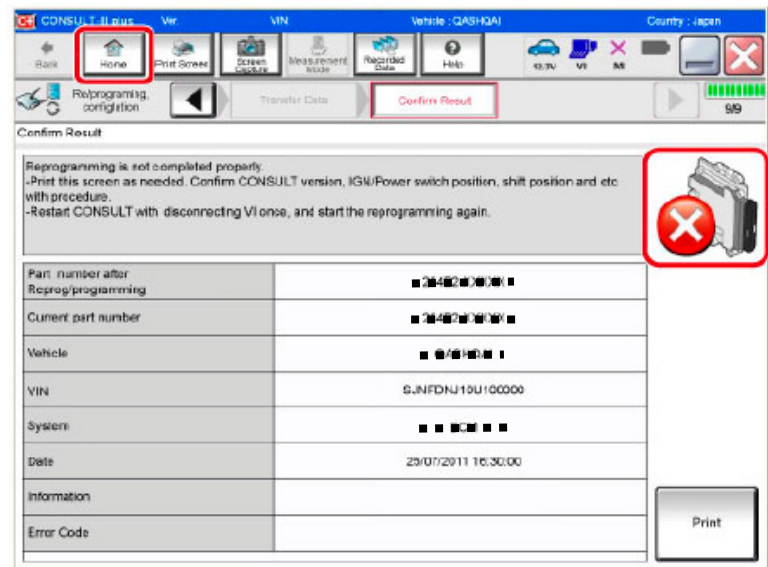
Figure 7

If reprogramming does not complete and the “X” icon displays as shown in Figure 7:

- Check battery voltage (12.0 – 15.5 V).
- CONSULT A/C adapter is plugged in.
- Ignition is ON, engine OFF.
- Transmission is in Park.
- All C-III plus / VI cables are securely connected.
- All C-III plus updates are installed.
- **Select Home, and restart the reprogram procedure from the beginning.**
