GROUP	NUMBER	
CAMPAIGN	18-01-017	
DATE	MODEL	
APRIL , 2018	ACCENT (HC)

HC ACCENT SPARK PLUG REPLACEMENT (SERVICE CAMPAIGN T2X)

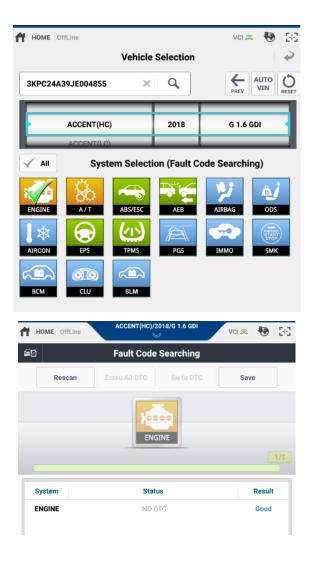
- Reinstall the ignition coils, ignition coil connectors, and engine cover in reverse order of removal.
- Attach a GDS to perform Fault Code Searching of the Engine System to check for any DTC P0300-P0304 and select Erase All DTC if any are found.
