SERVICE BULLETIN

Classification: ST14-009b	Reference: NTB14-053b	Date: April 19, 2018
------------------------------	--------------------------	-------------------------

2014-2018 ALTIMA; HYDRAULIC ELECTRIC POWER STEERING SERVICE INFORMATION

APPLIED VEHICLES: 2014-2018 Altima (L33)

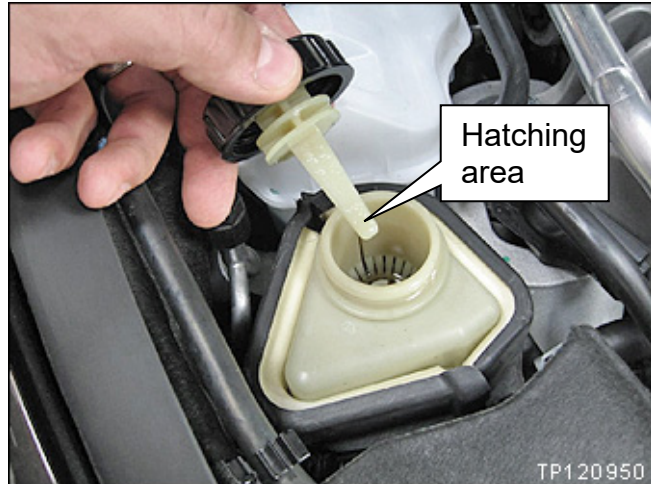
Figure 1

Check the fluid level of the Hydraulic Electric Power Steering (H-EPS) system.

- Check fluid level with the ignition OFF and fluid temperature between 0° – 30°C (32° – 86°F).
- Power steering fluid level should be within the hatching area of the indicator on the power steering reservoir tank cap.
- If fluid is needed, use only genuine NISSAN E-PSF or equivalent.

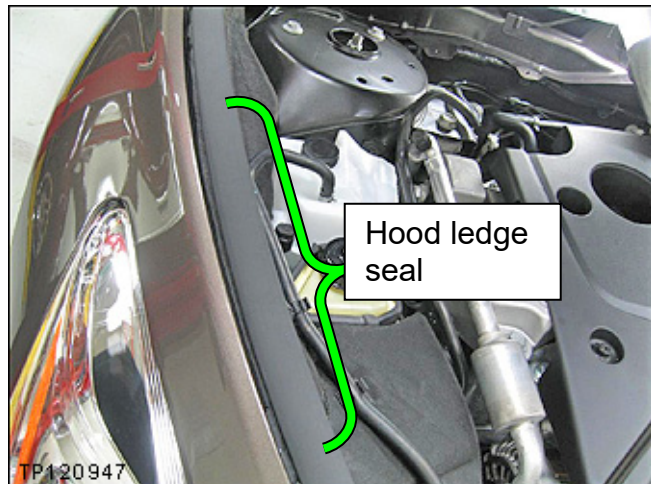
Figure 2

Make sure the right front hood ledge seal (passenger side) is installed correctly.

- Install the seal correctly.
- or
- If damaged, replace the seal.
- or
- If missing, install a seal.

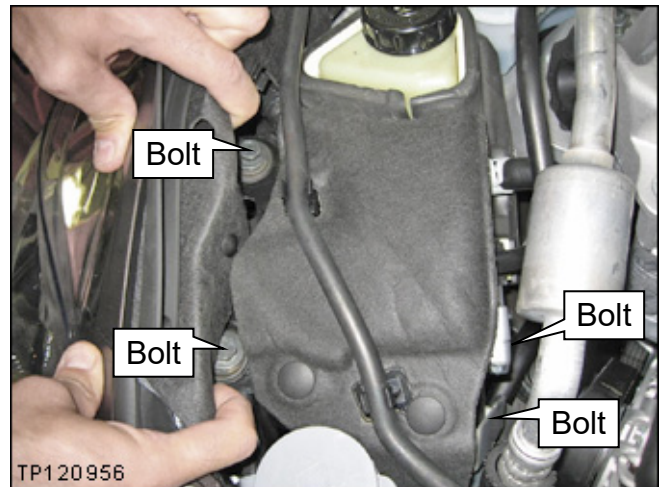
Figure 3

Make sure there is no binding on the H-EPS pump mounting isolator as follows:

- a. Loosen the four (4) H-EPS pump mounting bolts.
- b. Move the H-EPS pump a small amount from side to side.
- c. Tighten the mounting bolts.

Mounting bolts torque:

13.5 N•m (1.4 kg-m, **10 ft-lb**)

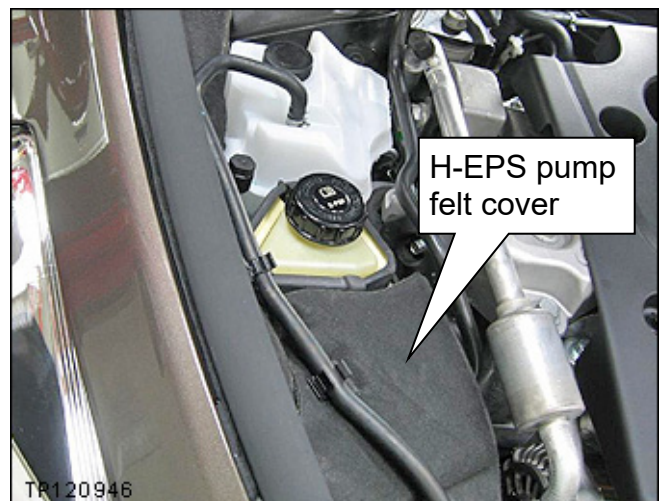
Figure 4

Make sure the H-EPS pump felt cover is installed correctly.

- Install the felt cover correctly.
- or
- If damaged, replace the felt cover.
- or
- If missing, install a felt cover.

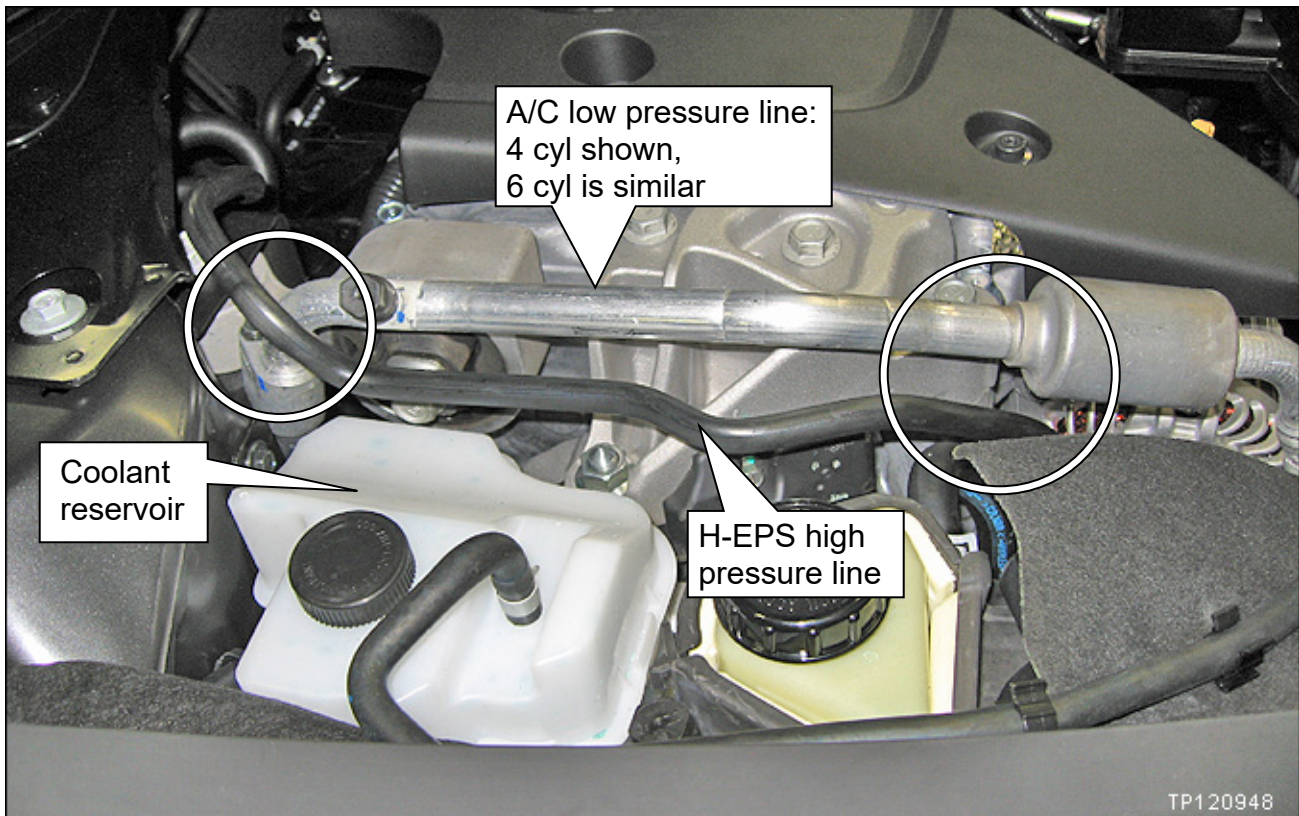
Figure 5

Check the H-EPS high pressure line and the A/C low pressure line. Make sure they are **not** touching each other (see Figure 5).

Check the H-EPS high pressure line and coolant reservoir. Make sure they are **not** touching each other (see Figure 5).

- a. Check the two locations circled in Figure 5.
- b. If the lines are touching, reposition the lines so they are **not** touching.

- a. Make sure the coolant reservoir is mounted correctly; its locator boss must be seated in the mounting hole.
- b. If needed, reposition the H-EPS line so it is **not** touching the reservoir.

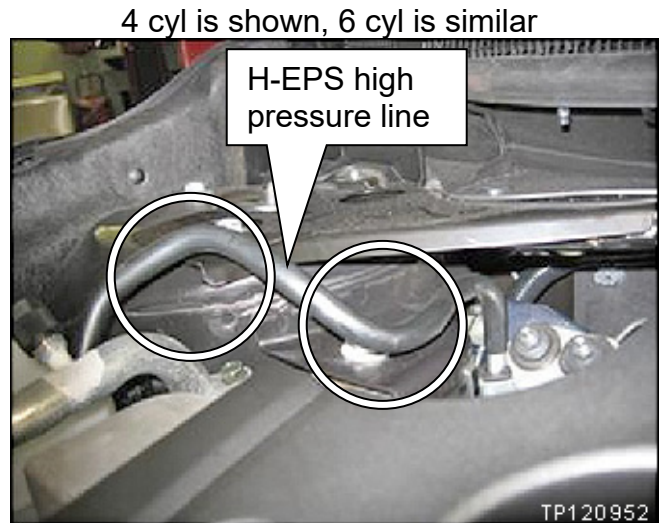
Figure 6

Make sure the H-EPS high pressure line is **not** touching the strut tower brace or the torque rod mounting bracket.

- a. Check the two locations circled in Figure 6.
- b. If needed, reposition the H-EPS high pressure line so it is **not** touching.

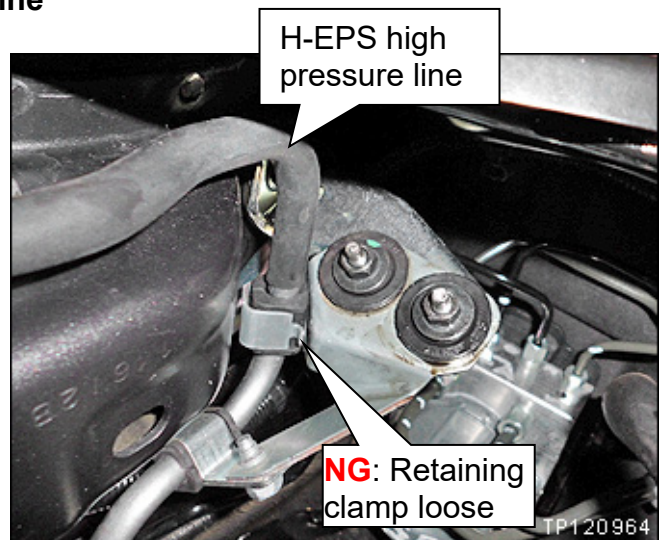
Check the H-EPS high pressure line retaining clamp shown in Figure 7.

- a. Make sure the clamp is secured correctly.
 - Figure 7 shows a clamp that **is not** secured correctly.
- b. If the clamp is loose like the one shown in Figure 7, replace the H-EPS high pressure line.
 - Refer to the Electronic Service Manual (ESM), section **ST-Steering System**, for replacement information.

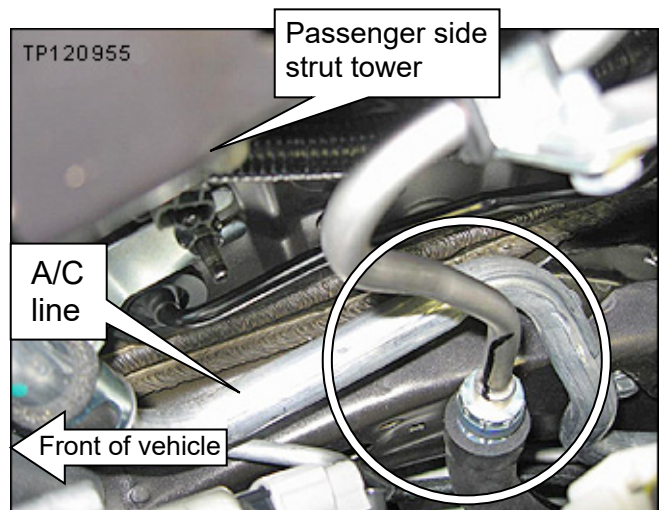
Make sure the H-EPS high pressure line is not touching the A/C line or vehicle body.

NOTE: The view in Figure 8 is downward from the inboard side of the passenger side strut tower.

- a. Check the area circled in Figure 8.
- b. If needed, reposition the lines so they are **not** touching.
- c. If needed, reposition the H-EPS line so it is **not** touching the vehicle body.

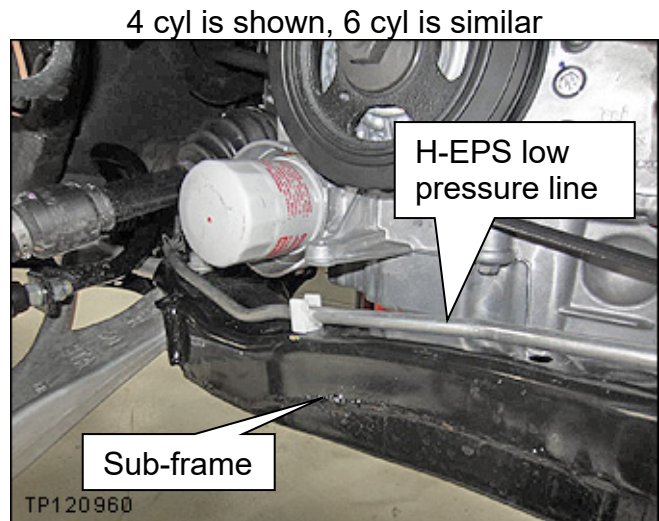
Make sure the H-EPS low pressure line is **not** touching the sub-frame near the front of the engine.

- a. If needed, reposition the H-EPS low pressure line so it does **not** touch the sub-frame.

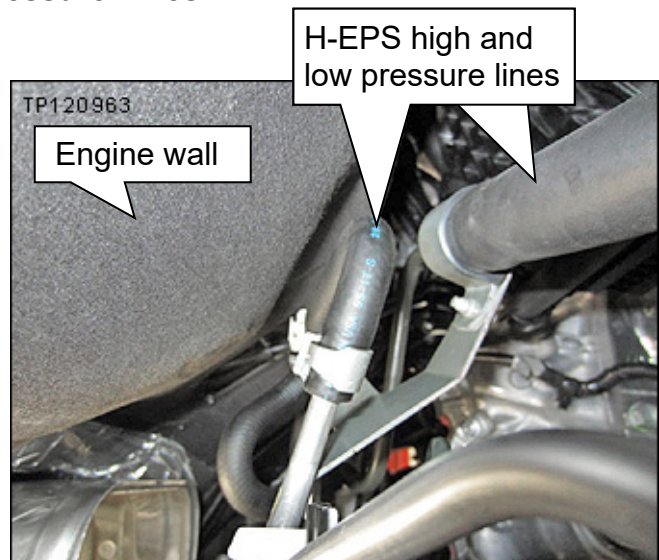
Make sure the H-EPS high and low pressure lines under the vehicle are **not** touching surrounding parts.

- a. Lift the vehicle.
- b. Visually check the routing of the under-vehicle H-EPS high and low pressure lines.
- c. If needed, reposition the H-EPS high and low pressure lines so they are **not** touching any surrounding parts.

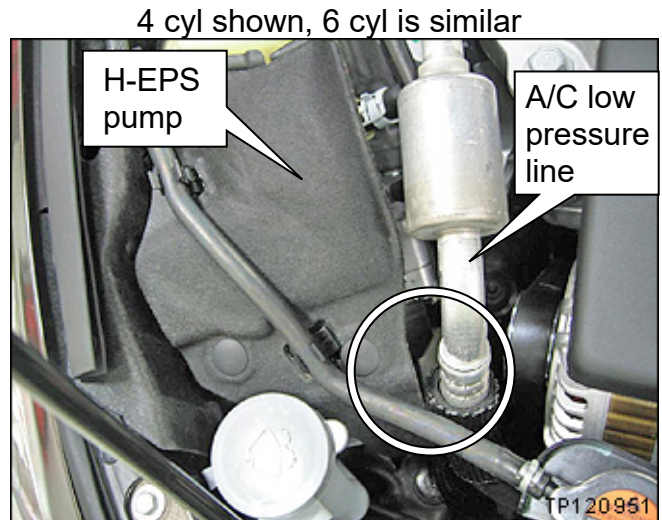
Figure 11

Make sure the A/C low pressure line is **not** touching the H-EPS pump.

- Check the location circled in Figure 11.
- If needed, reposition the A/C low pressure line so it is **not** touching the H-EPS pump.

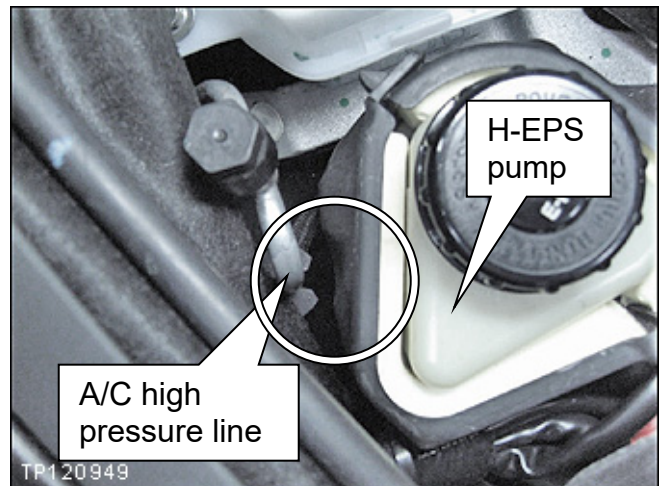
Figure 12

Make sure the A/C high pressure line is **not** touching the H-EPS pump.

- Check the location circled in Figure 12.
- Wiggle the H-EPS pump and observe the A/C high pressure line. If it moves, it is touching.
- If needed, reposition the A/C high pressure line so it is **not** touching the H-EPS pump.

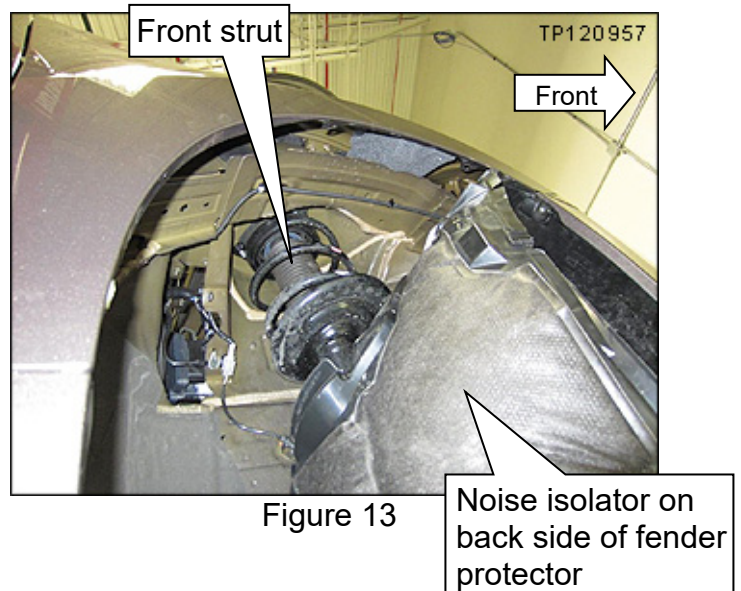
Figure 13

Make sure the noise insulator is installed inside the RH (passenger side) front fender protector:

- Remove the passenger side front wheel.
 - Partially remove the fender protector.
 - Refer to the ESM, section **EXT-Exterior**, as needed.
 - Confirm the insulator is in place.
 - Make sure the insulator is installed correctly
- or
- If damaged or missing, replace the fender protector with insulator.

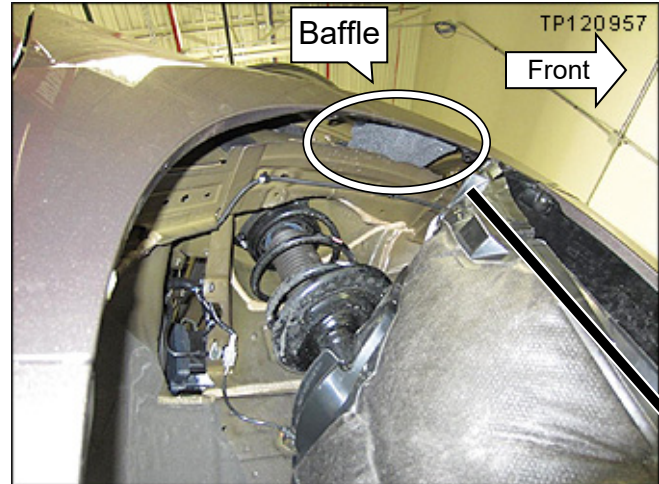
Figure 14

Make sure the baffle is positioned properly inside the RH (passenger side) front fender.

- Make sure the baffle is flush against the fender.
- There should be no gap between the fender protector and baffle when the fender protector is installed.
- If needed, reposition the baffle or install a new one.

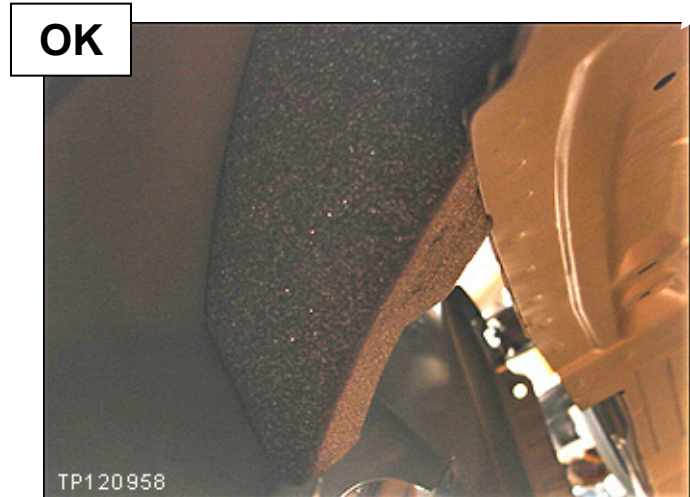
Figure 15 – baffle is **installed correctly**.

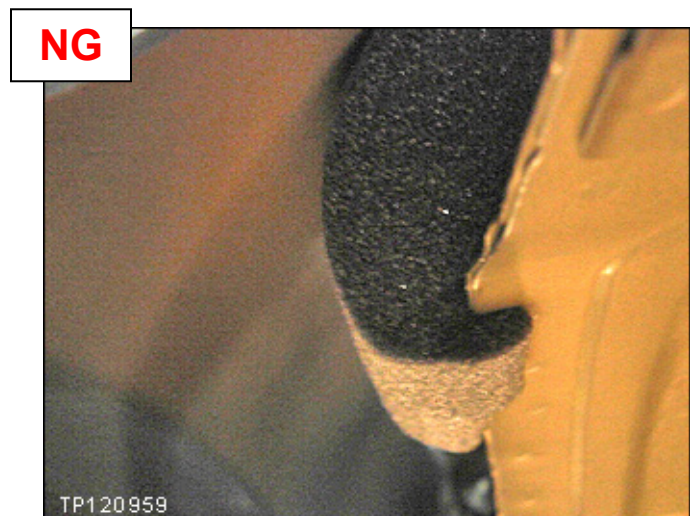
Figure 16 – example of a baffle **installed incorrectly**.

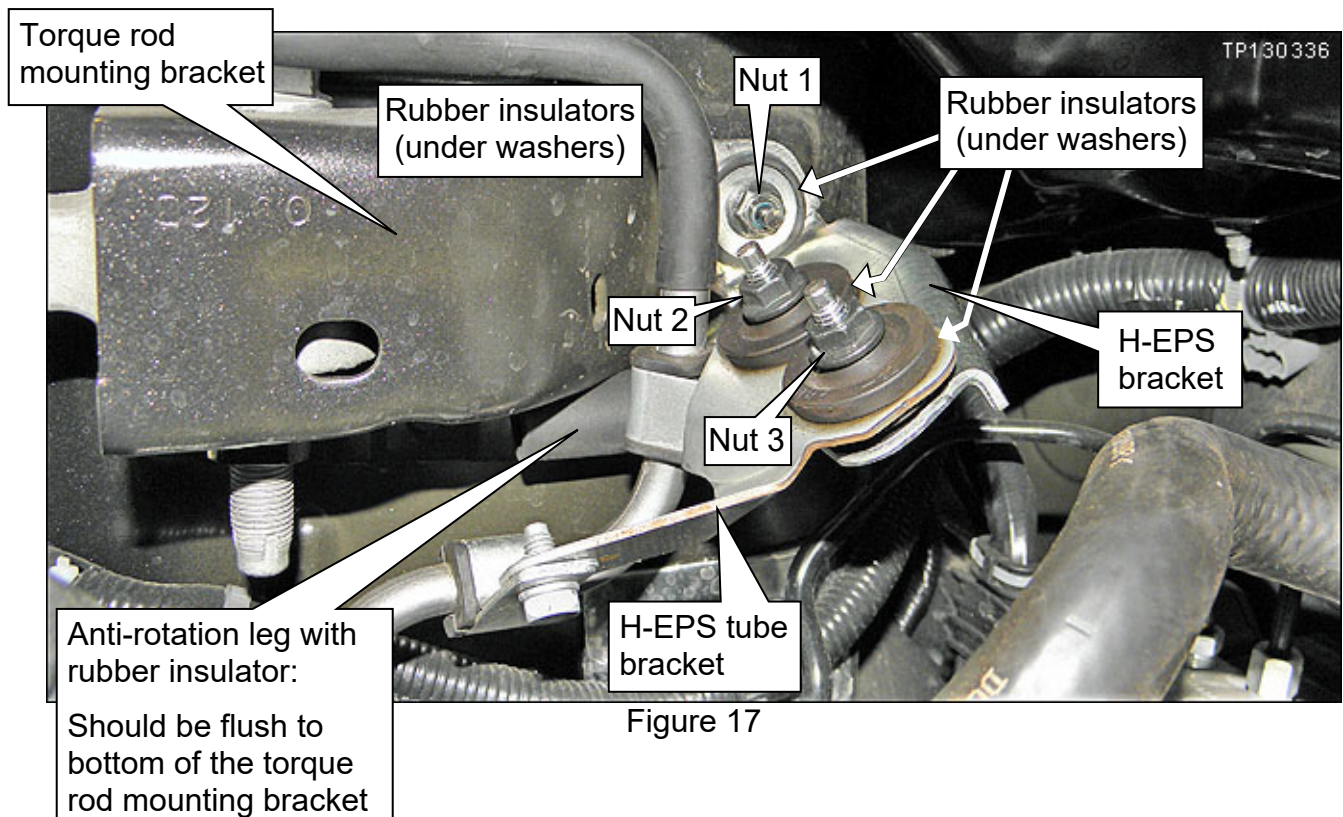
Make sure the H-EPS bracket and the H-EPS tube bracket are not touching (see Figure 19).

Make sure the anti-rotation leg of the H-EPS bracket is flush to the bottom of the torque rod mounting bracket (see Figure 17).

- a. Make sure there is a gap between the brackets all the way around.
- b. Make sure the rubber insulators are seated properly.
- c. If needed, reposition the brackets so they are not touching.

- a. Check the position the H-EPS bracket, make sure its anti-rotation leg is flush to the bottom of the torque rod mounting bracket.

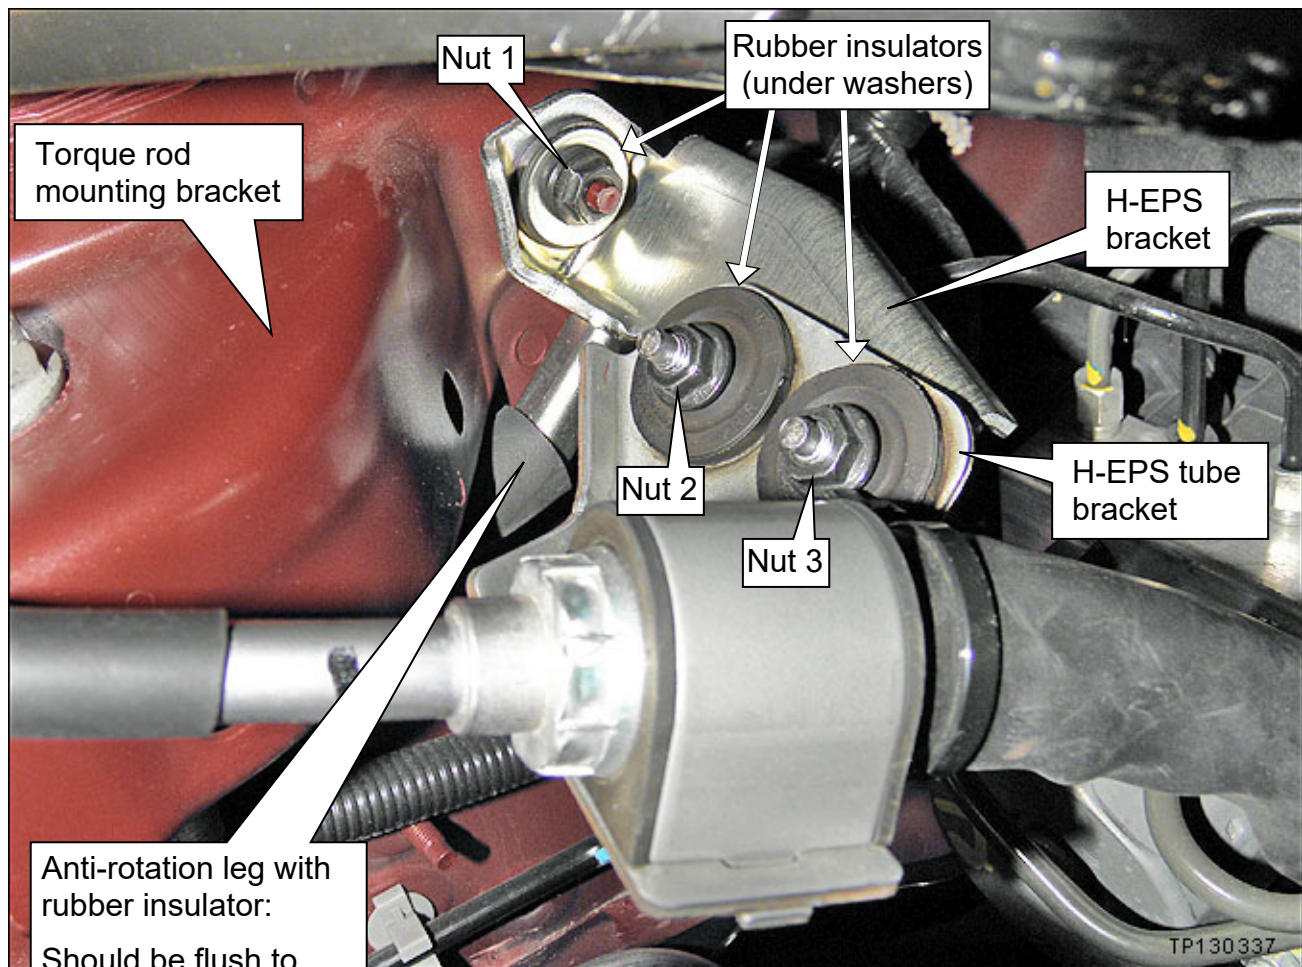
Figure 18

Make sure the H-EPS bracket and the H-EPS tube bracket are not touching (see Figure 18).

Make sure the H-EPS bracket's anti-rotation leg is flush to the bottom of the torque rod mounting bracket (see Figure 18).

Anti-rotation leg with rubber insulator:
Should be flush to bottom of the torque rod mounting bracket

- Make sure there is a gap between the brackets, all the way around.
- Make sure the rubber insulators are seated properly.
- If needed, reposition the brackets so they are not touching.

- Check the position the H-EPS bracket, make sure its anti-rotation leg is flush to bottom of the torque rod mounting bracket.

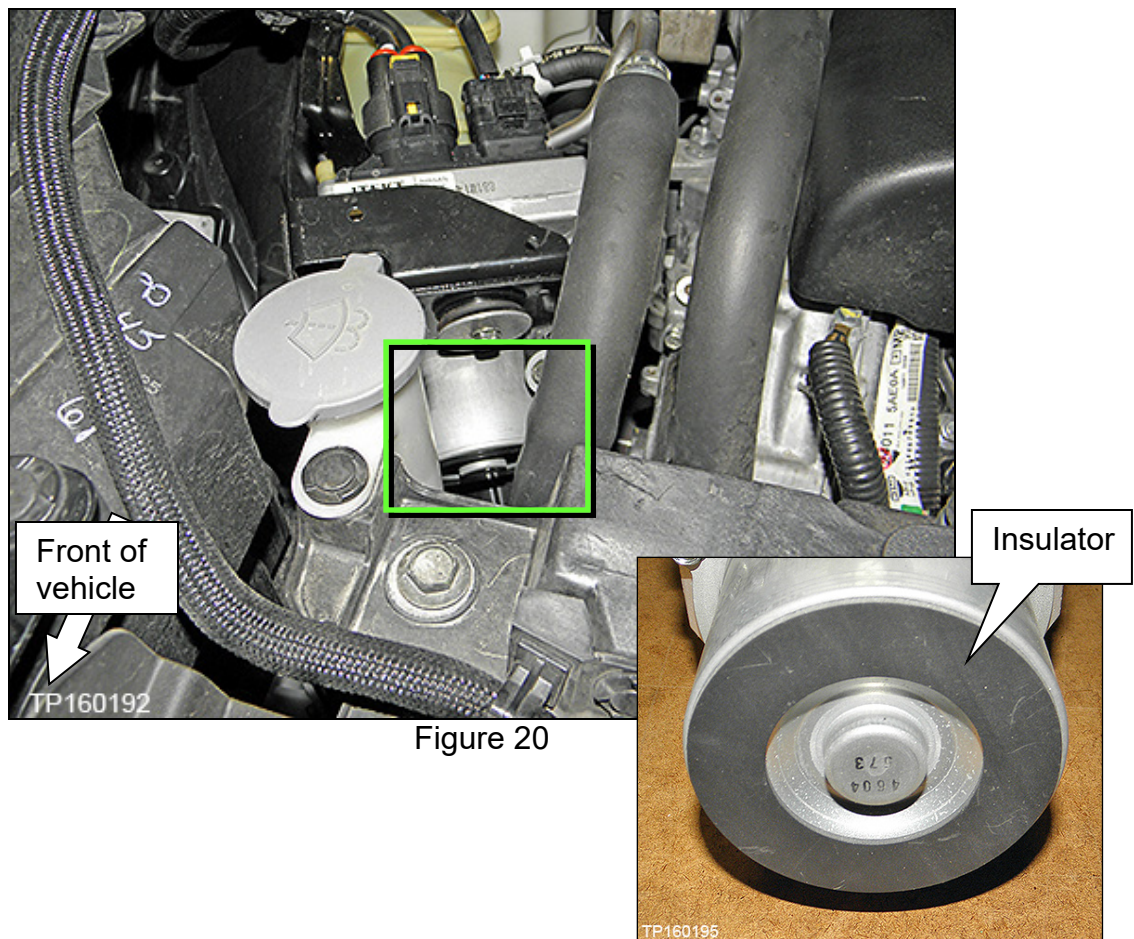
Figure 20

2. Locate the power steering pump motor housing and confirm an insulator is installed.

3. If missing, install an insulator.
