## Technical product information

| Topic | W12 Engine oil leaks |
| Brand | Bentley |
| Transaction No. | 2050914/1 |

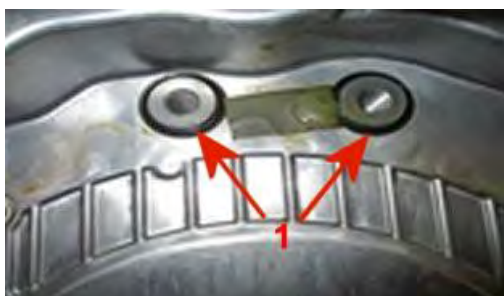
Figure 1

A number of oil seals, part number 07P109091C, have been produced with a flaw. When this flaw is present an oil leak may result.

Leak Figure 1: Engine oil present at interface of engine and transmission. The leak may be emanating from one or both of the oil seals part number 07P109091C located in the main timing chain cover, these two seals (item 1 figure 1, 1a and 1b) are located in the top of the timing chain cover through which the upper two gearbox to crankcase securing bolts pass into the crankcase via the adaptor plate and timing chain cover.

If one rear timing chain cover seal is leaking replace both seals in that timing chain cover.

Reference the workshop manual for remove and fit of Engine and Gearbox Rep.Gr.10 and Rep.Gr.37 then to replace the timing chain cover seals reference Rep.Gr.13

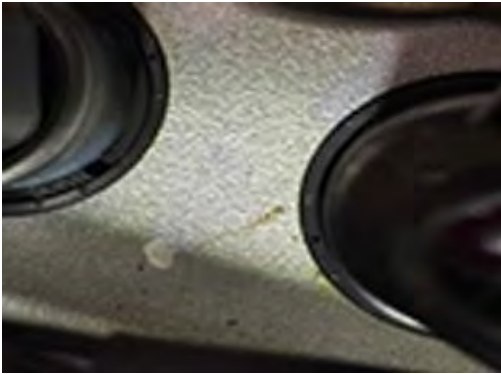
Figure 2

Leak Figure 2: Engine oil present on camshaft cover adjacent to camshaft control solenoid. The leak is likely to be emanating from oil seal part number 07P109091C located in the camshaft cover through which the camshaft control solenoid protrudes

Only replace the seals in the component that is leaking i.e. if one camshaft control solenoid seal in Bank one camshaft cover is leaking then replace both camshaft solenoid seals in the Bank one camshaft cover.

Reference the workshop manual for remove and fit procedures to replace this seal: Rep. Gr.15 for camshaft cover and control solenoid seals.
