**Loose or Damaged M8 Threaded Inserts for the Protective Panel Below Engine**

Model	Model Year	Model Type	VIN Range	Vehicle-Specific Equipment
918 Spyder	2015	918	All	N/A

Loose or Damaged M8 Threaded Inserts

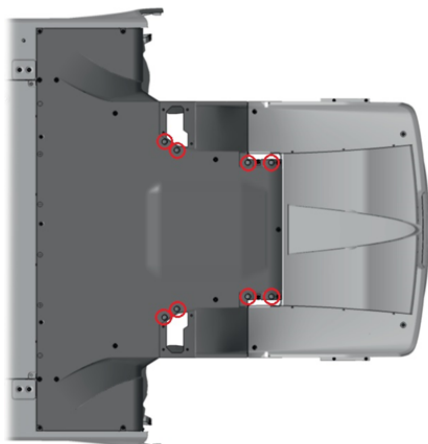
The protective panel below the engine is actually an integral part of the rear CFRP monocoque. The rear suspension must never be laden without this panel properly installed and at least the eight M8 fasteners installed and tightened to specification (see Figure 1).

Figure 1: Protective panel below the engine, M8 fasteners indicated

If one of the M8 threaded inserts is discovered damaged or loose, please submit a TLAR in the PTEC system with a detailed description along with photos before attempting a repair. The photos must be sharply focused and clearly show both the insert and the entire bored hole within the structure. Only one standard repair attempt is often possible and the Technical Hotline will advise the best course of action.

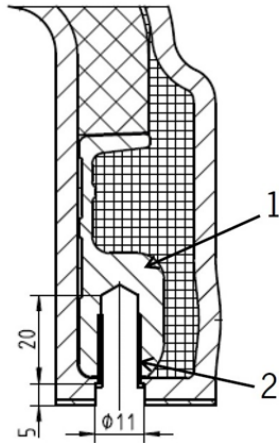
The threaded inserts for these M8 fasteners are recessed 5mm below the surface and thread into aluminum extrusions encapsulated within the structure of the CFRP monocoque; not the CFRP structure itself (see Figure 2).

- 1. Aluminum Extrusion
- 2. Threaded Insert

Figure 2: Cross section CFRP the structure
