Remote Key Batteries Are Prematurely Discharged

Model	Model Year	Model Type	VIN Range	Vehicle-Specific Equipment
Panamera	2018	971	N/A	N/A

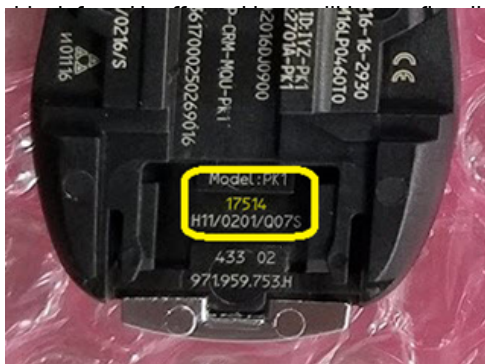
Figure 1

The manufacturing process was modified and no longer damages the key. Keys produced after 8/25/2017 are not affected by this defect. Keys with a digit production date code '17345' or higher. (See figure 1.)

The first two digits are the year: **17** = 2017
 The next two digits are the calendar week: **34** = calendar week 34
 The last digit is the day of the week: **5** = Friday

1. The part to be replaced was produced before the countermeasure date of 8/25/2017. (The five digit production date code is lower than 17345.)
2. The replacement part was produced after the countermeasure date of 8/25/2017. (The five digit production date code is 17345 or higher.)
