Noise Symptom - Door Window Glass Making Noises: Reworking front power windows mechanism (SY 02/18)

Model Line: **Macan**

Model Year: **As of 2015**

Subject: **Front power windows**

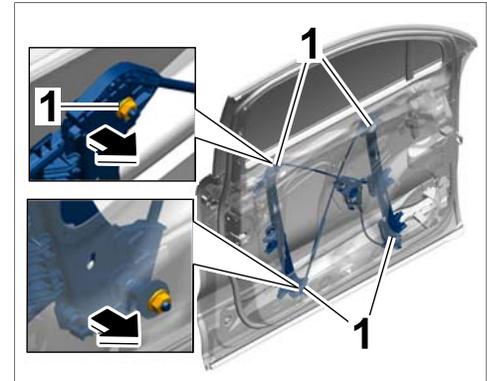
Front power windows mechanism

Symptom: **Unusual noises can occur when you open and close the front door window.**

Squeaking, rattling or noises can indicate that the door window glass is stiff.

Cause: The screws on the front power windows mechanism may have loosened.

If you find no damage, re-tighten nuts on the front power windows mechanism.

- Work Procedure:
- 1 Remove front door panel. ⇒ *Workshop Manual '705919 Removing and installing front door panel'*
 - 2 Check front window guide and front power windows mechanism for damage.
 - 3 If you find damage on the front window guide, replace damaged components. ⇒ *Workshop Manual '644519 Removing and installing front window guide'*
 - 4 If you find damage on the front power windows mechanism, replace damaged components. ⇒ *Workshop Manual '645219 Removing and installing front power windows'*
 - 5 If no damage is found, tighten nuts ⇒ *Front power windows mechanism-1-* to ⇒ Tightening torque 7.5 Nm (5.5 ftlb.) .

Location	Explanation	Type	Basic value	Tolerance 1	Tolerance 2
Nuts on front power windows mechanism		Tightening torque	7.5 Nm (5.5 ftlb.)
