70 Noises from headliner/sunroof area

70 18 66 2038029/6 March 16, 2018. Supersedes Technical Service Bulletin Group 70 number 17-56 dated February 6, 2017 for reasons listed below.

Model(s)	Year	VIN Range	Vehicle-Specific Equipment
A3, Q3	2015 - 2018	All	Not Applicable
A4	2010 - 2012	All	Not Applicable
A4 allroad	2013 - 2017	All	Not Applicable
A8	2010 - 2018	All	Not Applicable
Q5	2010 - 2017	All	Not Applicable
Q7	2010 - 2015	All	Not Applicable

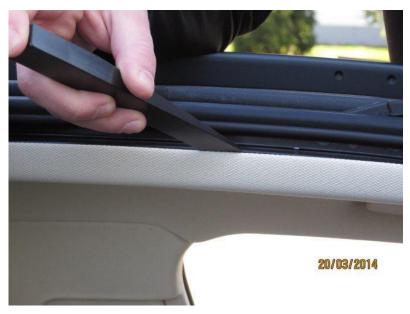
Figure 1. Unclipping the sunroof cover trim frame.

Remove the glass sliding roof panel(s). Remove the beam for the sunroof rollershade. Carefully unclip and remove the sunroof cover trim frame (Figure 1).

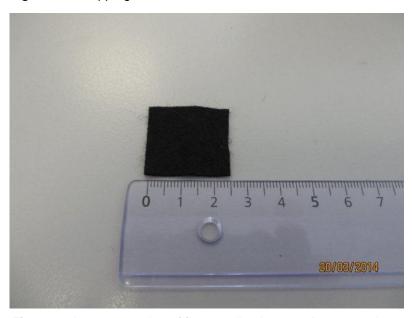
Figure 2. A 20mm section of fleece adhesive tape D 373125A2.

The number of retaining clips will vary by model. A piece of dampening tape (fleece adhesive tape D 373125A2) will be applied to each clipping point. Cut pieces of the tape 20mm long (Figure 2).

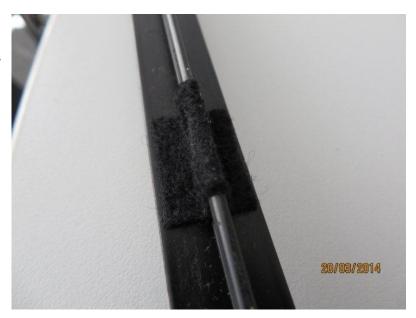
Figure 3. Fleece adhesive tape section applied.

3. Apply the sections of fleece adhesive tape to the sunroof cover trim frame to each clipping point as shown (Figure 3 and Figure 4).

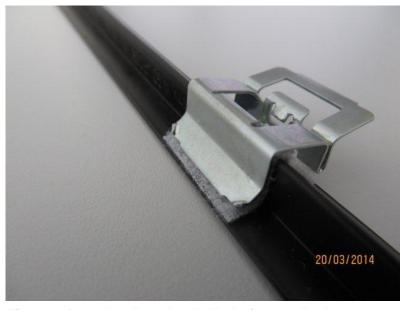
Figure 4. Retaining clip isolated with the fleece adhesive tape.

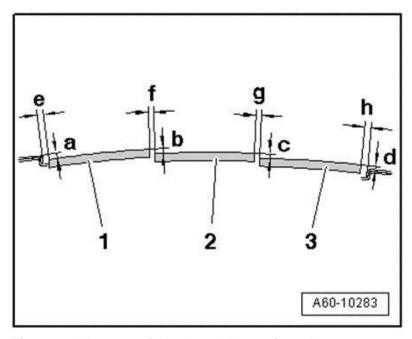
Figure 5. Adjustment of the glass sliding roof panels.

Reassemble the components removed for this modification.
 Ensure that the glass sliding roof panels are adjusted properly according to the repair manual (Figure 5).
