Technical Service Bulletin

90 Audi connect Key User entry cannot be selected in MMI menu, "Request user list manually"

90 18 90 2050584/1 March 2, 2018.

Model(s)	Year	VIN Range	Vehicle-Specific Equipment
A4, A5, Q5, and Q7	2018	All	With connected gateway

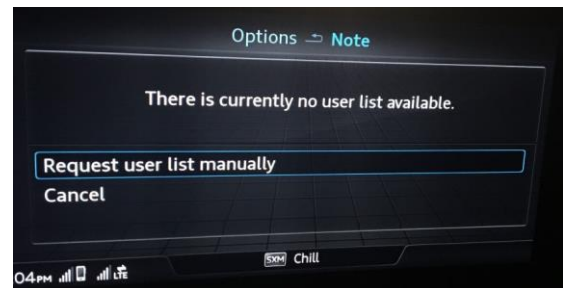
- The Key User login screen cannot be accessed in the MMI's Audi connect menu.
- When the customer attempts to access this screen, they see a persistent message of "Request user list manually" even after this option is selected multiple times.
- The customer's vehicle is a MY2018.

Figure 1. Error message seen in the MMI.

The MMI is the user interface to the connected gateway data bus on board diagnostic interface, J533 (address word 0019). When attempting the Key User pairing in the vehicle, the MMI communicates with the connected gateway and the connected gateway (cGW) communicates with the Audi connect backend server (MBB). There is a known communication issue between the cGW and MBB which is currently under analysis. It has not been determined if the cause of the issue is with the backend (MBB) or the control unit (cGW) in the vehicle. Replacing the cGW is not authorized under this TSB.

The cGW must be hard reset by removing terminal 30 battery power from the module for five minutes. This can be done by pulling the terminal 30 fuse to the cGW located at the following locations:

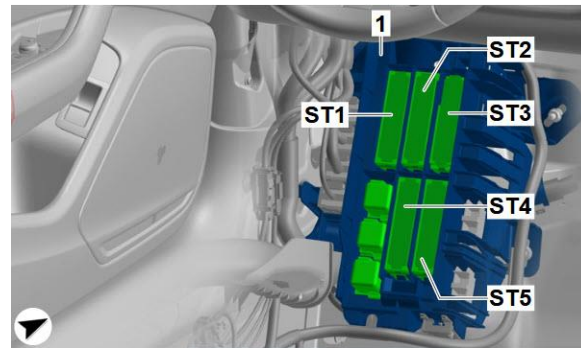
1. SR1 (Relay Fuse Panel 1), SB Fuse Panel, in carrier ST2 at fuse location SB7.
2. SR1/SB Relay Fuse Panel is located under the driver side dead pedal/footrest (Figure 2).

Figure 2. SR1/SB Relay Fuse Panel.

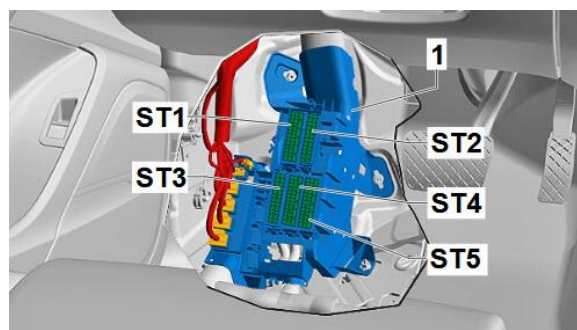
1. SR2 (Relay Fuse Panel 2), SB Fuse Panel, in carrier ST5 at fuse location SB7.

2. SR2/SB Fuse Panel B is located under the driver side dead pedal/footrest (Figure 3).

Figure 3. SR2/SB Fuse Panel.
