Technical Service Bulletin

90 Audi connect Key User entry cannot be selected in MMI menu, "Request user list manually"

90 18 91 2050584/2 March 22, 2018. Supersedes Technical Service Bulletin Group 90 number 18-90 dated March 2, 2018 for reasons listed below.

Model(s)	Year	VIN Range	Vehicle-Specific Equipment
A4, A5, Q5, and Q7	2018	All	With connected gateway

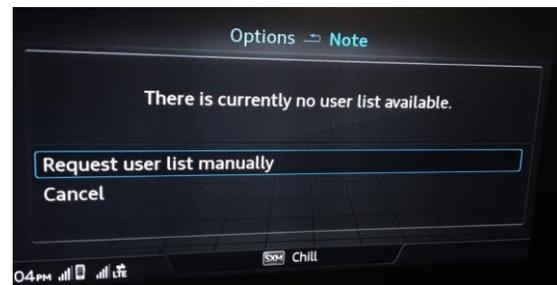
- The Key User login screen cannot be accessed in the MMI's Audi connect menu.
- When the customer attempts to access this screen, they see a persistent message of "Request user list manually" even after this option is selected multiple times.
- The customer's vehicle is a MY2018 built after CW 22/17.

Figure 1. Error message seen in the MMI.

The MMI is the user interface to the connected gateway data bus on board diagnostic interface, J533 (address word 0019). When attempting the Key User pairing in the vehicle, the MMI communicates with the connected gateway and the connected gateway (cGW) communicates with the Audi connect backend server (MBB). There is a known communication issue between the cGW and MBB which is currently under analysis. It has not been determined if the cause of the issue is with the backend (MBB) or the control unit (cGW) in the vehicle. Replacing the cGW is not authorized under this TSB.

For MY18: Please perform the work-around solution provided below. This issue only affects the initial attempt of performing the Key User pairing in the MMI. After performing the work-around solution, the issue will be permanently resolved for the customer.

The cGW must be hard reset by removing terminal 30 battery power from the module for five minutes. This can be done by pulling the terminal 30 fuse to the cGW located at the following locations:

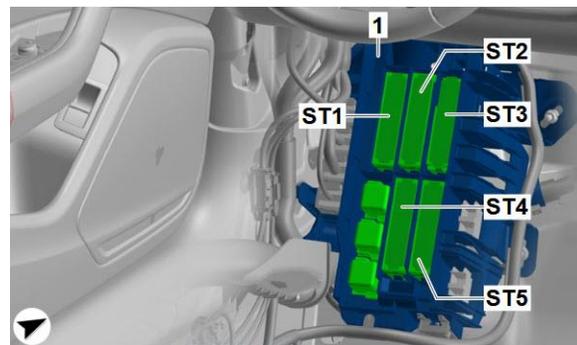
Figure 2. SR1/SB Relay Fuse Panel.

1. SR1 (Relay Fuse Panel 1), SB Fuse Panel, in carrier ST2 at fuse location SB7.
2. SR1/SB Relay Fuse Panel is located under the driver side dead pedal/footrest (Figure 2).

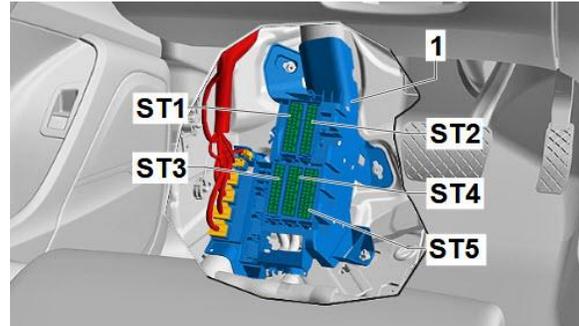
Figure 3. SR2/SB Fuse Panel.

1. SR2 (Relay Fuse Panel 2), SB Fuse Panel, in carrier ST5 at fuse location SB7.

2. SR2/SB Fuse Panel B is located under the driver side dead pedal/footrest (Figure 3).
