Technical Service Bulletin

PSS 91 MMI screen goes blank after iPhone is connected to USB port

91 18 84 2044130/6 March 5, 2018. Supersedes Technical Service Bulletin Group 91 number 18-76 dated February 20, 2018 for reasons listed below.

Model(s)	Year	VIN Range	Vehicle-Specific Equipment
A4, A5, Q5, and Q7	2017	All	Audi smartphone interface

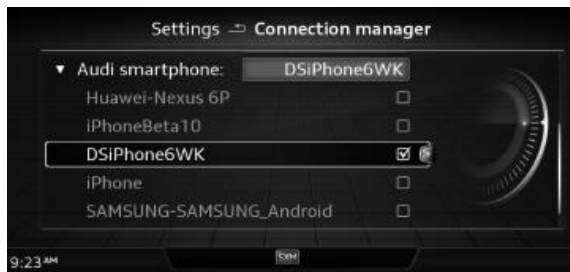
Figure 1. iPhone is selected for ASI (CarPlay).

3. Create a PSS record in the PSS application through the Pending Service Solutions (PSS) link in AccessAudi (under *App Links >> Service >> Pending Service Solutions (PSS)*), or through the Technical Assistance page in Elsa.
4. As a temporary workaround, ask the customer to:
 - **If the screen goes blank when CarPlay is accessed immediately after the car is started or if the screen flashes back to the MMI menu after selecting CarPlay:** connect the iPhone after the car is started and while the transmission is still in the park position. If the customer gets into this condition they can fix the concern by going to the connection manager (Figure 1) and deselecting the iPhone (Figure 2) and reselecting under Audi Smartphone Interface (*Settings >> Connection Manager >> Audi Smartphone Interface*; Figure 1). This will force the MMI to start a new CarPlay session with the iPhone.

- **If the screen flashes when selecting CarPlay after using the backup camera:** inform the customer there is no current workaround. If the customer has this issue they can temporarily fix the concern by going to the connection manager (Figure 1) and deselecting the iPhone (Figure 2) and reselecting under Audi Smartphone Interface (*Settings >> Connection Manager >> Audi Smartphone Interface*; Figure 1). This will force the MMI to start a new CarPlay session with the iPhone.

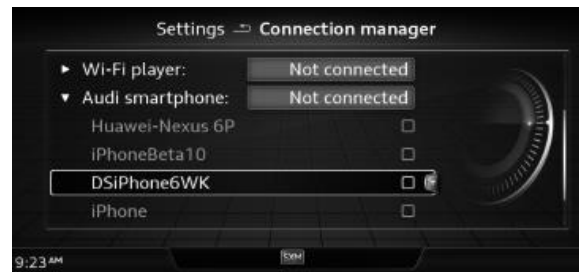
Figure 2. iPhone is no longer selected for ASI (CarPlay).
