Technical Service Bulletin

91 Concerns about GPS or satellite radio reception, repair coaxial cable

91 18 87 2045106/3 March 22, 2018. Supersedes Technical Service Bulletin Group 91 number 17-04 dated January 26, 2017 for reasons listed below.

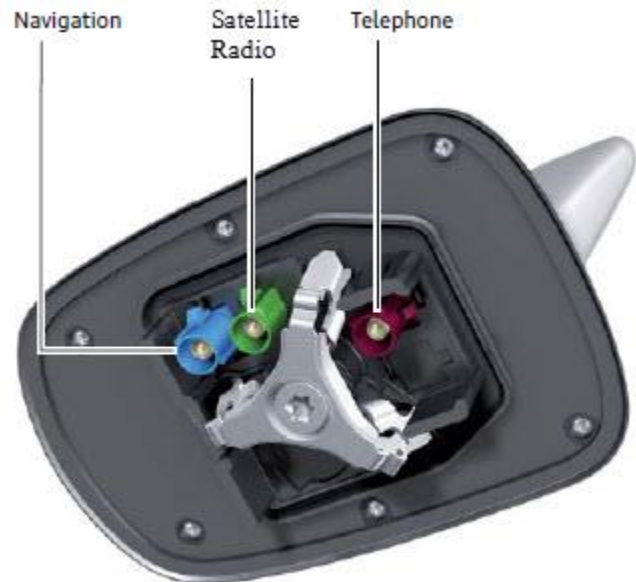
The correct circuit can be identified by the color on the antenna connector (Figure 1). Not all antenna connectors are laid out the same.

Figure 1. Identify the correct circuit by the color of the antenna connector. Blue: Navigation. Green: Satellite Radio. Connector placement on antenna will change by vehicle options, reference the wiring diagram for your specific vehicle.

4. Replace the FAKRA connector and coaxial connection at the shark fin antenna for the applicable circuit, see instructions below.

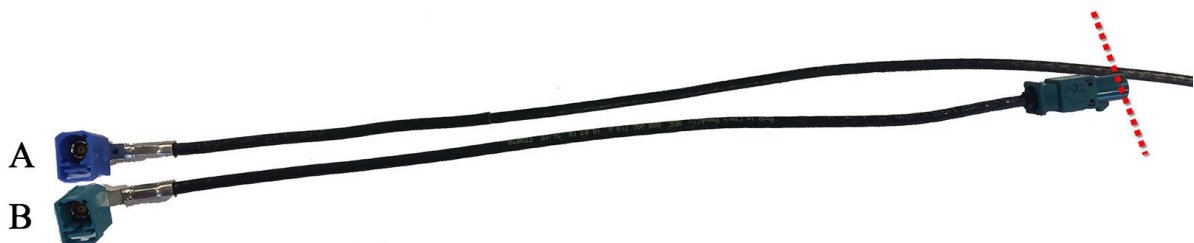
Figure 2. Measure you're the cut point on the vehicle's antenna coaxial wiring (A) based off the length of the replacement coaxial "Adapter Antenna Cable" (B). The removed length of cable from A should be equal to the length of cable B.

5. Follow instructions located in the repair manual to access the FAKRA connectors for the shark fin antenna. Only disconnect the connector for the circuit associated with the customer's concern.
7. Cut off a section from the vehicle's coaxial wiring for the applicable antenna circuit. Make sure the removed section is the same length as the Adapter Antenna Cable (part number 000098710A). Measure this cut based off the cabling you receive (Figure 2).

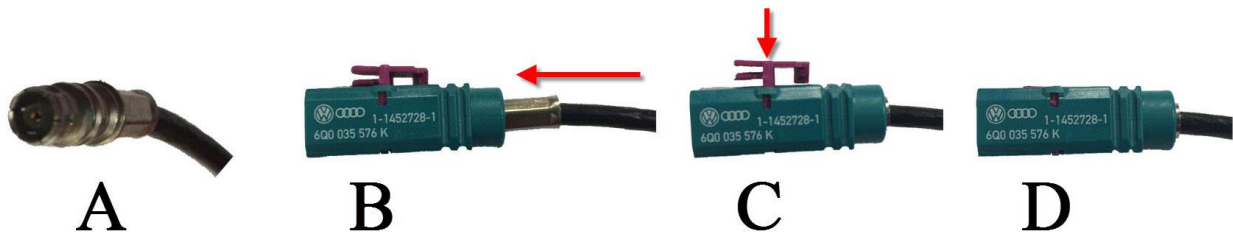
Figure 3. A: Coaxial wire with female coaxial terminal end installed. B: Insert female coaxial terminal end into FAKRA connector until fully seated. C: Coaxial female terminal is fully seated in FAKRA connector, press down the locking tab of the FAKRA connector. D: Completed assembly.

- Utilizing VAS6720 (Aerial Cable Repair Set), identify the coaxial wiring type used in your application (RG174 or RTK031). Reference the vehicle repair manual, or the instructions provided with the VAS6720 and install a female coaxial terminal onto the vehicle side of the coaxial harness. For visual of coaxial cable with female coaxial terminal installed (Figure 3, item A).

- Install FAKRA connector part number 6Q0035576K onto the female coaxial terminal you installed in the previous step. Ensure the FAKRA connector is fully seated onto the coaxial connector and the locking tab is pressed all the way down (Figure 3).

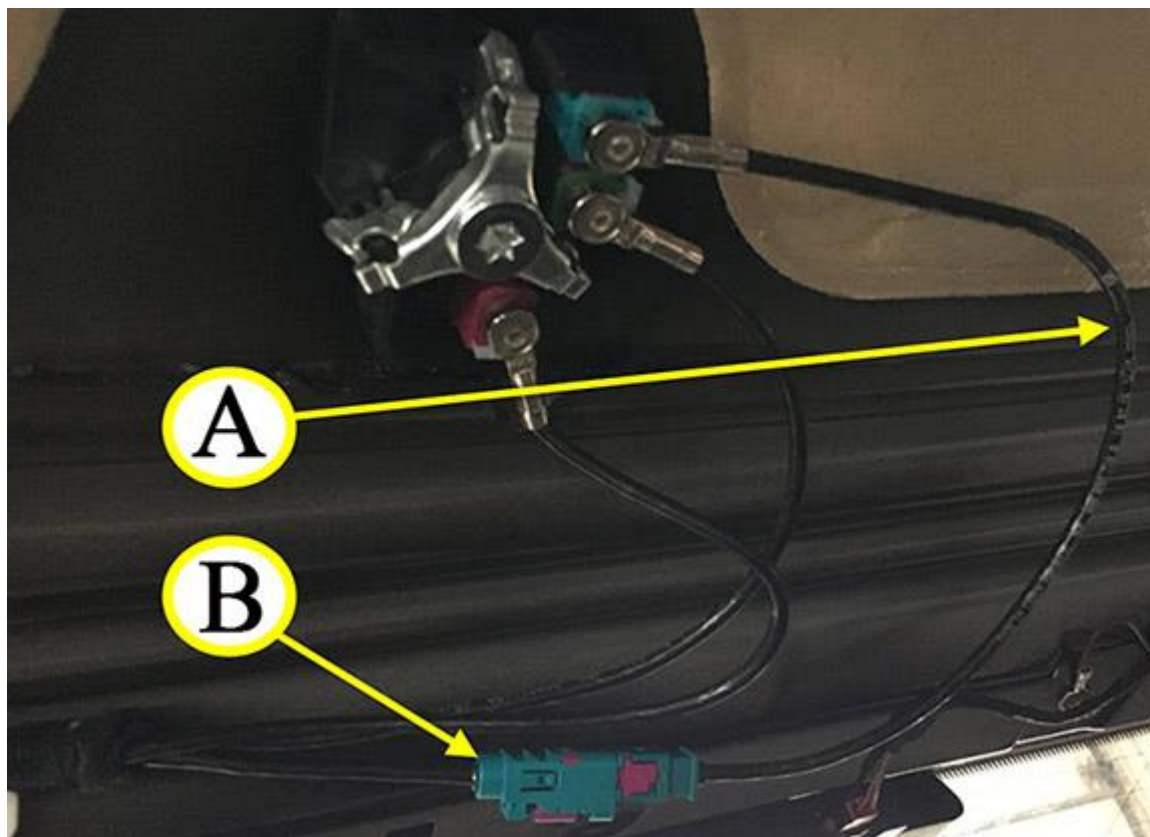
Figure 4. Install the Adapter Antenna Cable (A) onto the shark fin antenna and connect to the newly created FAKRA connection (B). Wrap a layer of cloth tape around FAKRA connection B to avoid any unwanted noises.

- Install the Adapter Antenna Cable onto the shark fin antenna and connect it to the newly installed FAKRA connector from the previous step. Wrap the new FAKRA connection with cloth tape (part number 000979950) to avoid any unwanted noises.
