Body ATU
January 2018

Work specific to Cabriolet, A5/B9 Cabriolet

Q7/A4 – power-operated rear lid

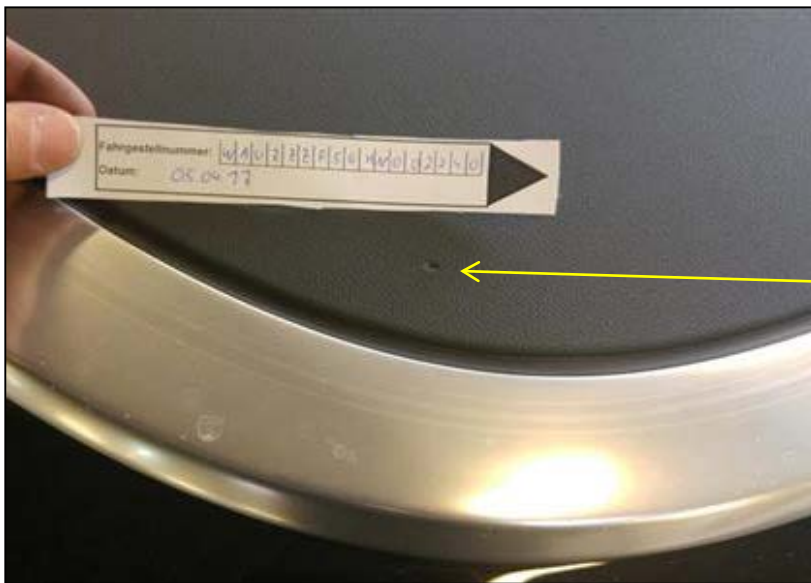
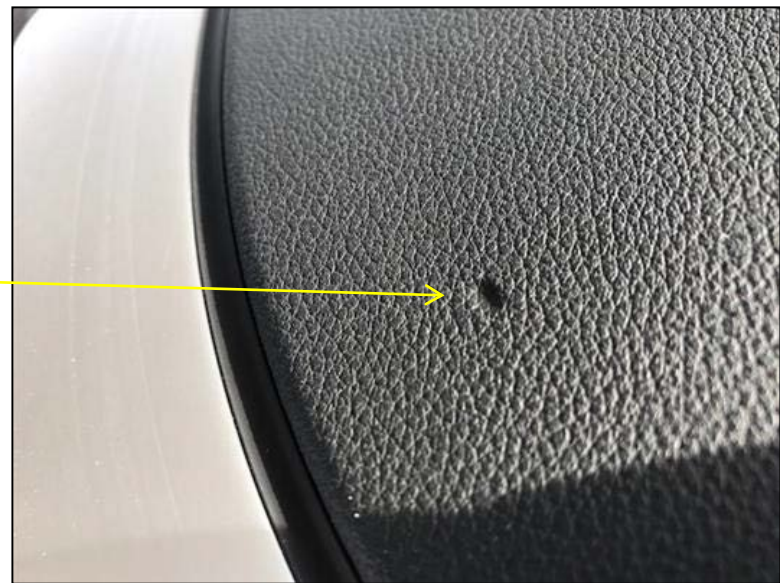
1.1) Visible imprint on CRCL trim

Concern: Imprint on CRCL trim.

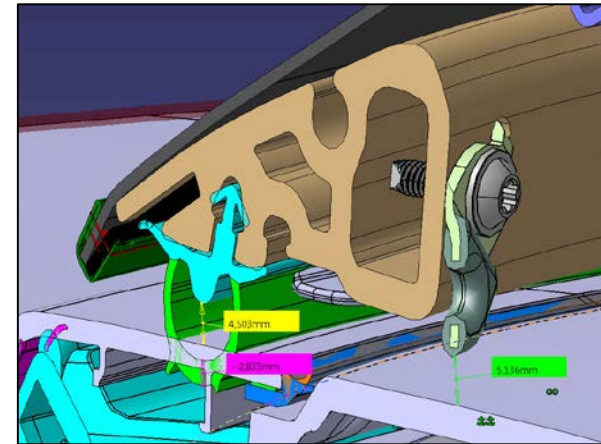
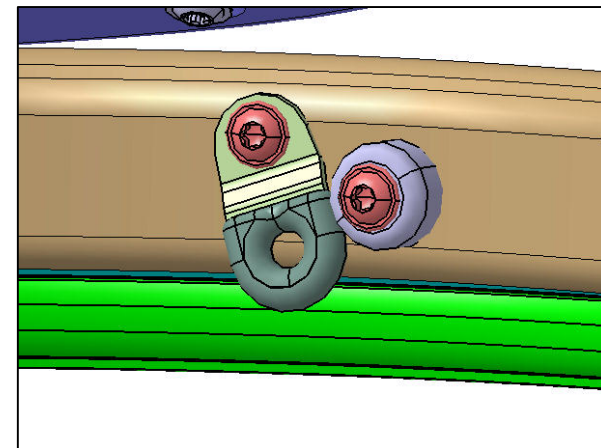
- > Eyelet of cable guide can move freely and may, in the worst case, become positioned against fixed stop pin.
- > As a result, there is insufficient distance between edge of eyelet and surface of CRCL trim.
- > In this position, edge of eyelet makes an indentation (imprint) in CRCL trim.

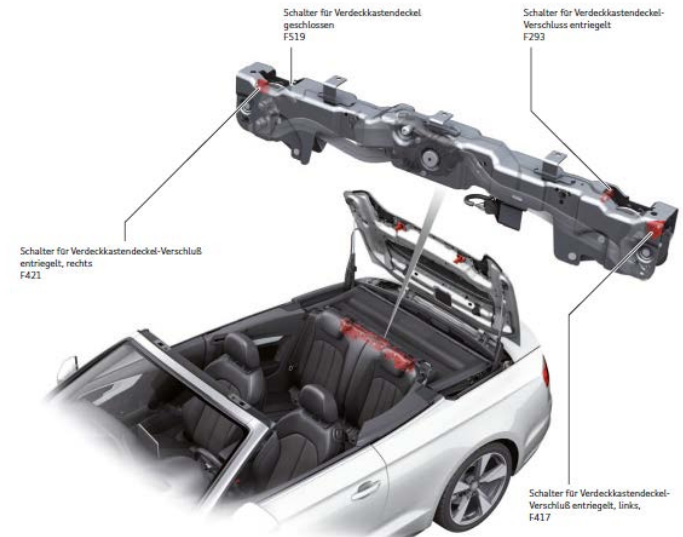
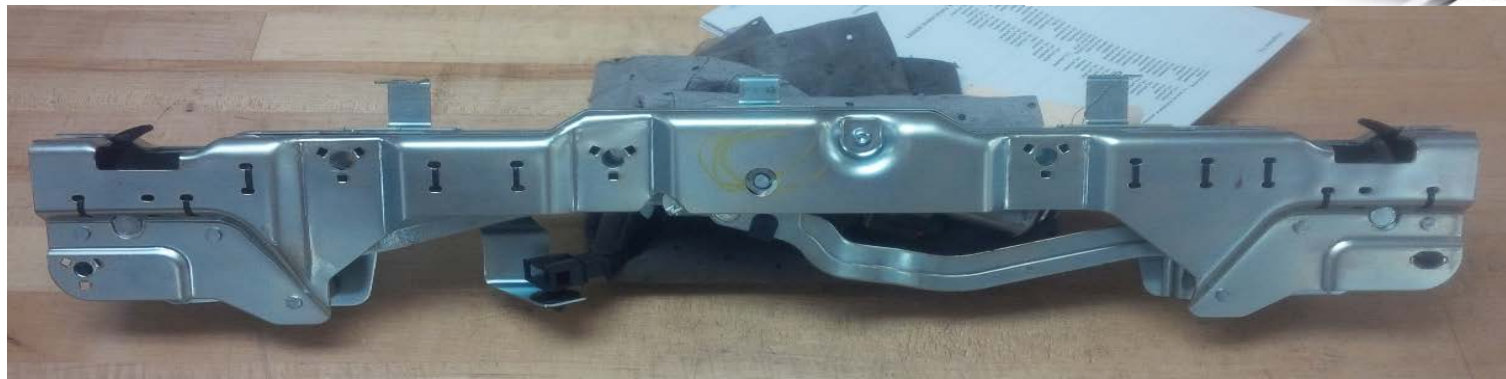
1.2) Convertible roof does not open → malfunction of CRCL lock:

- > Roof does not open/close.

Data logger identifies one or more of the following switches as the cause:

- > F293
- And/or
- > F417

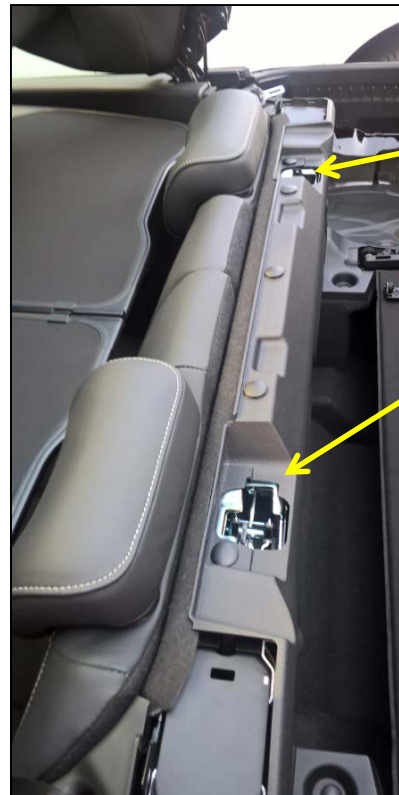
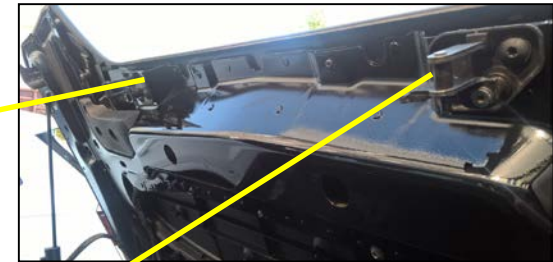
CRCL lock is constructed as a complete assembly. Switches fitted in module show delayed or different switching times when closing CRCL.

The operation of convertible roof may be interrupted as a result.

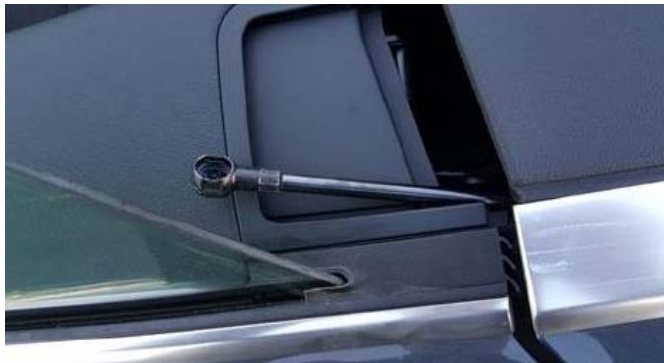
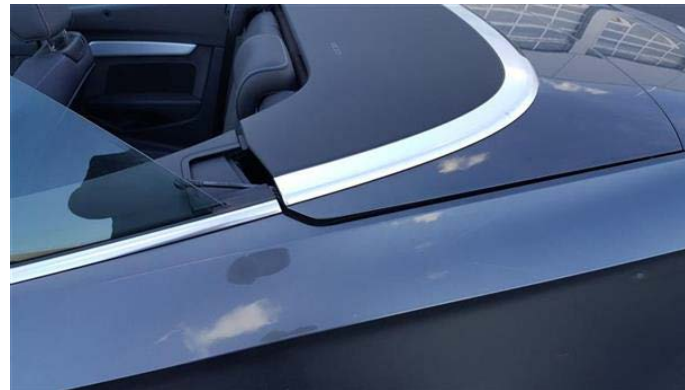
1.3) Hydraulic cylinder (CRCL closed) fallen off CRCL:

- Still possible to open/close convertible roof.

- Fallen off: lying detached on blocked roof hinge flap with no further damage.

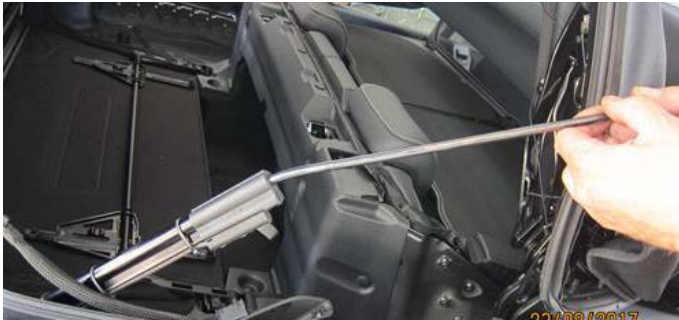
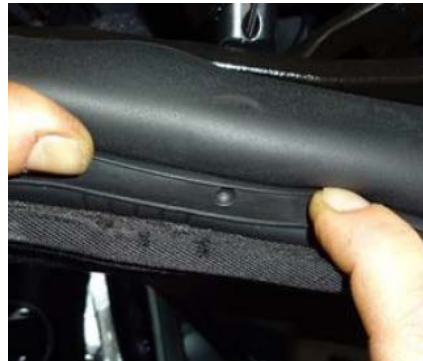
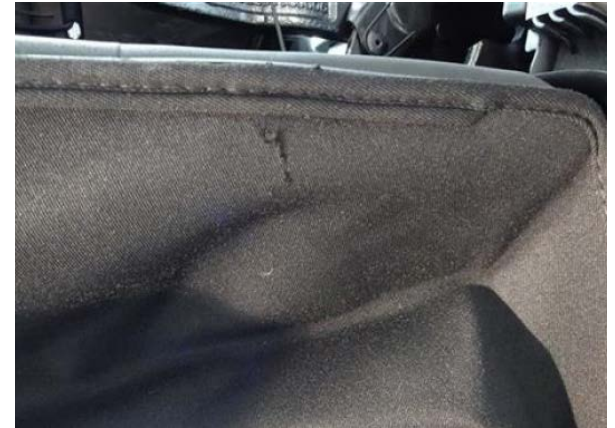
- Opening/closing interrupted.

- Fallen off: push rod of hydraulic cylinder bent.
- Subsequent damage: roof frame trim and/or convertible roof cover/headliner is damaged.

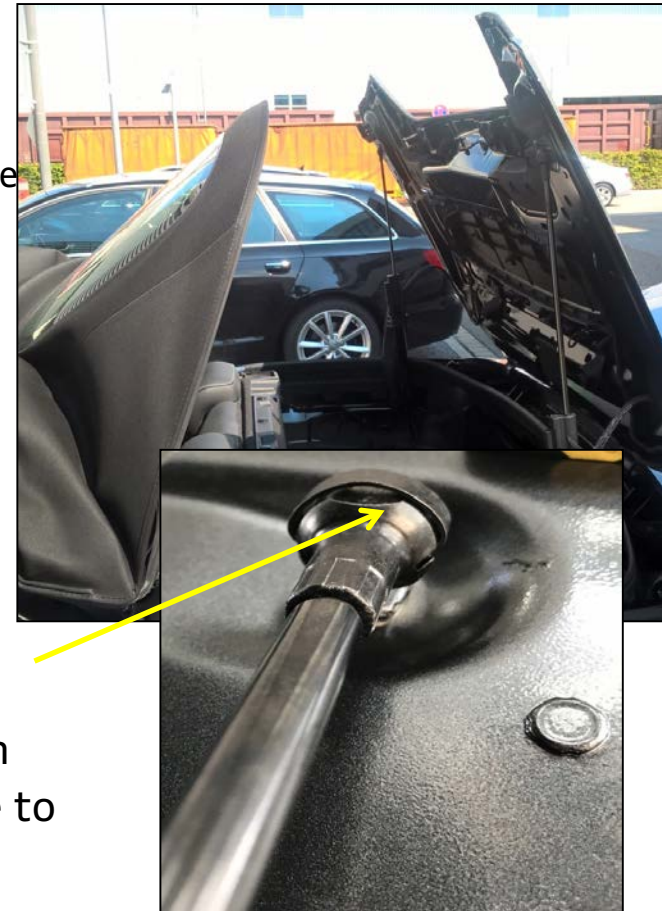
- › Ball socket of corresponding hydraulic cylinder on CRCL become detached when roof is closed.
- › If the roof is operated, piston rod can collide with and damage various surrounding components.

Due to concerns of creaking noises when CRCL is open, tolerances at ball stud and ball socket were reduced:

- › Paint applied to ball stud
- › Plastic ring for ball socket

As a result, the retaining clip of ball socket does not reach end position on ball stud and can become unfastened due to relative movement.

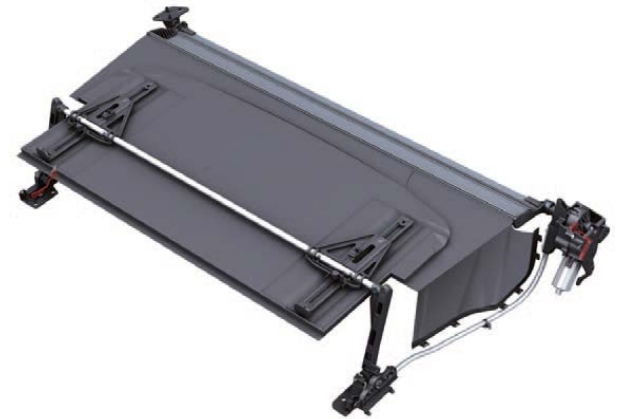
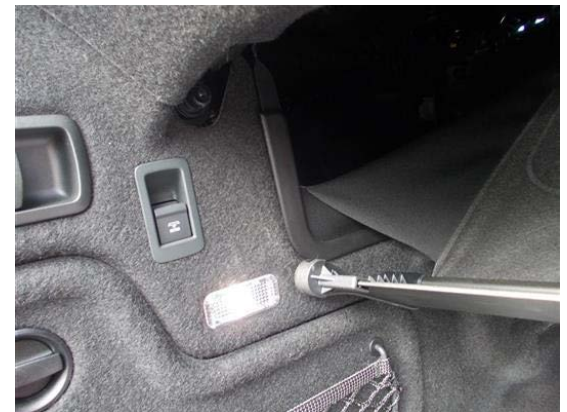
2.1) Roof compartment tray disconnected at drive:

- > Upon opening luggage compartment lid, the customer sees that front trim of variable roof compartment tray is detached on left side.
- > Tray can no longer be operated using button or convertible roof control system.

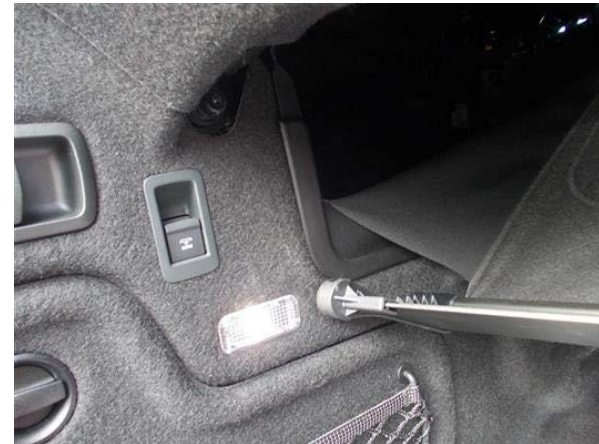
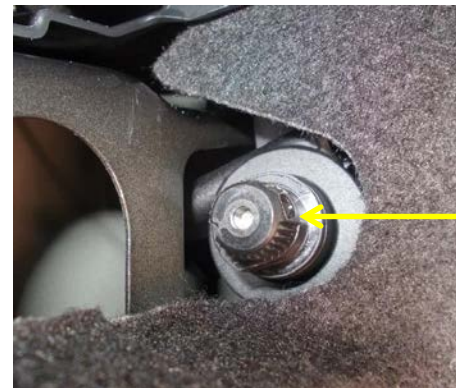
- > Retaining ring of drive shaft is not properly engaged during assembly.
- > When roof compartment tray is operated or pressure is applied to front trim (e.g. loading luggage compartment), the retaining ring may come loose and fall off.

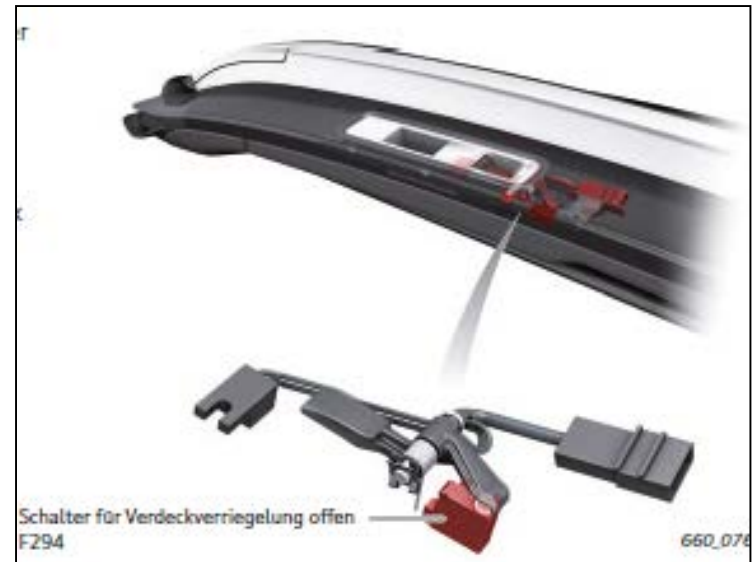
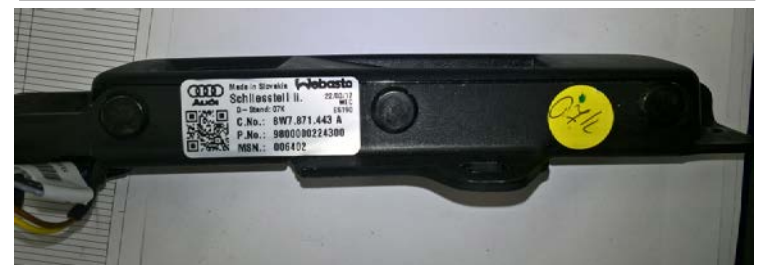
3.1) Convertible roof receiver in rear window frame – wiring damaged:

- > Roof does not open/close.

- > F294

- > *Short to earth (poss. sporadic)*

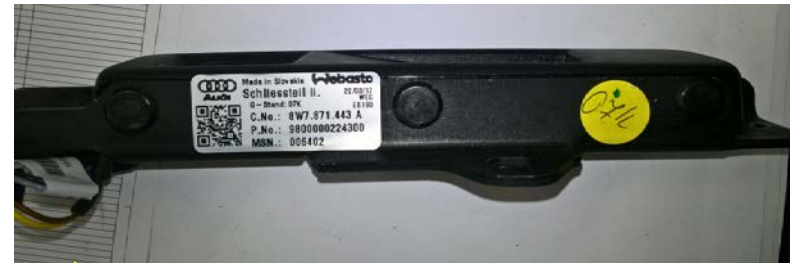
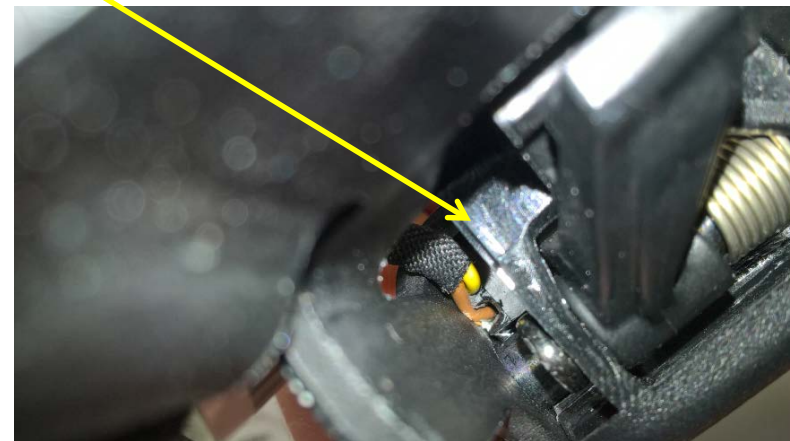
- Insulation on internal wiring for convertible roof receiver damaged at supplier when two halves of assembly housing are joined. Over time, this leads to a short to earth/short circuit caused by relative movement.

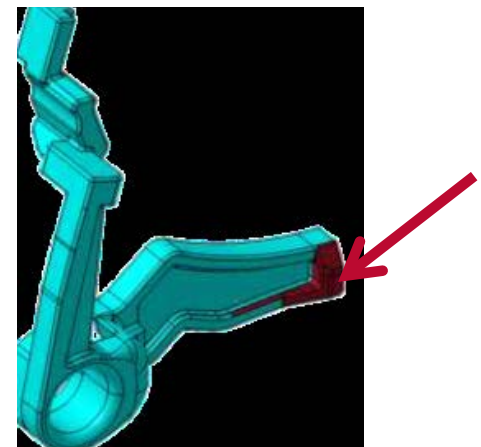
Rear lid lock sticks in first catch

When opened, the power-operated rear lid remains stuck in the first catch of the rear lid lock. It can only be opened by pressing the button in the handle, on the remote control key or in the door trim. The problem usually occurs when opening the rear lid for the first time.

Due to insufficient coverage at the lowest tolerance for the snow load lever, the locking pawl in the lock is released too early.

- › When operated slowly, the lock sticks in the first catch (customer must unlock twice).

- › Modified component geometry of snow load lever.

- › Replace rear lid lock.
- › There are no DTC(s) stored in the diagnostic memory.

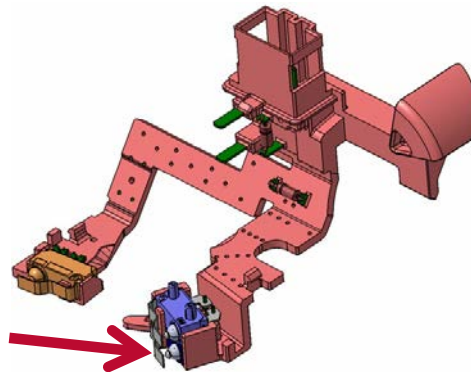
Rear lid only opens approximately 25 cm

During opening, the power-operated rear lid stops moving after opening approximately 25 cm (sporadic fault). It is then generally only possible to completely open and close the rear lid by hand. This problem often depends on the temperature.

Bent switch lugs on the first catch microswitch can prevent it from switching, causing the first catch to remain closed although the rear lid lock is completely released.

- › The rear lid opens approximately 25 cm and then stops, as only from this opening height onwards does the rear lid control module require a signal from the first catch to continue powering the rear lid drives.

- › Modified packaging at sub-supplier and camera surveillance of switch lugs on production line starting in October 2017 and onwards.

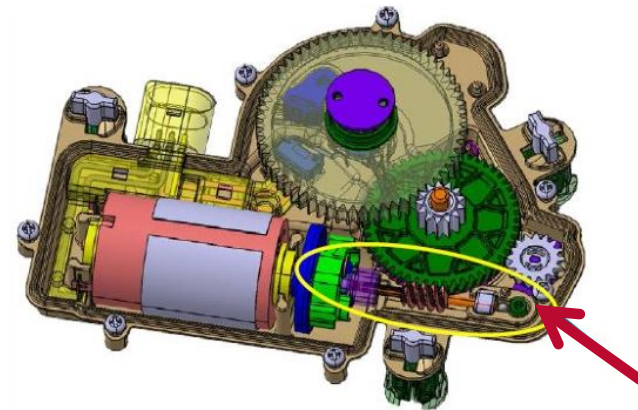
Rear lid is not pulled completely closed

The power-operated rear lid does not close completely/closes only as far as the first catch in the rear lid lock. The rear lid must be pressed fully closed by hand. The problem occurs most often at cold ambient temperatures.

Too great a tolerance in the screw shaft drive can cause the power latching system drive to stick. The power latching system drive does not reach the end position after it is operated. End switch for power latching system drive is not operated.

- The rear lid control module creates the DTC B113E29 “Power latch - implausible signal - static” in the diagnostic memory.
- The rear lid control module cuts off current to the power latching system drive until this DTC is at least passive/sporadic again.

- Additional component check at -4° F screw shaft sorting starting in December 2016 onwards.

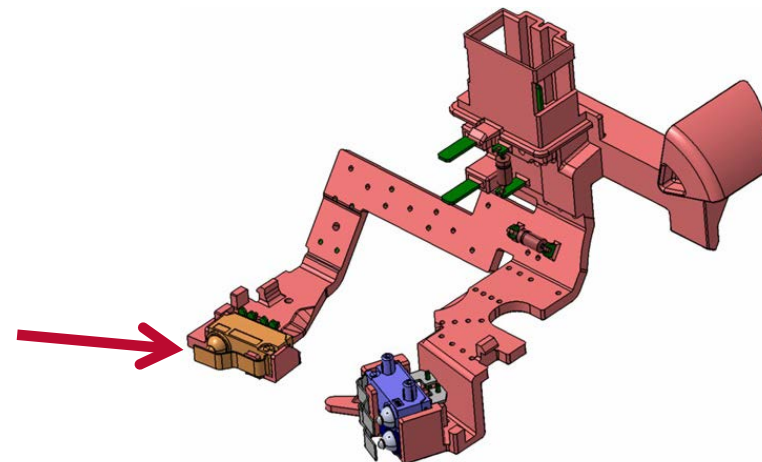
Rear lid is not pulled completely closed

A bent switch lug on the main catch microswitch can cause the microswitch to switch prematurely even though the rear lid lock is only closed as far as the first catch.

- The rear lid control module registers that both microswitches already indicate a closed position.
- The rear lid control module does not send current to the power latching system motor, as the control module registers from the microswitch signals that the rear lid lock is already closed (even though the rear lid lock is physically only in the first catch).

- Modified packaging at sub-supplier and camera surveillance of switch lugs on production line starting in October 2017 onwards.

- Replace rear lid lock.
- There are no DTC(s) stored in the diagnostic memory.

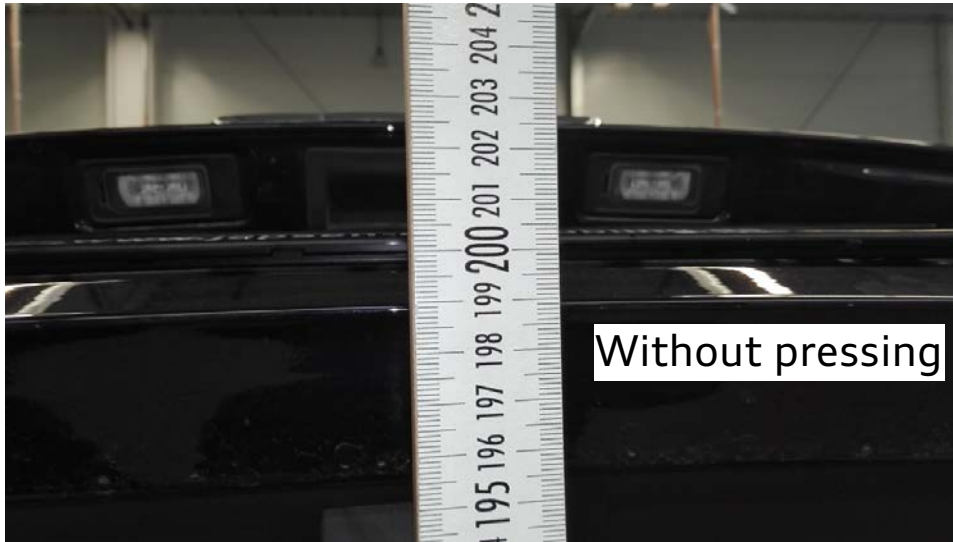
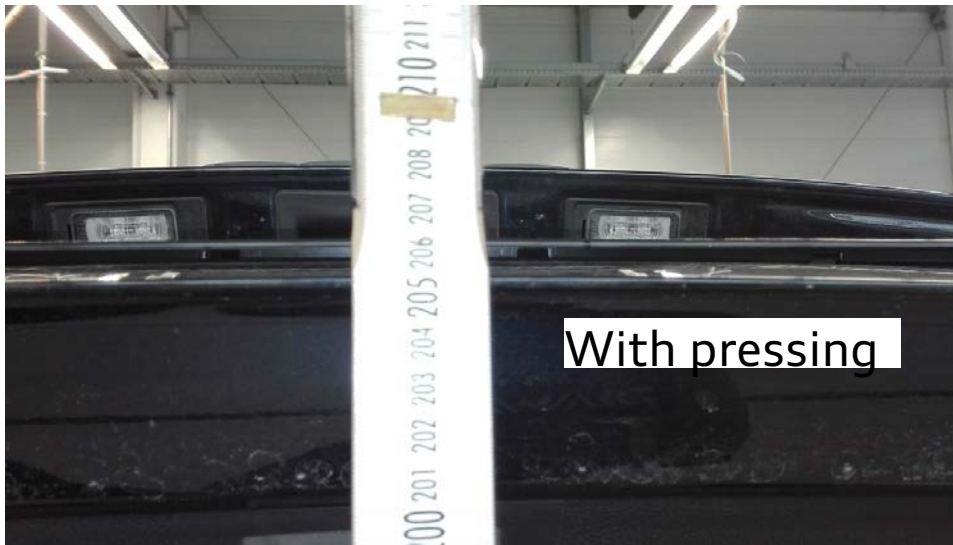
Rear lid does not open all the way

- The power-operated rear lid does not open all the way. After opening, there is still enough play towards top that it can be pressed by hand for the last 6 to 10 cm of the possible opening height.
- The problem generally occurs at cold ambient temperatures.

- When vehicles leave the factory, the rear lid has a small amount of play when it is completely open. The play increases if the opening height has been reprogrammed via the button in the rear lid trim.
- This is caused by play in the drive system and the value for the upper lock-in range that was entered at the factory. The result is that the maximum power-operated opening range can no longer be set.

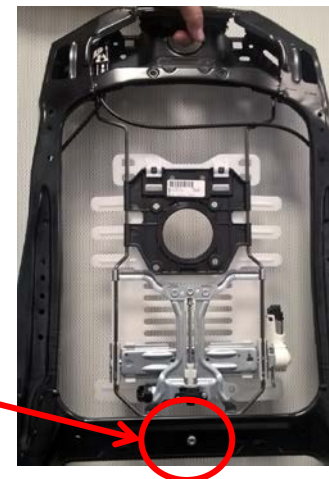
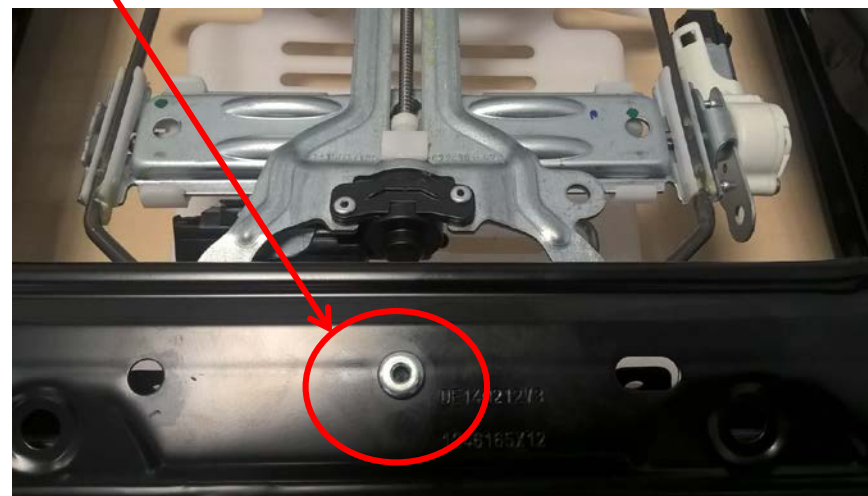
If the noises are coming from the area of the outer backrest frame, this may be caused by the connection between the lumbar support and the outer backrest frame.

- › Drill out old rivet and fit a larger rivet.

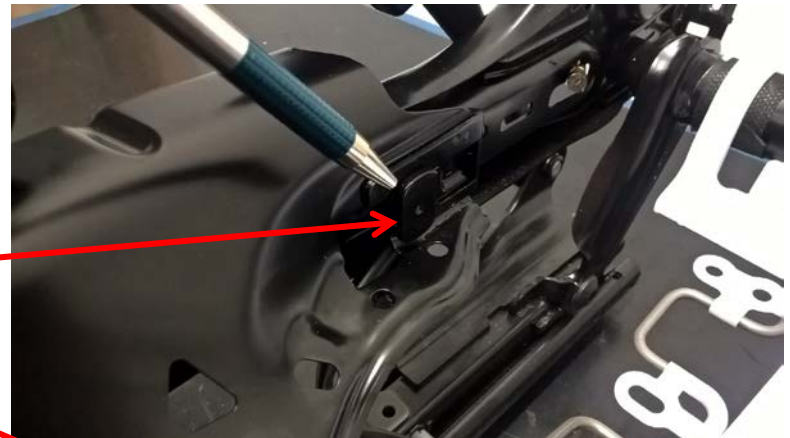
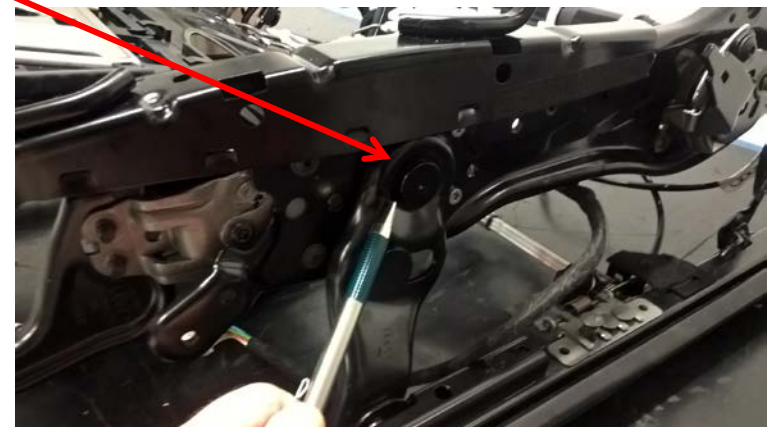
TT (3rd generation): Noises from front seats – e.g. seat frame

If the noises are coming from the area of the seat frame, this may also be caused by the connection to the hinged lever (top).

- › Please try to eliminate the noise by varying the height of the seat.
- › If this is not successful, the seat frame can be replaced.

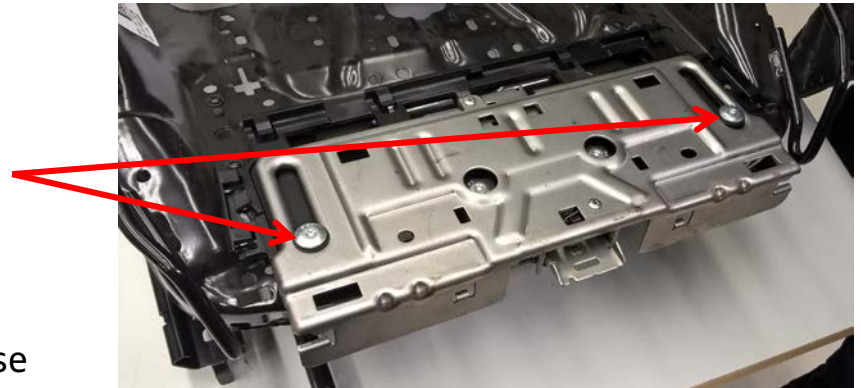
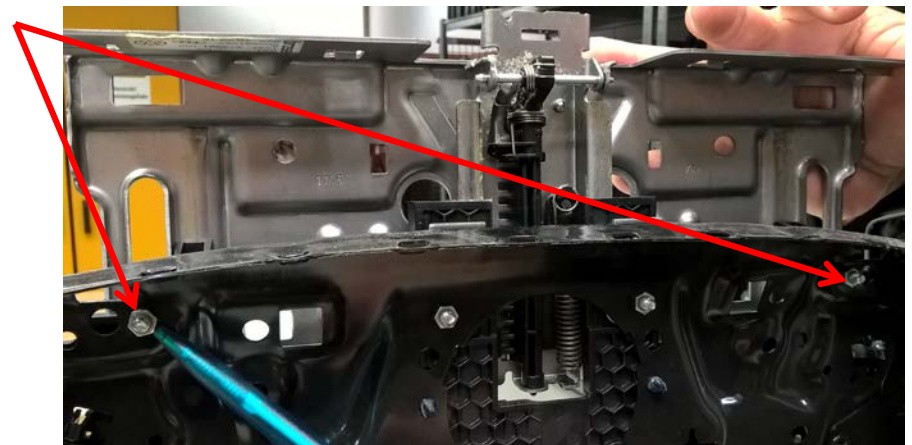
If the noises are coming from the area of the seat depth adjuster, this may also be caused by the connection between the seat depth adjustment unit and the seat frame.

- › Fit self-locking nuts instead of nuts and increase tightening torque to 7 Nm.

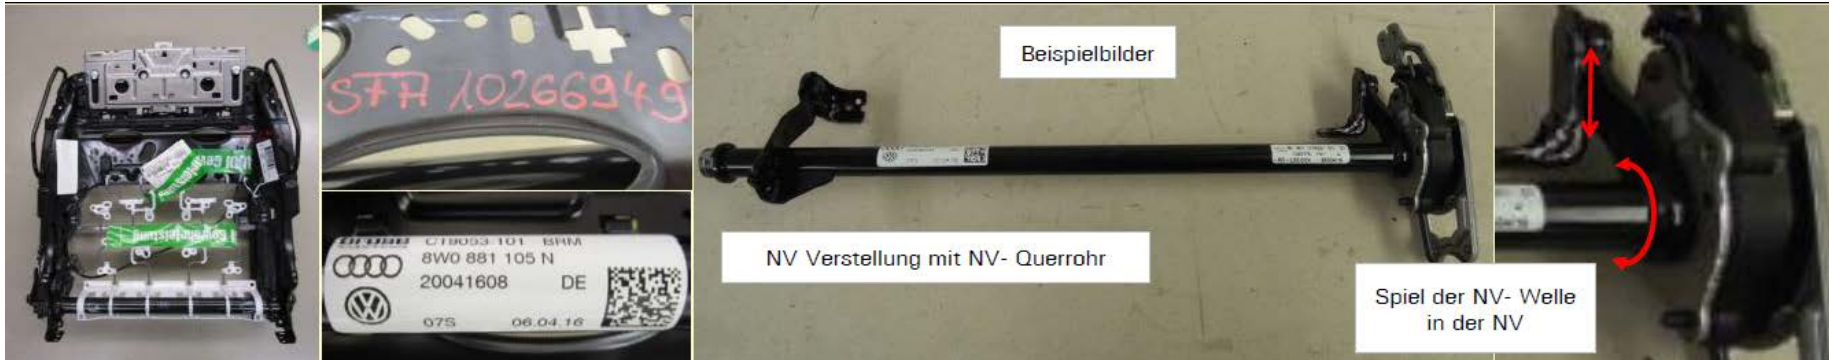
MLB: Noises from seat rake adjuster

If the noises are coming from the area of the seat frame, this may also be caused by the seat rake adjuster at the transverse tube of the seat frame.

- › Please try to eliminate the noise by varying the seat rake adjustment.
- › If this is not successful then the seat frame can be replaced.
