SI B11 03 18
Engine

N63R ENGINE: ENGINE OIL LEAK DIAGNOSIS AT TURBOCHARGER

G12 (750Li Sedan) Produced from 5/2015	G12 (ALPINA B7 Sedan) Produced from 12/2015	G30 (M550iX Sedan) Produced from 12/2016
--	---	--

With the N63R engine

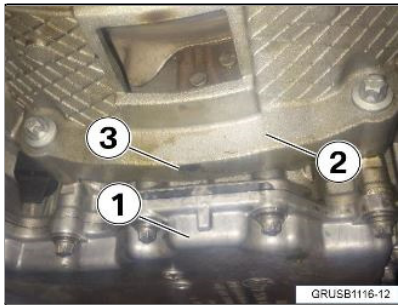
<p>GRUSB1116-12</p>	<p>The engine oil will exit the vehicle from between the engine and transmission.</p> <p>Engine oil pan (1) Transmission bell housing (2) Engine oil residue (3)</p>

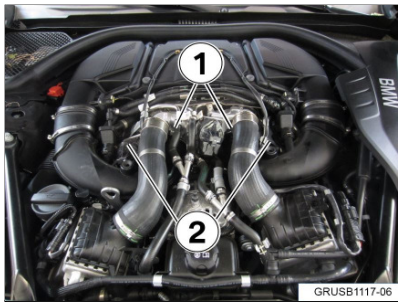
<p>GRUSB1117-06</p>	<p>1. Remove the acoustic engine cover.</p> <p>When diagnosing the engine oil leak it is necessary to use a borescope to identify if the source of the leak is coming from under the turbochargers.</p> <p>Insert the borescope to the inside (1) and outside (2) of the induction pipes.</p> <p>Rotate the borescope 360 degrees to search for any leaks.</p> <p>Try using the bore scope in the strait and 90° viewing positions.</p>

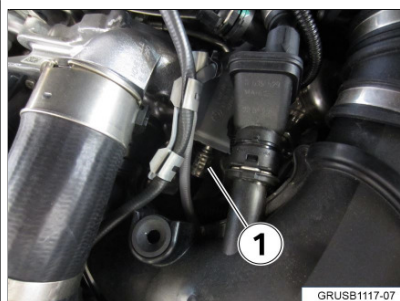
2. Pay special attention to any ferruled or clamped hose connections (1).

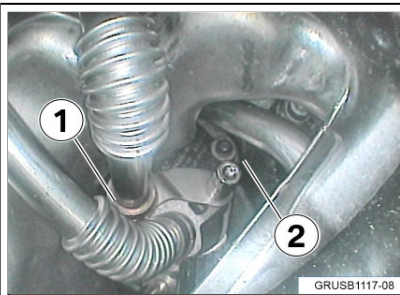
3. Insert the borescope downward towards the turbocharger oil return pipes.

Look for leaking connections (1).
Also search around the block surface for any standing engine oil (2).

Replace the turbocharger engine oil supply (feed) lines if found leaking.

Replace the oil supply (feed) lines using part number 11 42 7 934 654 (cylinder 1-4) and 11 42 7 934 655 (cylinder 5-8).
