SI B17 01 18
Cooling Systems

HEATER HOSE IS CONTACTING THE STEERING SHAFT

G12 (740 Li and 740 Li xDrive Sedans)	G30 (540i and 540i xDrive Sedan)	G32 (640 xDrive GT)	
---------------------------------------	----------------------------------	---------------------	--

With the B58 engine

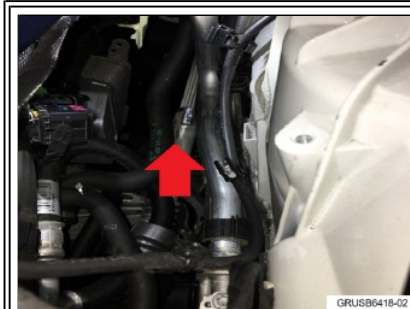
The customer may complain of a coolant leak from the front of the vehicle, or a noise when turning the steering wheel. The customer may also complain of a low coolant check control message.

The steering shaft can contact the heater hose, possibly wearing through the hose.

Install a hose retaining bracket to position the hose away from the steering shaft. Replace the heater hose if already damaged.
