SI B18 03 18
Exhaust Systems

SERVICE ACTION: CHECK THE EXHAUST CLAMPS AT THE CATALYTIC CONVERTERS (F90)

F90 (M5)		
----------	--	--

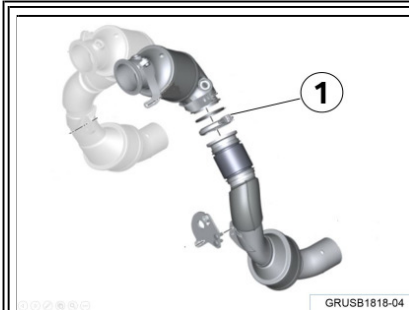
The screw clamps that secure the upper and lower catalytic converters (1) may loosen over time.

The screw clamps may have not been tightened to specification.

Check and if necessary, torque the screw clamps to specification.

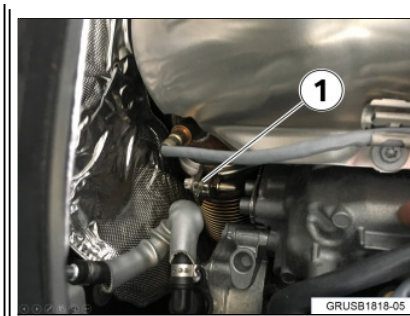
2. Inspect the screw clamps between the catalytic converts for

both banks 1 and 2. **Note:** Bank 2 is shown

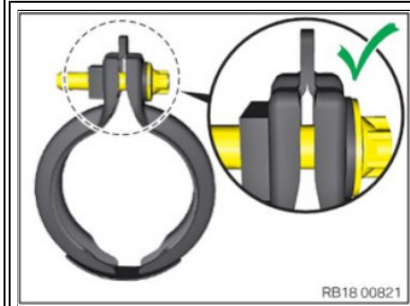
3. Correctly installed clamps have the tabs touching.

If the clamp is installed correctly, reinstall the engine acoustic cover. No further repairs are necessary

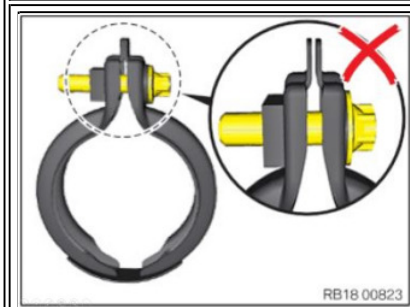
4. An incorrectly installed clamp will have a gap where the two tabs should touch.

5. Remove the strut brace as described in Repair Instruction **REP 11 12 070 Removing and refitting/replacing the acoustic cover.**
