SI B51 23 17  
Body Equipment

## HUMMING NOISE DURING SMOOTH ACCELERATION

This Service Information bulletin replaces SI B51 23 17 dated **September 2017**.

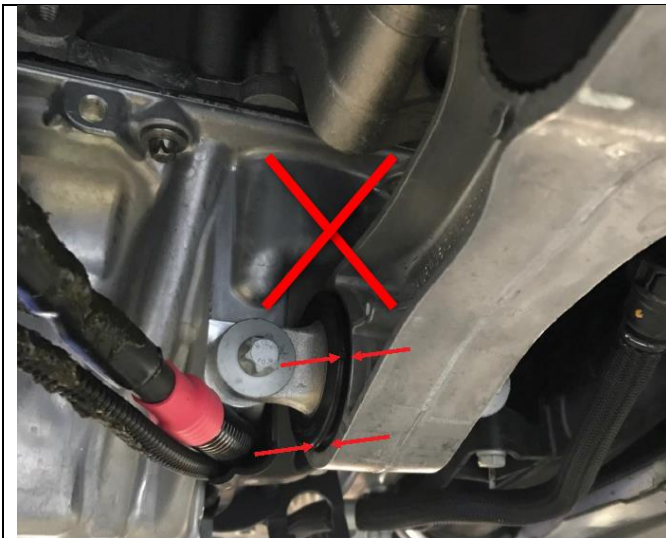
4. Inspect the rubber mount of the engine stabilizer link.  
**Is the rubber mount sliding out from the stabilizer link as seen to the left?**

<p>5. Replace the engine stabilizer link according to <b>REP 22 11 095</b> “<b>removing and installing/replacing holder with rubber mount</b>”.</p> <p>6. Test drive the vehicle.</p> <p><b>Has the noise been eliminated?</b></p> <p><b>YES</b>– no further repairs are required for this issue.</p> <p><b>NO</b> – continue diagnosis for other issues.</p> <p>

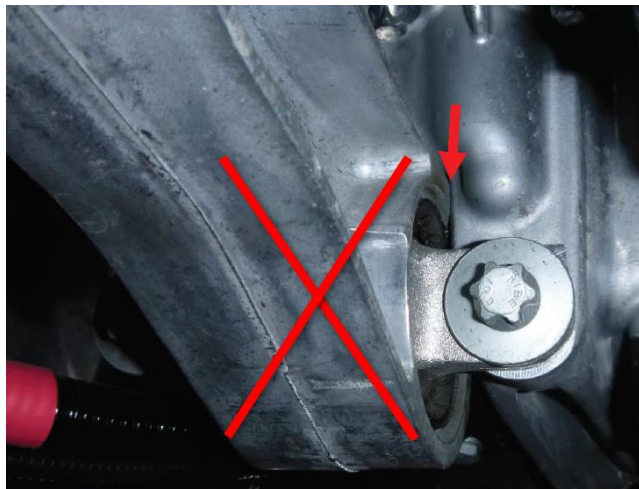
Note: In extreme cases engine stabilizer link may contact engine oil sump as shown in lower picture at left.
