AIR BAG LAMP ILLUMINATED. FAULT CODE 9309A0

F15 (X5 40e)

PHEV vehicles with N20 engine

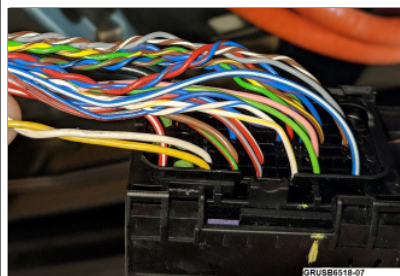
Here you can see the two wires white

<p>and Yellow are under tension</p>

10. These two wires need to have some tension relieved on them. Remove the last 8" of tape from the harness at the EME connector to introduce some stress relief into this connection at the EME.
