SI M51 05 16
Body Equipment

WATER LEAK IN REAR HATCH

F55 (Cooper, Cooper S Hardtop 4 door)	F56 (Cooper, Cooper S Hardtop 2 door)
---------------------------------------	---------------------------------------

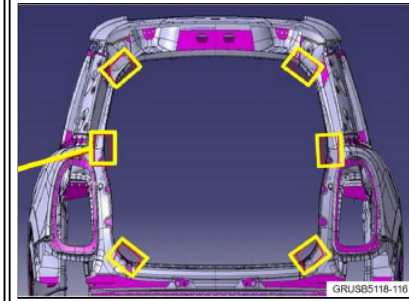
2. Inspect the application of body sealer at the hatch seams in the 6 locations shown to the left.

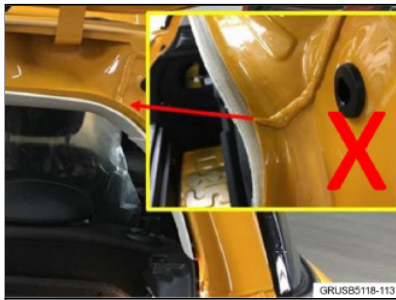
Does a raised portion of body sealer extend all the way to the end of the body seam as seen to the left?
