DRAG LINK REPLACEMENT

Prevost vehicles

On the vehicles affected by this bulletin, proceed to the replacement of the drag link.

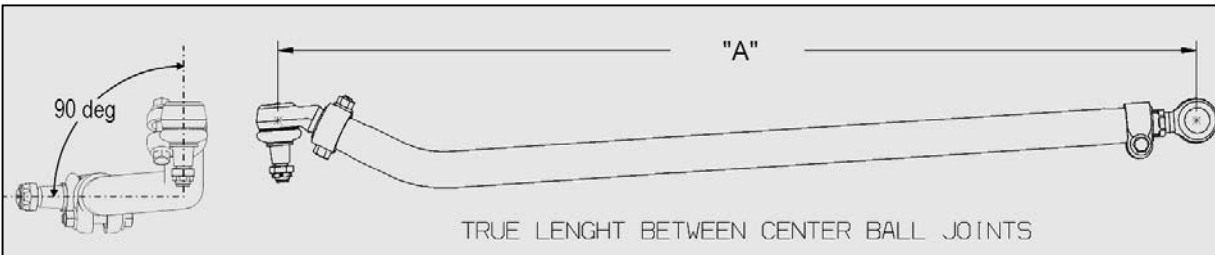
FIGURE 1

length A = 52" 3/8" ± 1/16" (1330mm ± 2mm)

length A = 53" 3/8" ± 1/16" (1356mm ± 2mm)

5. Check if the pre-adjusted length of the drag link is correct. To do so, try to install it between the steering arm and the pitman arm. If the length is not adequate, it must be adjusted to the required length. Use dimension "A" to adjust the length of the replacement drag link or you may use the replaced drag link for length reference.

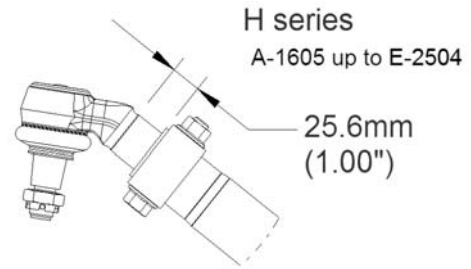
FIGURE 5

The limits of the adjustment sleeve do not provide enough extension.

- Unscrew the drag link elbow ball joint out **1 inch**. The tapered shank must point down as shown on FIGURE 1.

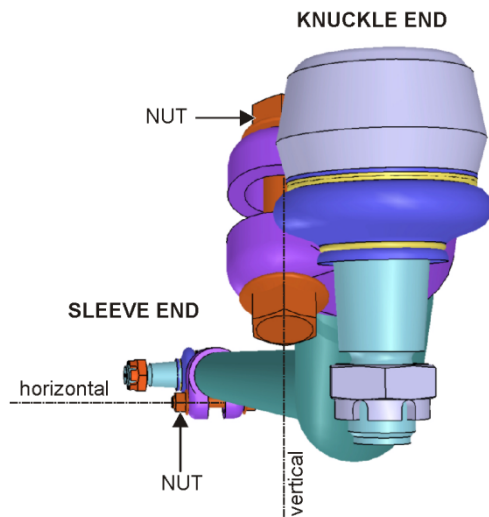
FIGURE 6: NOTE THE VERTICAL ORIENTATION OF THE CLAMP BOLT AT THE NUCKLE END AND ON WHICH SIDE THE NUT MUST BE POSITIONED

- To prevent interference between the ball joint clamp bolts and other components of the steering system, the clamp bolt must be positioned vertically as shown on FIGURE 6. **Tighten the clamp nut to 118-133 lbf-ft.**

Bolt and nut should be replaced every time they are unscrewed. While assembling the clamp, make sure the bolt does not touch the drag link tube.

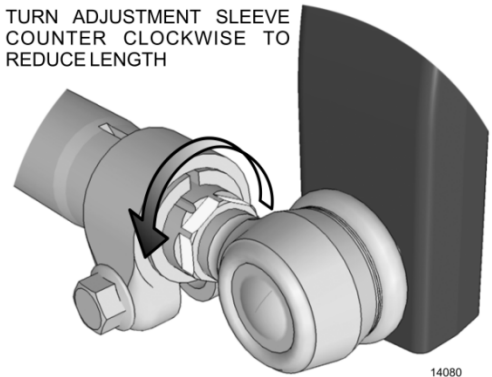
FIGURE 8

TURN ADJUSTMENT SLEEVE
COUNTER CLOCKWISE TO
REDUCE LENGTH

12. Fine adjustment of the drag link length if required should be performed exclusively by turning the adjustment sleeve while preventing the tube and joint from rotating.

- To extend, turn the sleeve clockwise.
- To retract, turn counter clockwise.

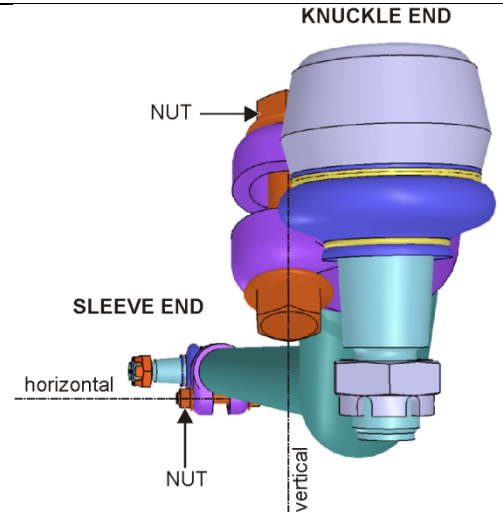
FIGURE 11: NOTE THE HORIZONTAL ORIENTATION OF THE CLAMP BOLT AT THE SLEEVE END AND ON WHICH SIDE THE NUT MUST BE POSITIONED

13. Adjust sleeve to the values of FIGURE 10.
14. Once the proper length adjustment is done, tighten the front end ball joint clamp. To prevent interference between the ball joint clamp bolts with other components of the steering system, the clamp bolt must be positioned horizontally as shown on FIGURE 11. **Tighten the clamp nut to 118-133 lbf-ft.**

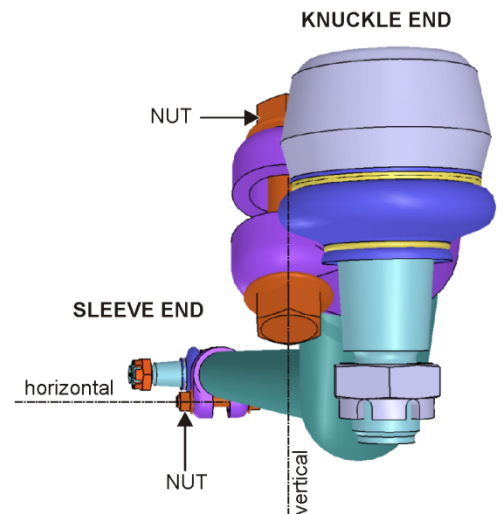
FIGURE 13: NOTE THE HORIZONTAL ORIENTATION OF THE CLAMP BOLT AT THE

SLEEVE END AND ON WHICH SIDE THE NUT
MUST BE POSITIONED

15. Adjust sleeve to the values of FIGURE 12.
16. Once the proper length adjustment is done, tighten the front end ball joint clamp. To prevent interference between the ball joint clamp bolts with other components of the steering system, the clamp bolt must be positioned horizontally as shown on FIGURE 13. **Tighten the clamp nut to 118-133 lbf-ft.**
