LTB01149NAS1

TECHNICAL BULLETIN

501-14: Handles, Locks, Latches and Entry Systems

'Hood open' Warning Message Displayed On Instrument Cluster

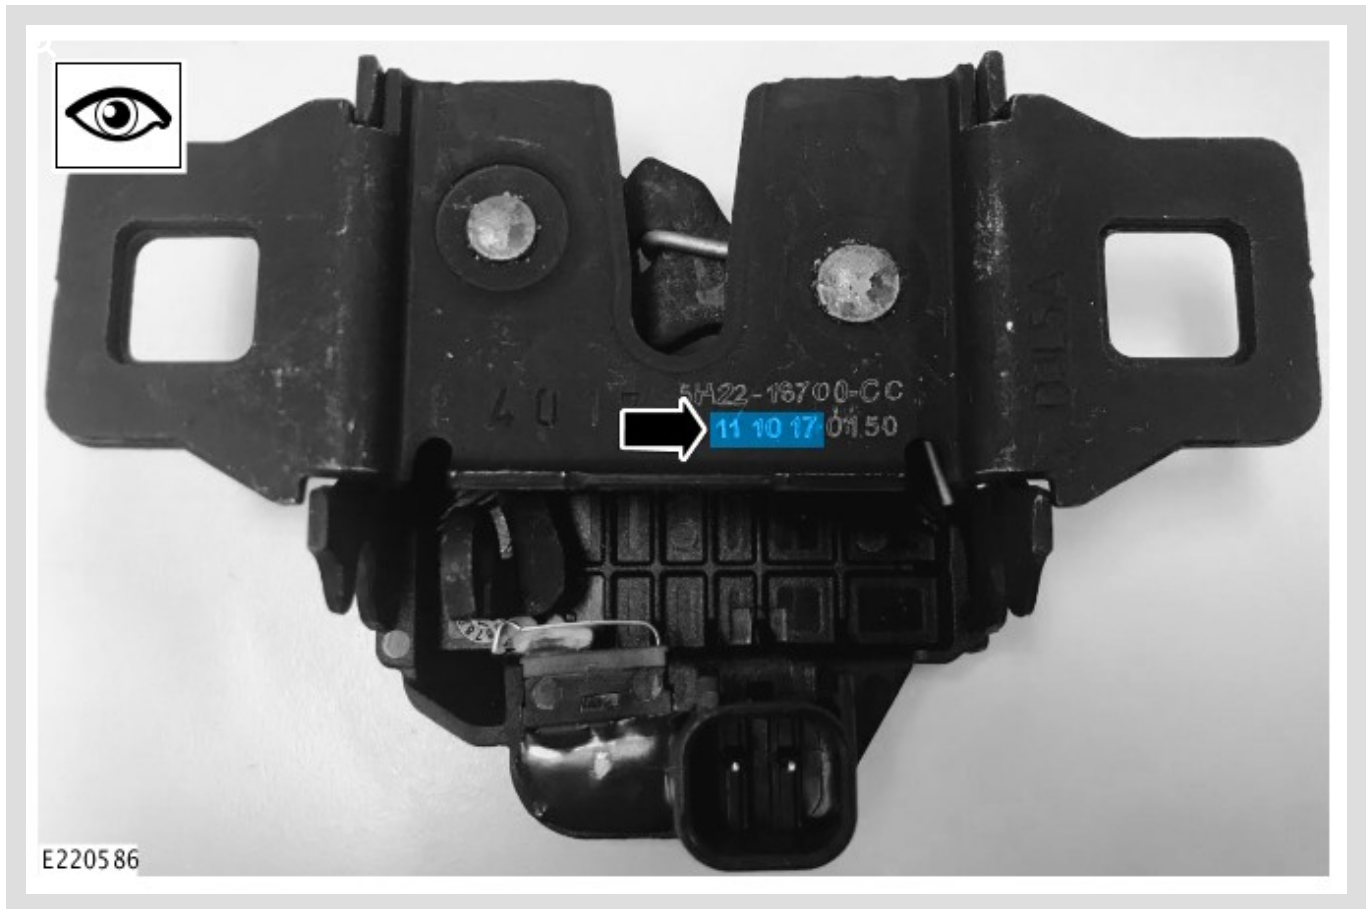
Make sure that the new hood latch date code (stamped on the hood latch) is **23/11/17** or later.

- 1 Replace the hood latch (see TOPIx Workshop Manual section 501-14: Handles, Locks, Latches and Entry Systems - Hood Latch).
