**NA\_MACK\_Vehicle\_Range****NA\_MACK\_Vehicle\_Range**

**NA\_VOLVO\_Vehicle\_Range****NA\_VOLVO\_Vehicle\_Range**

Oil Contamination Of The Clutch Due To Rear Crankshaft Adaptor O-ring Leakage - Oil Leak At Clutch And Flywheel Housing; Possible Burnt Clutch Smell And/Or Clutch Slipping; Possible Customer/Initial Report Of Crankshaft Rear Main Seal Leak - **OBD13 And Newer (16-Pin Diagnostic Connector)**

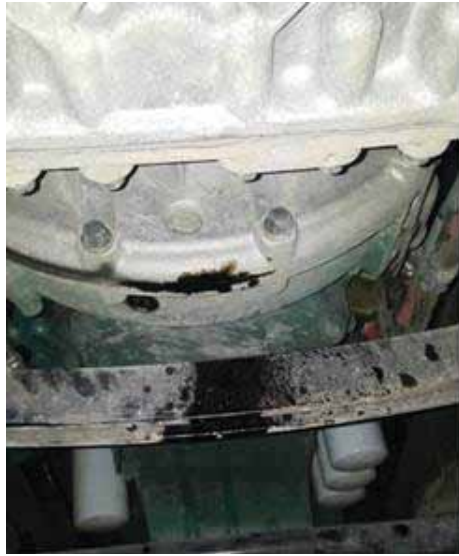
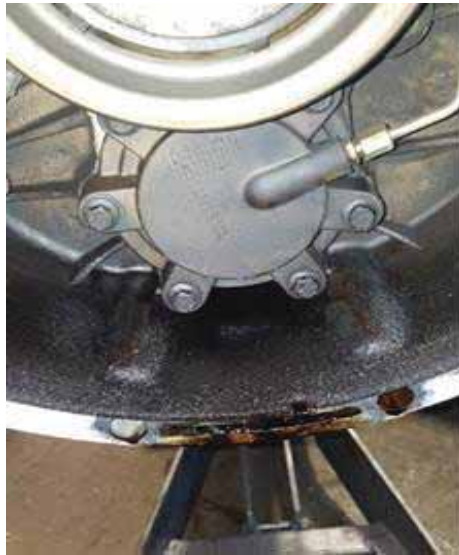
Engine Oil Accumulation in Bottom of Flywheel Housing

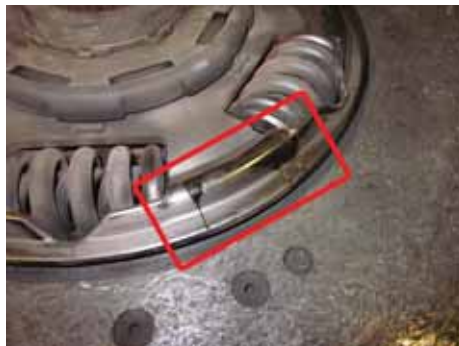
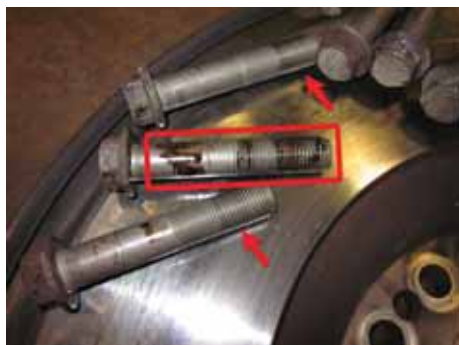
**Engine Oil on the Clutch Disk and Flywheel Bolt threads**

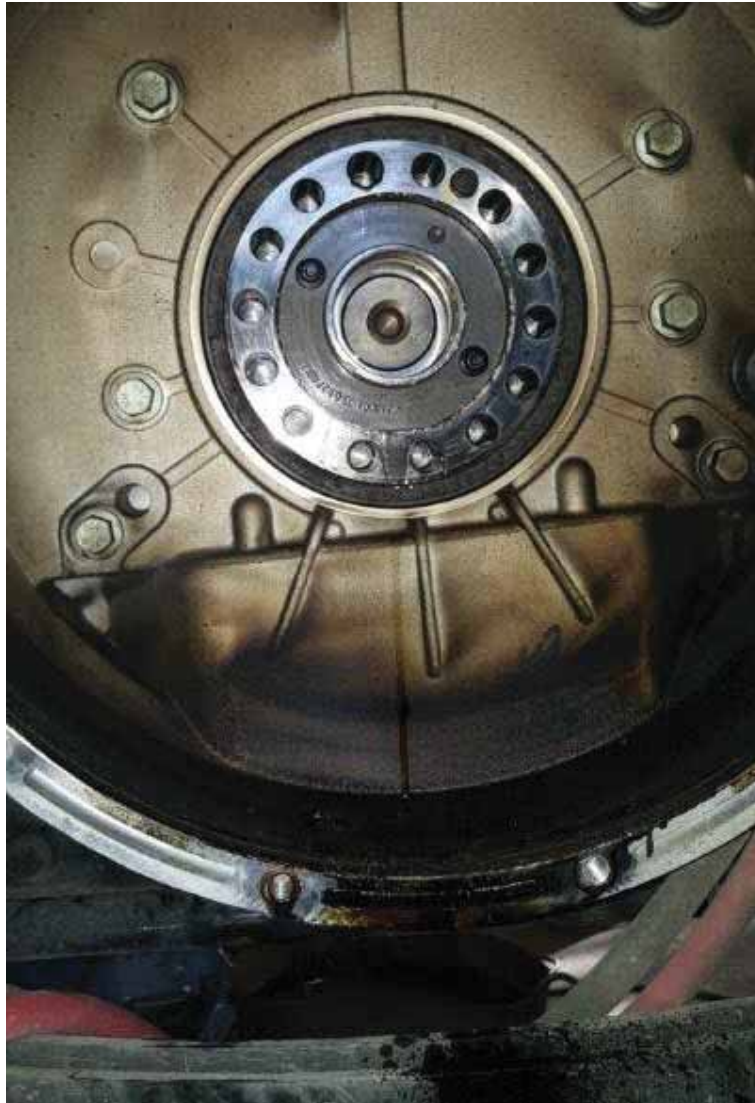
**Engine Oil Leak - Not from Main Seal** - Note that there is no oil path visible from the bottom of the crank flange down the face of the housing to the visible buildup

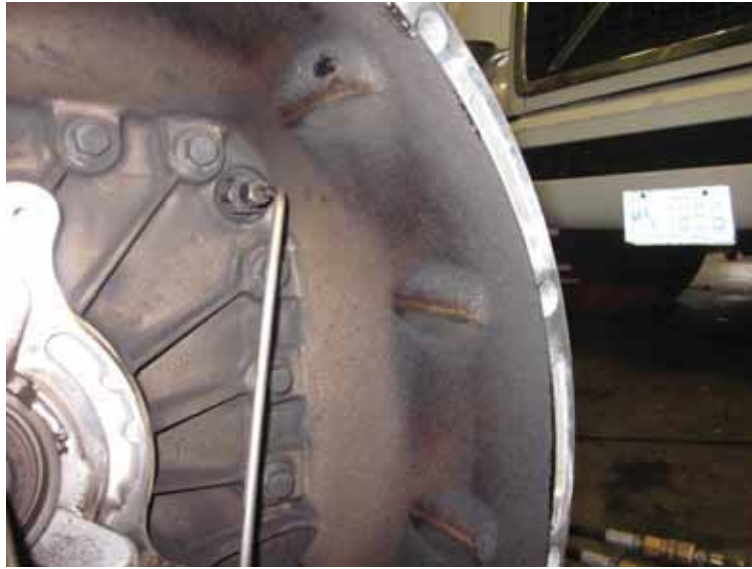
Oil Film visible on inner circumference of the Clutch Housing

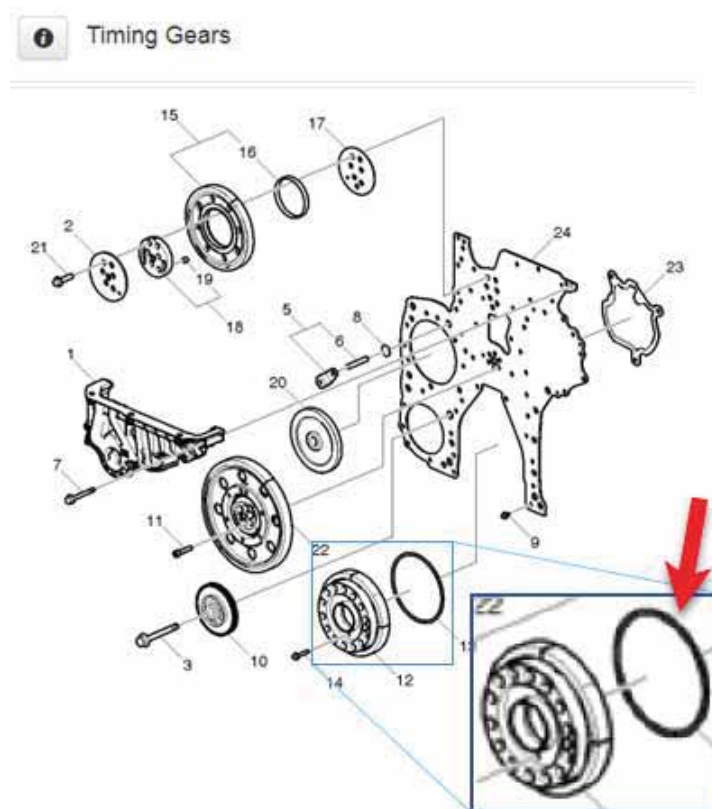
Note that the O-ring is located under the Timing Gear assembly in Impact, not the Crankshaft assembly.

A. This repair will require the removal of the flywheel housing in order to remove the rear crank flange adaptor and replace the o-ring. An exploded diagram showing the o-ring can be seen below:
