LTB01156NAS1 TECHNICAL BULLETIN 30 JAN 2018

303-01: Engine

Engine MIL Illuminated With DTC P132B-77 Stored

LTB01156NAS1 - Engine MIL Illuminated With DTC P132B-77 Stored | TOPIx

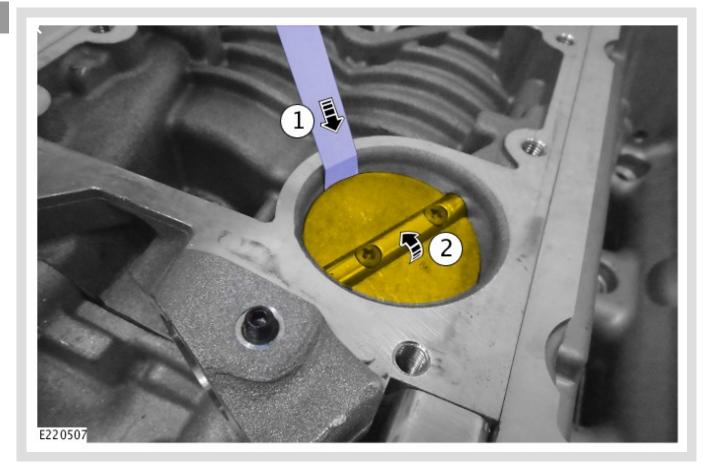
With the bypass valve in an open position, insert a feeler gauge **(1)** of 0.102 mm (0.004") into the valve body and close the valve **(2)**.

■ If the bypass valve is **NOT** set to a gap of 0.102 mm (0.004"), **continue to Step 3**.

If the bypass valve is set to a gap of 0.102 mm (0.004"), refer to TOPIx
Workshop Manual section 303-14A-E [depending on model]: Electronic Engine
Controls - Diagnosis and Testing and continue with diagnosis of DTC P132B 77 as a separate claim.
