## **JAGUAR LAND ROVER SHOP FOREMAN CONFERENCE CALL**

JANUARY 11, 2018

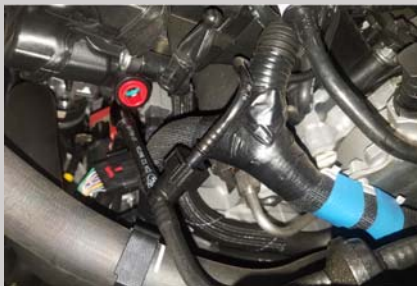
| Vehicle | Customer Concern | Details and Status | Publication |
|---|---|---|---|
| XCL vehicles equipped with GTDi engines and not covered by LTB00606NAS1 | A Customer may report the check engine lamp is on or various engine performance complaints. | <p>Diagnosis may identify a vacuum leak from a disconnected vacuum line from the intake manifold. This condition may be caused by boost pressure created during normal operation of the engine. Re-secure the line and make sure the fitting in the intake manifold is locked. Test the retention strength of the connection. Raise an EPQR if this condition is encountered and repaired. If parts replacement is required, hold the original parts for PRR.</p> | Under Investigation |

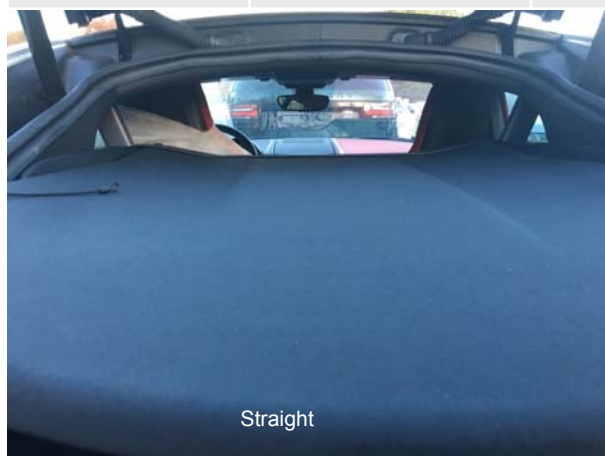
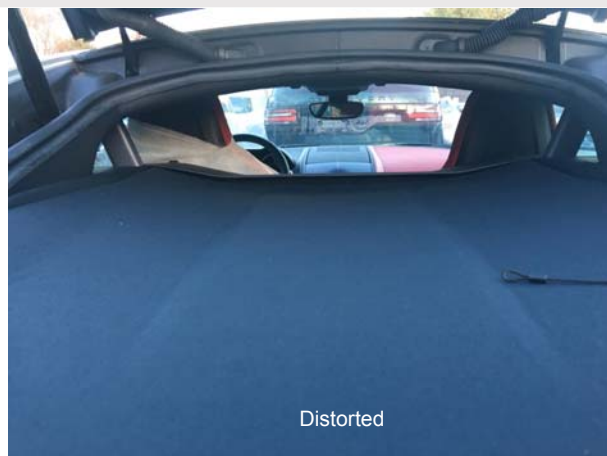
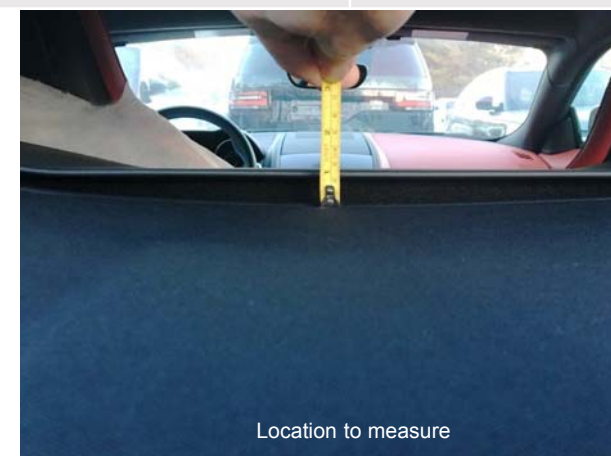
| Vehicle | Customer Concern | Details and Status | Publication |
|---|---|---|---|
| F-TYPE<br>Coupe | A Customer may report the load space cover is warping. | A Customer may find the Parcel Shelf (load space cover) is distorting, lowering in the center. This concern is currently under investigation. If you find any cases of this concern please submit an EPQR with picture showing the amount of distortion. | Under Investigation |
