Latest Vehicle Concern Fixes

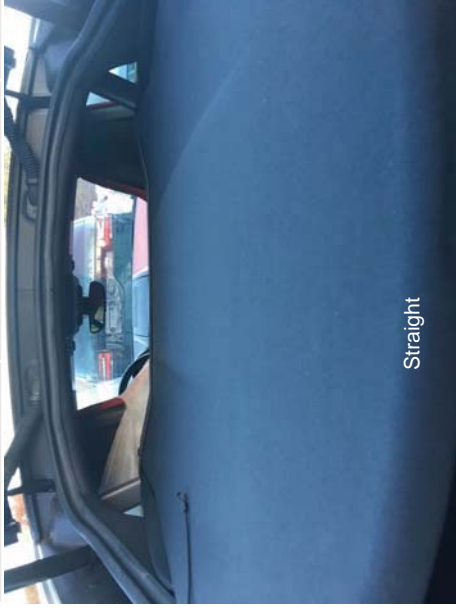
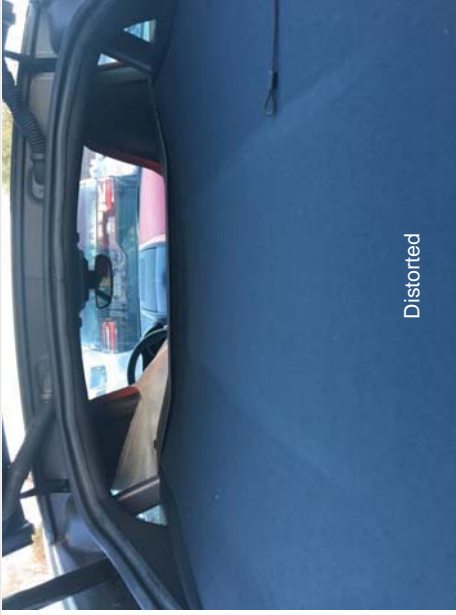
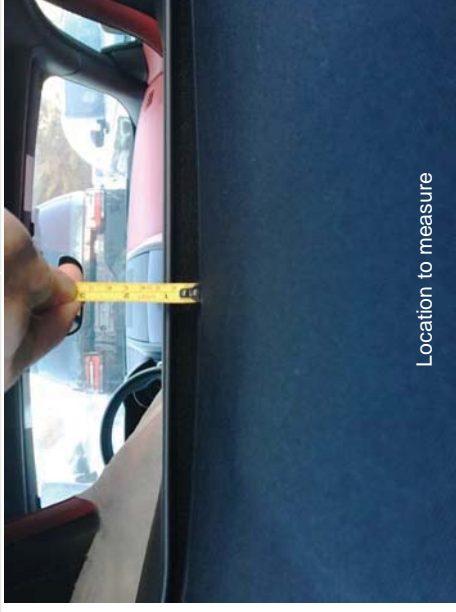
Vehicle	Customer Concern	Details and Status	Publication
Discovery 17MY onwards	A Customer may report difficulty in opening the hood.	A few reports have been received regarding difficulty opening the hood panel when the release level is pulled. The reports suggest that the cable is too long for the application and does not pull far enough to release the hood latches. This concern is currently being investigated. Should this concern be found please submit an EPQR for the vehicle to aid in the investigation.	Under Investigation
F-TYPE Coupe	A Customer may report the load space cover is warping.	A Customer may find the Parcel Shelf (load space cover) is distorting, lowering in the center. This concern is currently under investigation. If you find any cases of this concern please submit an EPQR with picture showing the amount of distortion.	Under Investigation
