Service Bulletin

File in Section: -
 Bulletin No.: 18-NA-003
 Date: January, 2018

Subject: Windshield Wiper Module Squeak Noise

Brand:	Model:	Model Year:		VIN:		Engine:	Transmission:
		from	to	from	to		
Buick	Enclave	2018	2018			All	All
Chevrolet	Traverse

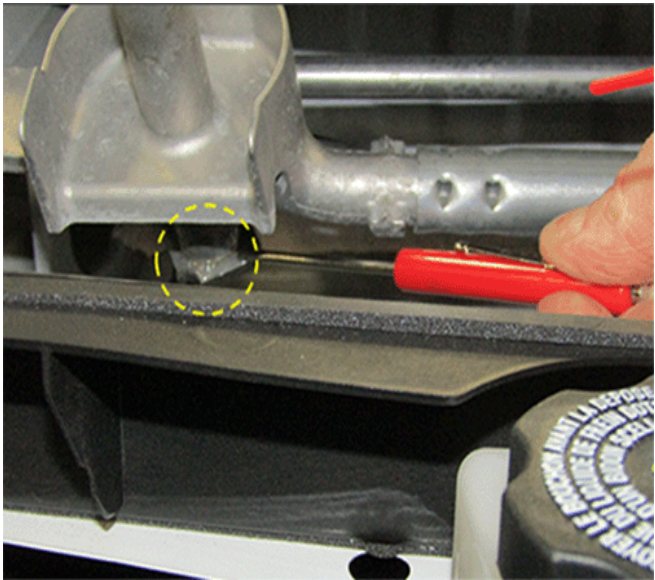
Involved Region or Country	North America, N.A. Export Regions
Additional Options (RPOs)	
Condition	Some customers may comment on hearing a squeak noise coming from the windshield wipers during normal operation.
Cause	The cause of the condition may be a lack of lubrication on the wiper pivot shaft from the manufacturer, during production of the wiper transmission.
Correction

<p style="text-align: right; font-size: small;">4924302</p> <p>Note: The O-ring location, shown circled in the graphic above, is for illustration purposes only. The O-ring is actually internal to the wiper pivot and IS NOT visible from this view.</p> <p>Lubricate the bottom O-rings on BOTH wiper pivot shafts following the Service Procedure below.</p>

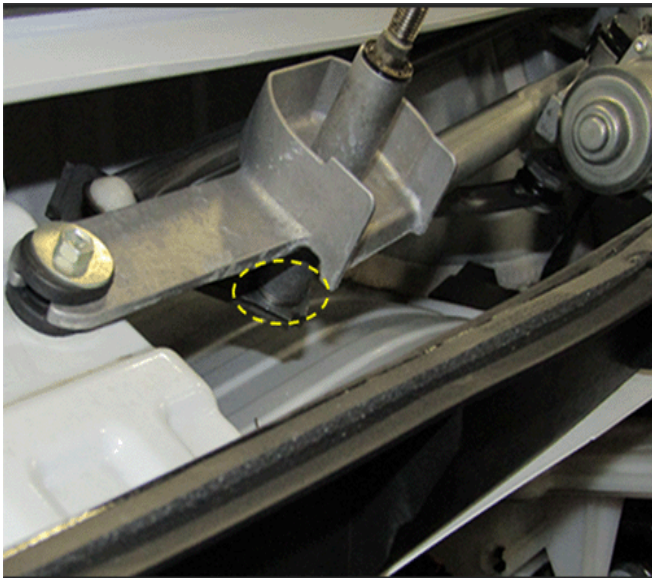
4924307

Note: The passenger side wiper pivot is shown in the graphic above.

2. Note the location of the bottom metal seam on both wiper pivot shafts.
