Service Bulletin

Bulletin No.: 18-NA-010

Subject: Information on Tire Repair for Continental ContiSilent Tire with Quiet Foam

Brand:	Model:	Model Year:		VIN:		Engine:	Transmission:
		from	to	from	to		
Buick	Regal	2018	2018

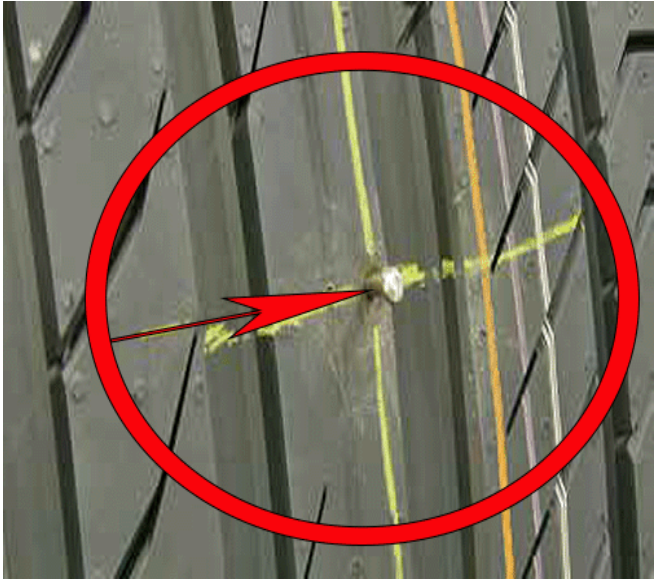
Involved Region or Country	North America
Condition	Some customers may comment on a tire losing air.
Cause

<p style="text-align: right;">4926148</p> <p>This condition may be caused by a foreign object puncturing in the tire tread area.</p>
