# Service Bulletin

Bulletin No.: 18-NA-025

**Subject:** Improperly Fit Floor Liners

Brand:	Model:	Model Year:		VIN:		Engine:	Transmission:
		from	to	from	to		
Cadillac	Escalade	2018	2018				
Chevrolet	Tahoe						
GMC	Yukon

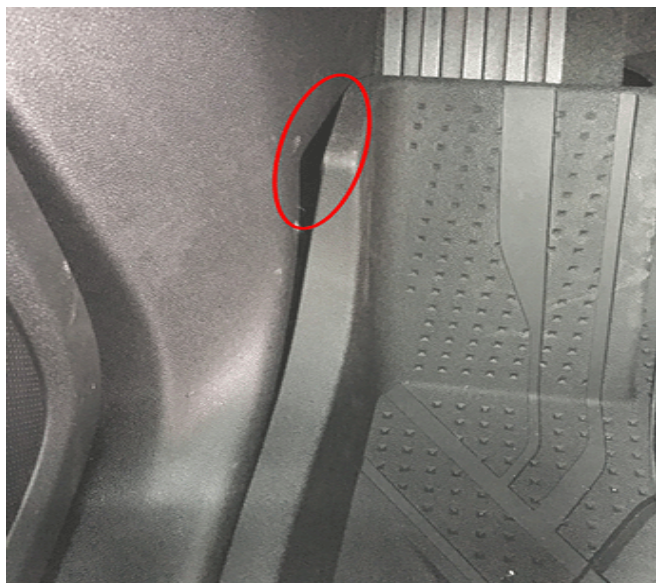
4944315

As shown in the graphic above, some vehicles will have the wiring harness routed incorrectly behind the drivers side trim garnish causing the floor liner to appear in a way as if the liner is incorrect for the vehicle.

1. Remove the front side door sill garnish molding.
2. Validate the wiring harness is routed properly behind the trim garnish.
3. Install the front side door sill garnish molding.
4. Validate that the liner sits flush to the side panel and carpet.
  - If the re-positioning of the wiring harness from behind the trim garnish centers the floor liner, no further repairs are needed.
  - If the re-positioning of the wiring harness from behind the trim garnish does not center the floor liner, proceed with procedure.

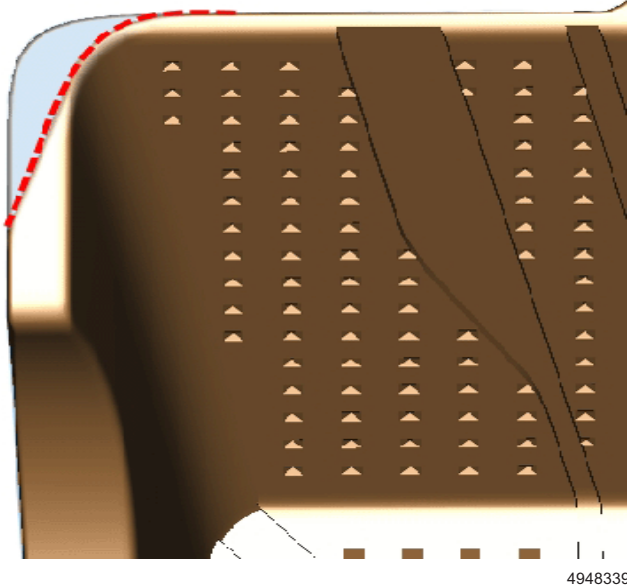
As shown in the graphic above, some vehicles will have the wiring harness routed incorrectly behind the passenger side carpeting causing the carpet to push the floor liner in a way to appear as if the liner is incorrect for the vehicle.
