Service Bulletin

Bulletin No.: 18-NA-031

Subject: Brief Rattle or Tick When Revving Engine in Park/Neutral or Rattle from Turbocharger on Cold Start

Brand:	Model:	Model Year:		VIN:		Engine:	Transmission:
		from	to	from	to		
Cadillac	ATS	2016	2019			3.6L (LF4)	
	CTS Sedan (VIN A)	2014	2019			3.6L (LF3)

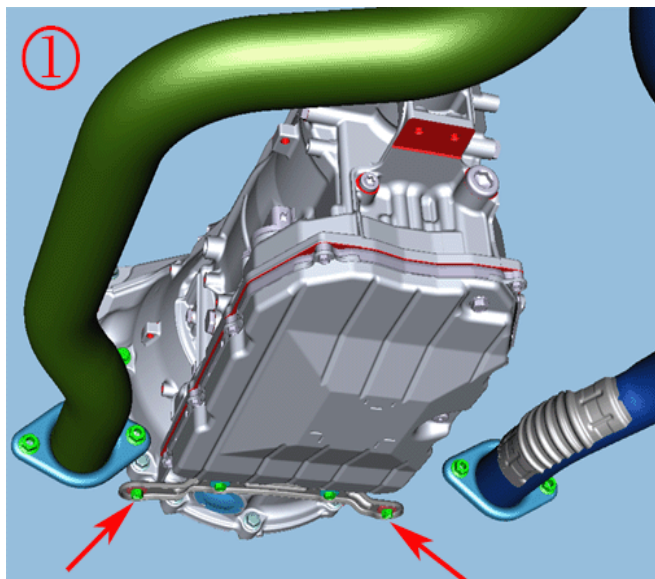
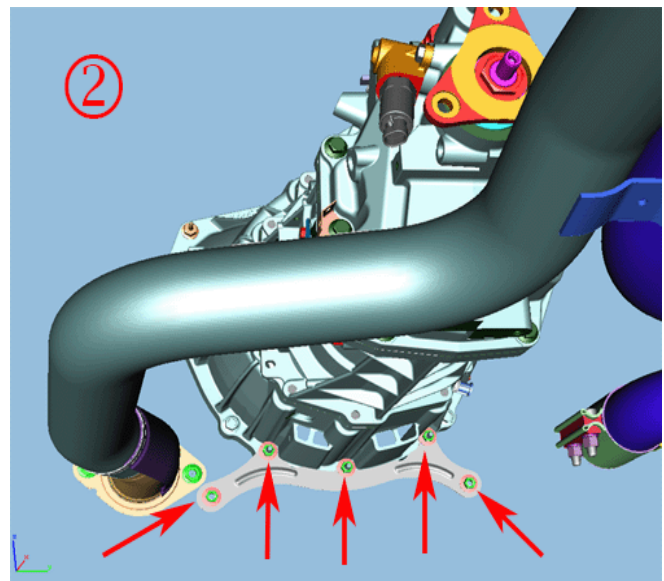
Inspect the M8 nuts that secure the catalytic converters to the exhaust bracket. RPO LF3 (1) and RPO LF4 (2) as shown above.

- If technician finds the M8 nuts are loose, it will be necessary to replace them with new torque prevailing nuts. Refer to the latest version of PI1234.
- If the technician finds that the nuts are torqued correctly, this is not the concern. Proceed to Loose Wastegate Actuator Arm procedure in this bulletin.

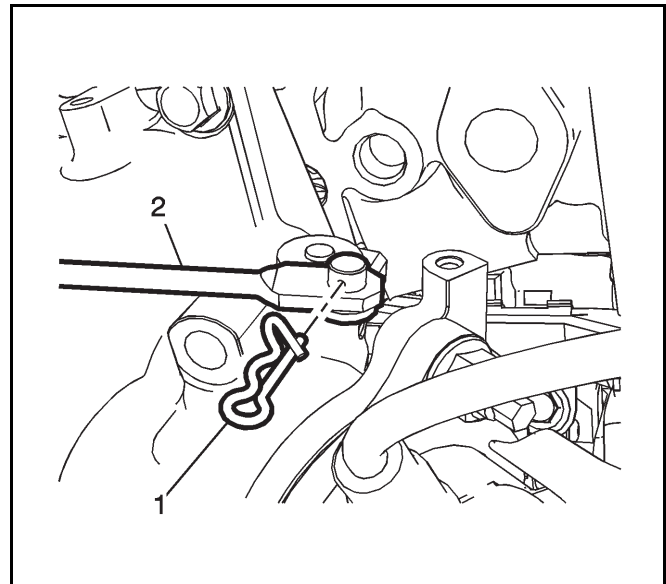
3339414

1. Remove the actuator arm retainer (1) that secures the wastegate actuator arm (2) to the wastegate valve.

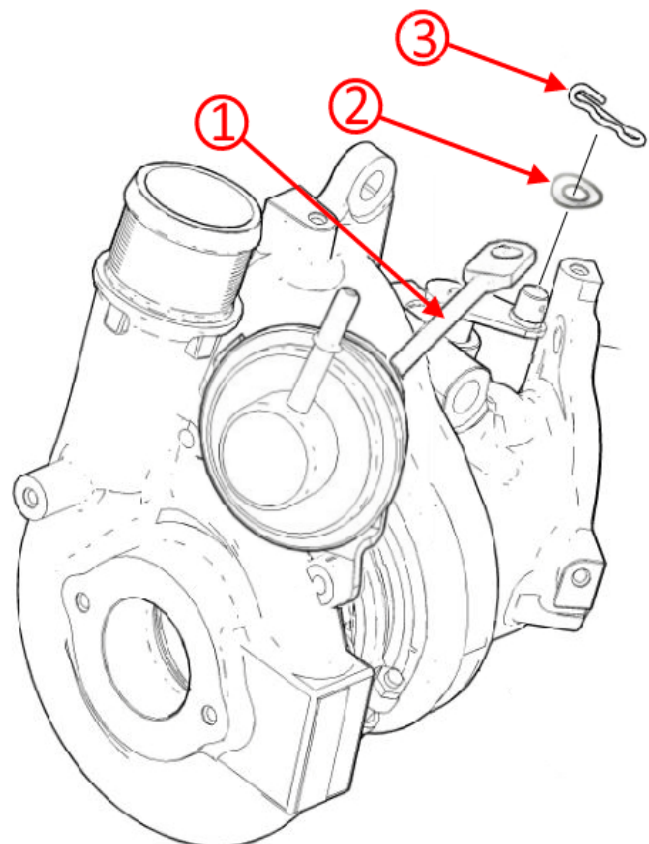
4952841

2. Remove turbo wastegate actuator arm (1) from the wastegate valve.

Important: It is vital that the spring washer is installed properly with the concave side pushing upwards against the actuator arm.

3. Install the cup spring washer (2) onto the wastegate valve with the concave side facing up.
4. Install the turbo wastegate actuator arm to the shaft.
5. Install the arm retainer (3).
6. Install previously removed components.
