# Service Bulletin

**Subject:** Information on Vibration Analysis and Diagnostic

**Models:** 2014 Chevrolet Silverado 1500  
 2015-2017 Chevrolet Silverado 1500  
 2014 GMC Sierra 1500  
 2015-2017 GMC Sierra 1500  
 EXCLUDES HD Trucks

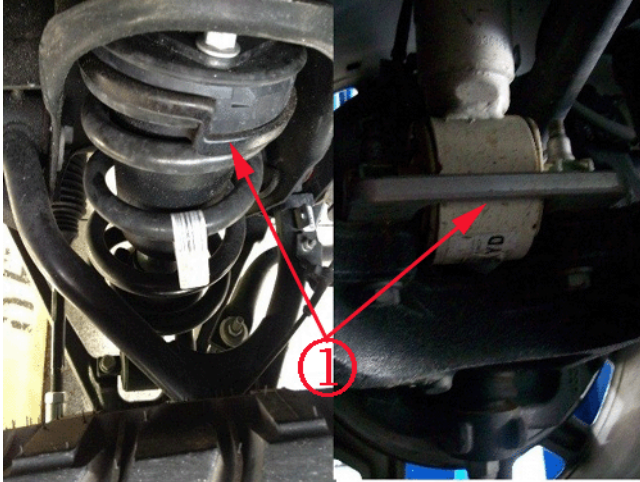
1. Inspect the truck for any aftermarket equipment installations. For example: non factory tires, wheels and/or lift kits or leveling kits – shims (1) installed as shown above. Aftermarket equipment does include running boards, bug deflectors, and window shades, etc. Remove any aftermarket that might cause vibration transmission paths.
2. Mark each tire valve stems location on the tire. This will be utilized to check for tire slippage on the rim.

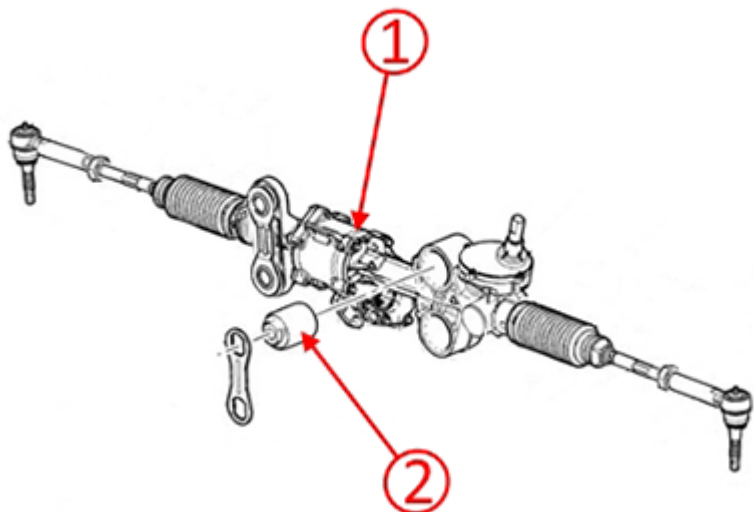
A revised steering bushing (2) has been released to address customer vibration concerns. After various testing and measurement of the T1 vibration, a vibration path from the tie rods =>steering rack=>steering bushings=>frame=>Body Mount=>Cabin Floor=>Seat has been identified. To help isolate the steering rack (1), a revised hydraulic bushing has been released and tuned to the T1 frequency. The new steering bushing dampens minor T1 vibrations. This is the reason that the causal part (normally the Tire/Wheel Assembly) must be corrected first. If the T1 vibration is over 20-25m/g's, the bushings will have little to no effect.

For vehicles with T1 vibrations under 20-25m/g's, replace steering bushing per parts catalogue. Utilize SI procedure "Steering Gear Mount Bushing Replacement" for replacement of the steering bushings.

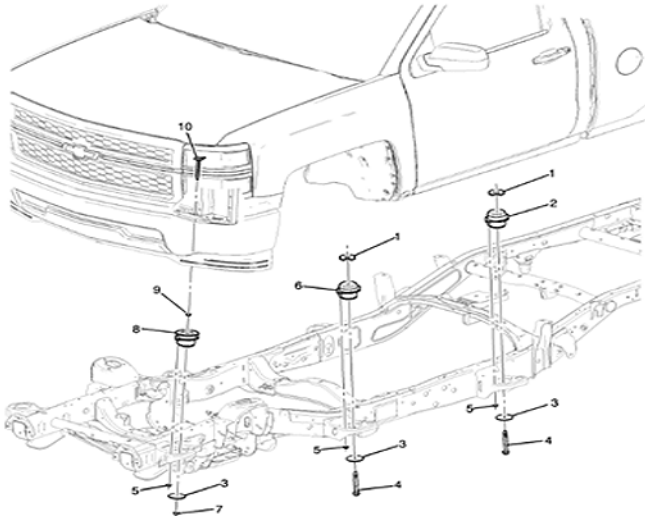
A revised Rear Cab Mount has been released to address customer vibration concerns. After various testing and measurement of the T1 vibration, a vibration

path from the tie rods =>steering rack=>steering bushings=>frame=>Body Mount=>Cabin Floor=>Seat has been identified. To help isolate the cab, a revised Cab Mount has been released and tuned to the T1 frequency. The new cab mount dampens minor T1 vibrations. This is the reason that the causal part (normally the Tire/Wheel Assembly) must be corrected first. If the T1 vibration is over 20-25m/g's, the cab mount will have little to no effect.

Correction: Replace Rear Cab Mount with Revised part number.

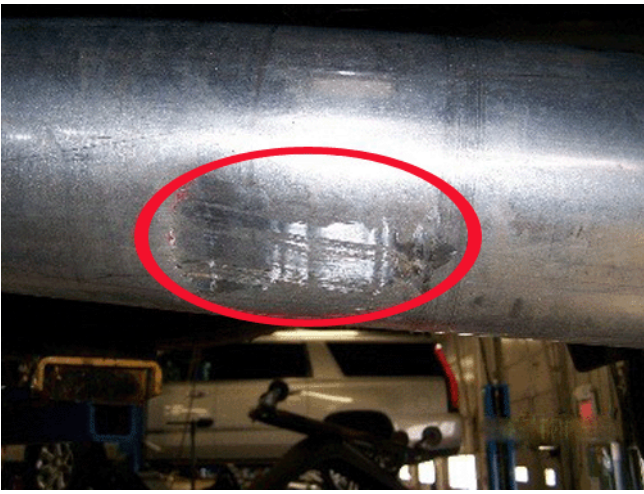
- Inspect the propeller shaft for dents or damage. There have been many cases of dented propeller shafts.
- For 4WD Trucks, remove the rear propeller shaft, seal output shaft and drive the vehicle in 4WD. If the vibration is gone, the rear prop shaft could be the problem.
- For vehicles with a 3:08 with a one-piece steel shaft, this can be replaced with a one-piece aluminum one that is utilized on all 3:42 and 3:73 ratios (K15543 and K15753 Models only).
- PIP5140: Low Speed Vibration 30-35 mph (48-56 km/h).
- Inspect the transmission output shaft bushing for irregular wear.

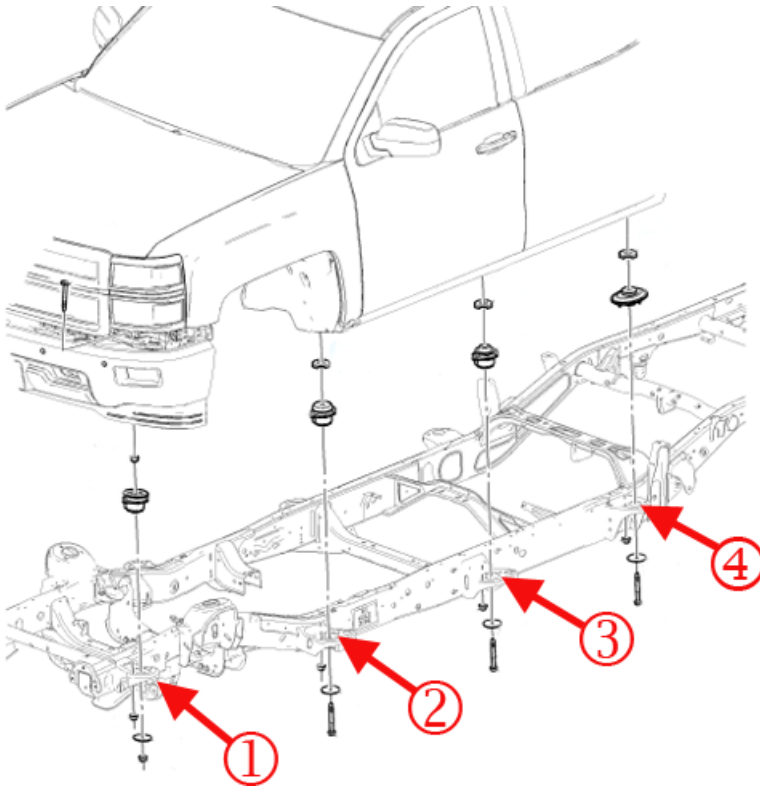
The numbers in the picture below indicate the specific mount position. The mounts on the passenger side of the vehicle are identified the same way. This will assist the technician to identify the correct location of each mount so they can be torque to the proper specification.

- 1 = body mount cushion front
- 2 = body mount cushion position number 1
- 3 = body mount cushion position number 2
- 4 = body mount cushion position number 3

Visually verify that the cab to box alignment is correct before re-torquing all mounts to specification found in Service Information, body repair, frame and under body section.
