Service Update

18058 Missing High Speed LAN Wires

Reference Number: N182149730 Release Date: March 2018 Revision: 00

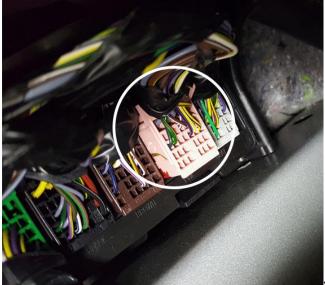
4975776

1. Locate the Body Control Module (K9, BCM) under the dash and gain access by pulling back the carpet in the passenger's foot well.
