# Customer Satisfaction Program

## 17455 Dinghy Towing Causing Tire Squeal

Reference Number: A172119210

Release Date: March 2018  
Revision: 00

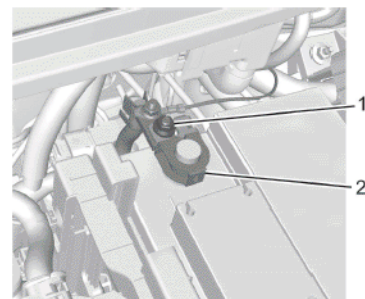
4962286

3. Loosen the negative battery cable nut (1).
4. Remove the negative battery cable (2) from the battery.

1. Install the negative battery cable (2) to the battery.
2. Install the negative battery cable nut (1) and tighten.
3. Turn the ignition on.

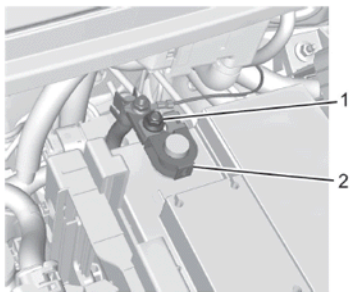
3. Desserrer l'écrou de câble négatif de batterie (1).
4. Déposer le câble négatif de batterie (2) de la batterie.

1. Reposer le câble négatif de batterie (2) sur la batterie.
2. Poser l'écrou du câble négatif de batterie (1) et le serrer.
3. Mettre le contact.
