Service Update

18085 Crankshaft Position Sensor Connector Terminal Seal Issue

Reference Number: N172124340

Make	Model	Model Year		RPO	Description
		From	To		
Chevrolet	Volt	2018	2018

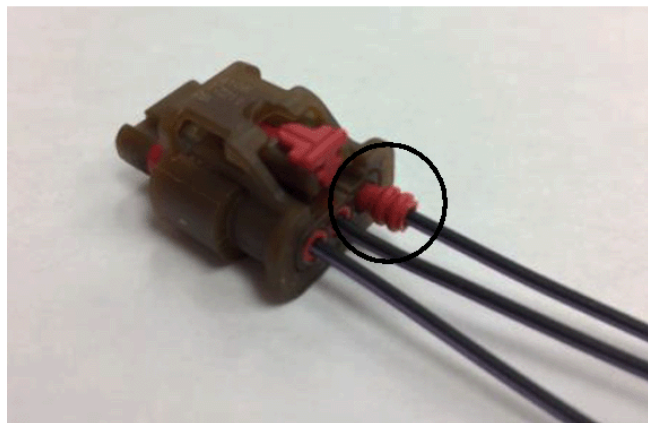
5001971

2. Inspect the crankshaft position sensor connector.
 - If the crankshaft position sensor does NOT have a terminal seal protruding as shown, no further action is required. Proceed to step 17.

- If the crankshaft position sensor connector has a terminal seal protruding as shown, proceed to step three.
3. Remove the Front Compartment Splash Shield. Refer to *Front Compartment Splash Shield Replacement* in SI.
 4. Remove the Front Underbody Air Deflector. Refer to *Front Underbody Air Deflector Replacement* in SI.
