Special Coverage Adjustment

18055 Side Impact Airbag Light On

Reference Number: N172125090

Release Date: March 2018
Revision: 00

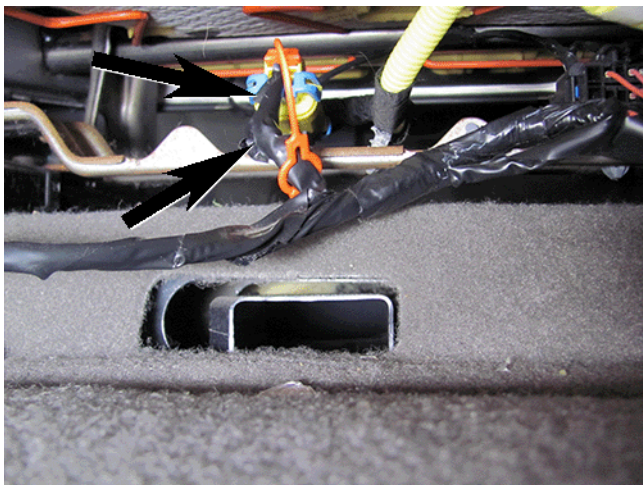
5000223

4. Locate the SIAB branch of the under-seat harness located on the rear of the lower seat frame.
