# Service Update

## 18088 Incorrect Engine Oil Fill Cap

Reference Number: N182154360

| Make | Model | Model Year | | RPO | Description |
|---|---|---|---|---|---|
| Chevrolet | Corvette | 2019 | 2019 | | |

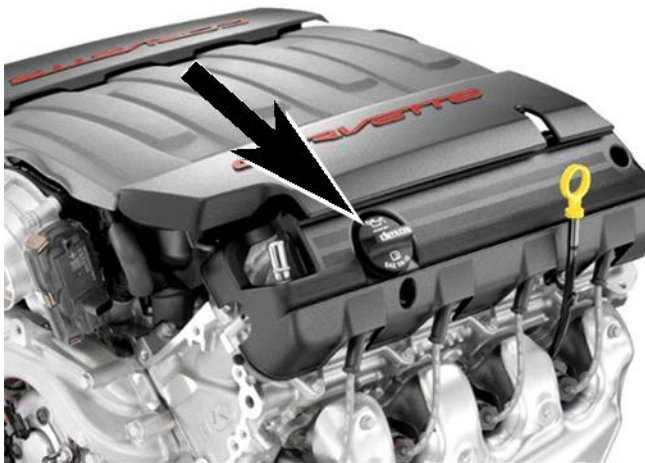
5019913

1. Raise the vehicle hood and locate the oil fill cap installed on the driver side of the engine.
