18065 Front Right Splash Shield Not Installed

Reference Number: N172133360

Make	Model	Model Year		RPO	Description
		From	To		
Cadillac	CT6	2018	2018	LTG	2.0L Turbo Engine

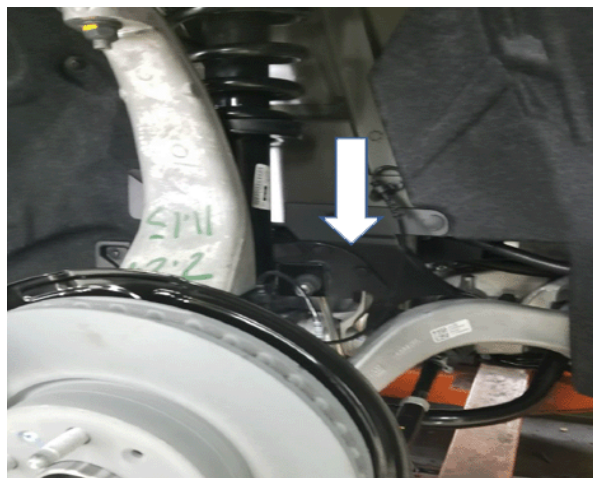
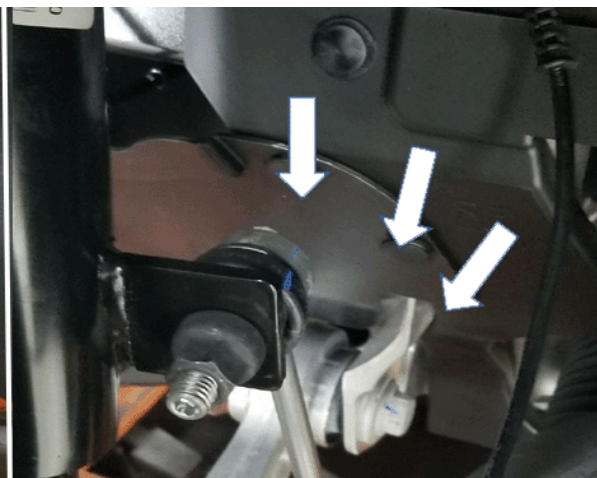
5003437

1. Raise and support the vehicle. Refer to *Lifting and Jacking the Vehicle* in SI.
2. Remove the right front wheel and tire assembly.

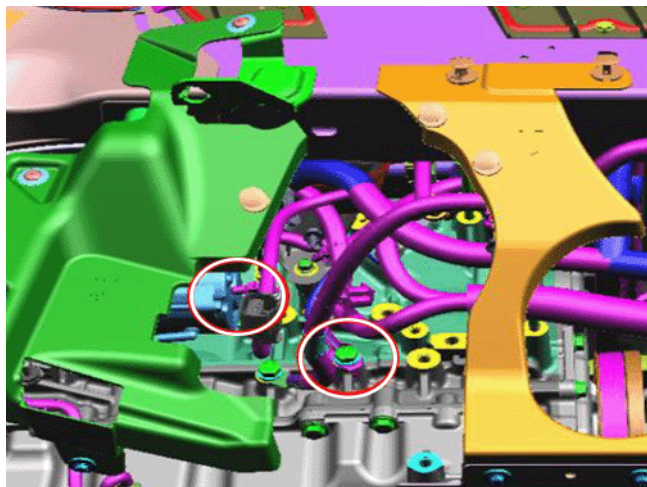
5003439

- If the engine front splash shield right side (front) is NOT installed, inspect the starter and ground ring terminals for any corrosion as shown above. Clean as required and install the engine front splash shield right side (front). Refer to *Engine Front Splash Shield Replacement - Right Side (Front)* in SI.
