Service Update

18078 Tow/Haul Mode IPC Telltale Not Functioning

Reference Number: N182151190

Release Date: March 2018

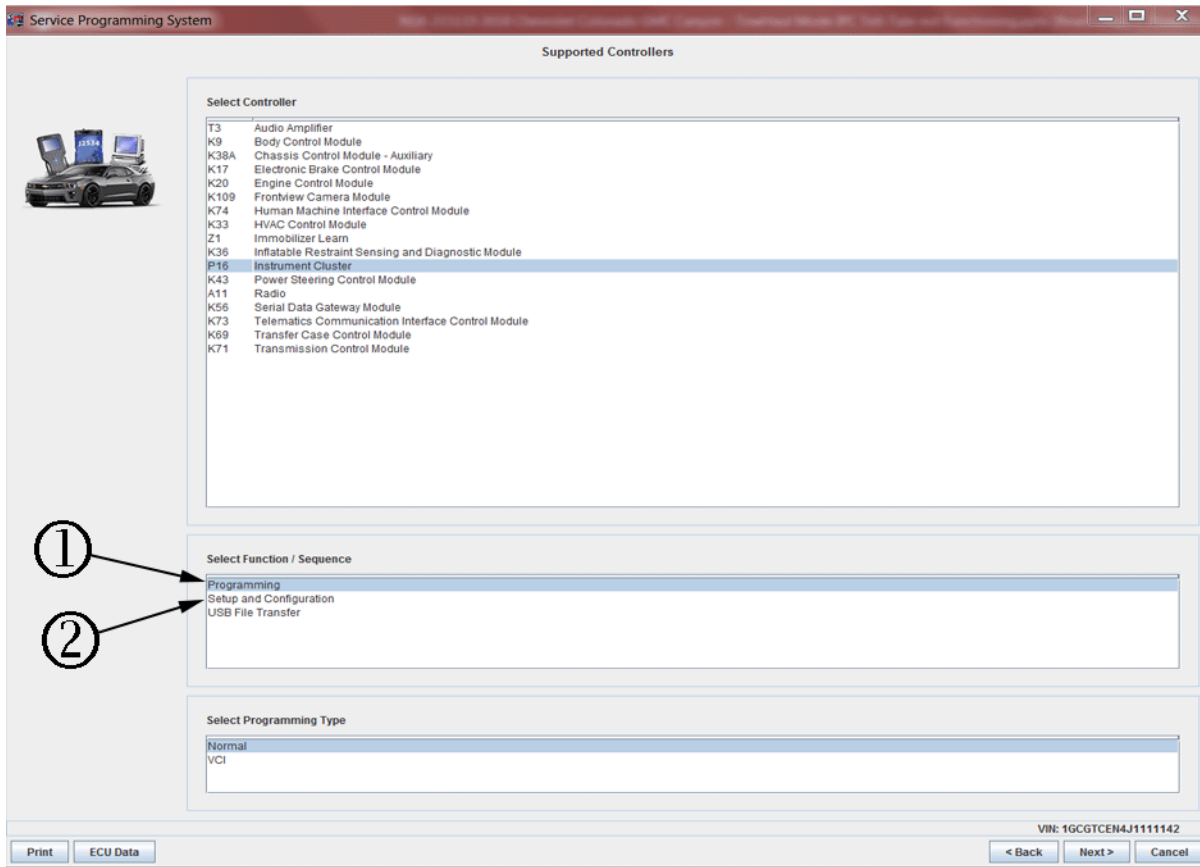
5026054

Note: Once instrument cluster “Programming” (1) is complete, select “Setup and Configuration” (2) and follow the on screen instructions. USB programming is not required.

1. Reprogram instrument cluster. Refer *P16 Instrument Cluster: Programming and Setup* in SI.
2. Once reprogramming is complete, with vehicle running, press the “Tow/Haul” button and confirm the light illuminates on the instrument cluster.
3. Record SPS Warranty Claim Code on job card for warranty transaction submission.
