May 19, 2018

09087 Version 2

## 2017 Ridgeline: Judder from the Torque Converter Lock-Up Clutch After Software Update (Snapshot Required)

Supersedes 17-026, dated April 13, 2017, to revise the information highlighted in yellow

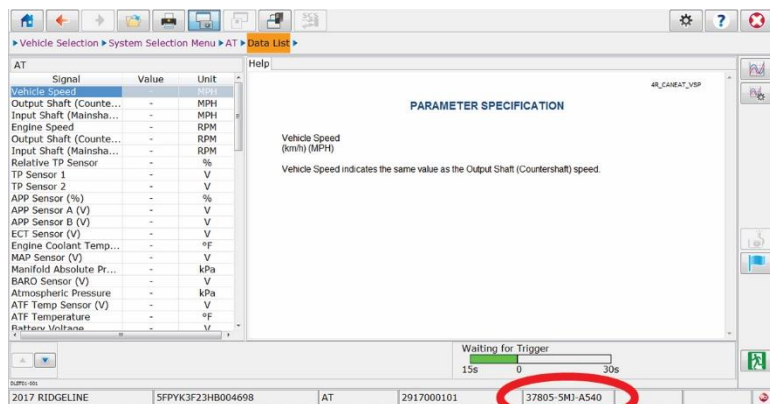
1. Connect the i-HDS, and go to the A/T Data List. Check to see if the software has been updated by comparing the program P/N against the table below.

- If the program P/N is listed below (or later), the vehicle has been updated. Go to step 2.

- If the program P/N is not listed, the vehicle has not been updated. Go to service bulletin 17-025  
*2017 Ridgeline: Judder from the Torque Converter Lock-Up Clutch After Software Update.*
2. Take an automatic transmission snapshot and forward it to Tech Line using the RO number. For more information about capturing and interpreting the data, refer to the job aid *Torque Converter Clutch Shudder and Vibration* and the *Tech2Tech@* video "Interpreting Torque Converter Judder Snapshot Data".
    - If the snapshot indicates there is a judder, go to REPAIR PROCEDURE.
    - If the snapshot does not indicate a judder, this bulletin does not apply. Continue with normal troubleshooting.
