09084 Version 2

2013–15 Crosstour V6: Judder from the Torque Converter Lock-Up Clutch (Snapshot Required)

Supersedes 17-041, dated June 20, 2017, to revise the information highlighted in yellow

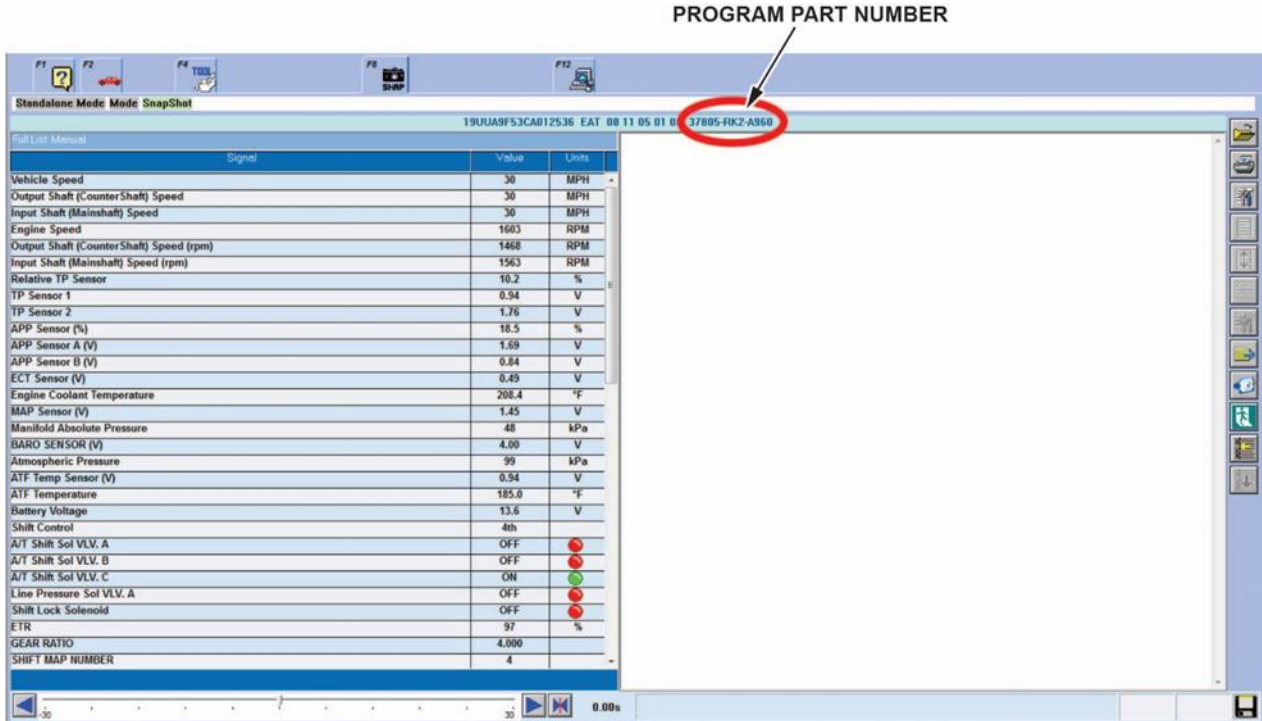
1. Connect the i-HDS, and go to the **A/T Data List**. Check to see if the software has been updated by comparing the program P/N against the table below.

- If the program P/N is listed below (or later), the vehicle has been updated. Go to Service Bulletin 17-042, 2013–14 Crosstour V6: Judder from the Torque Converter Lock-Up Clutch After Software Update.

- If the program P/N is not listed, the vehicle has not been updated. Go to step 2.
2. Take an automatic transmission snapshot, and forward it to Tech Line using the RO number. For more information about capturing and interpreting the data, refer to the job aid *Torque Converter Clutch Shudder and Vibration* and the *Tech2Tech®* video “Interpreting Torque Converter Judder Snapshot Data.”
 - If the snapshot indicates there is a judder, go to step REPAIR PROCEDURE.
 - If the snapshot does not indicate a judder, this bulletin does not apply. Continue with normal troubleshooting. NOTE: **You do not need to contact Tech Line after sending the snapshot.** However, if you do not send a snapshot, your claim may be subject to debit.

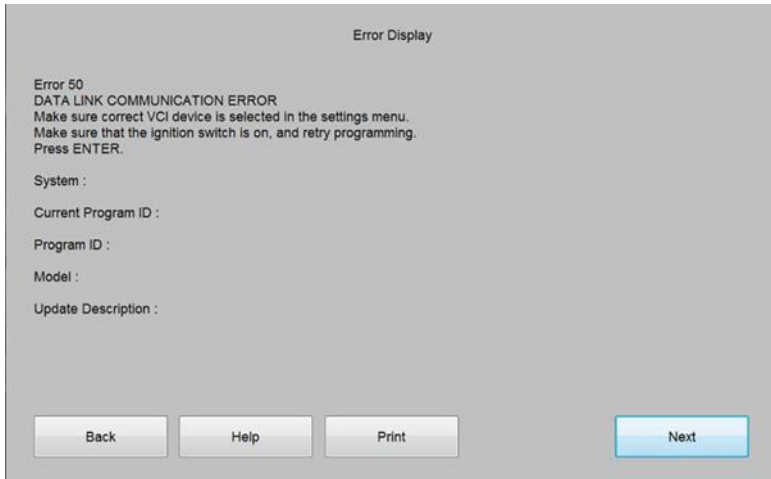
- You cannot update the vehicle using the MVCI as a standalone tool.
- Do not use the MongoosePro VCI tool.
- Make sure the 12-volt battery is fully charged before starting an update.
- Connect a fully charged jumper battery to the vehicle, and leave it connected during the entire procedure to maintain steady voltage.
- Never turn the ignition to OFF or ACCESSORY during the update. If there is a problem with the update, leave the ignition turned to ON.
- To prevent VSA modulator control unit damage, do not operate anything electrical (headlights, audio system, brakes, A/C, power windows, door locks, etc.) during the update.
- If you see the following **Error Display**, check that you are using the correct tool (MVCI or DST-i) with the i-HDS.

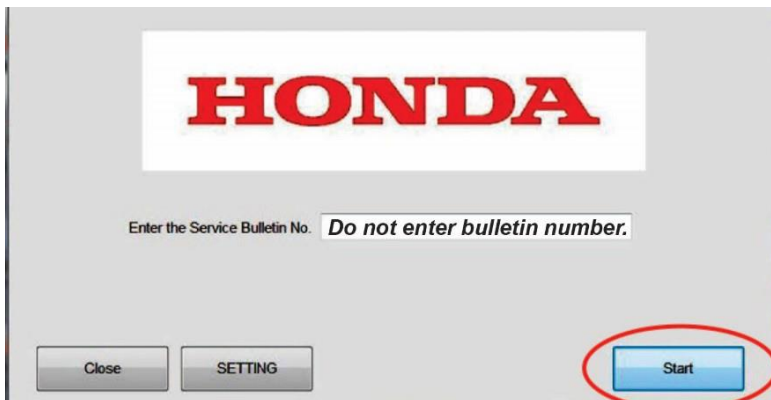
- Do not enter a bulletin number.
- If you receive a message that the vehicle has been already updated or that no update is available, check the **A/T Data List**. The header should indicate one of the following numbers (or later).

- If the program part numbers do not match those listed above, the i-HDS software needs to be reinstalled. Contact the Special Tools Hotline at **800-346-6327** for assistance.
