May 19, 2018

09085 Version 2

2013–15 Crosstour V6: Judder from the Torque Converter Lock-Up Clutch After Software Update (Snapshot Required)

Supersedes 17-042, dated June 20, 2017, to revise the information highlighted in yellow

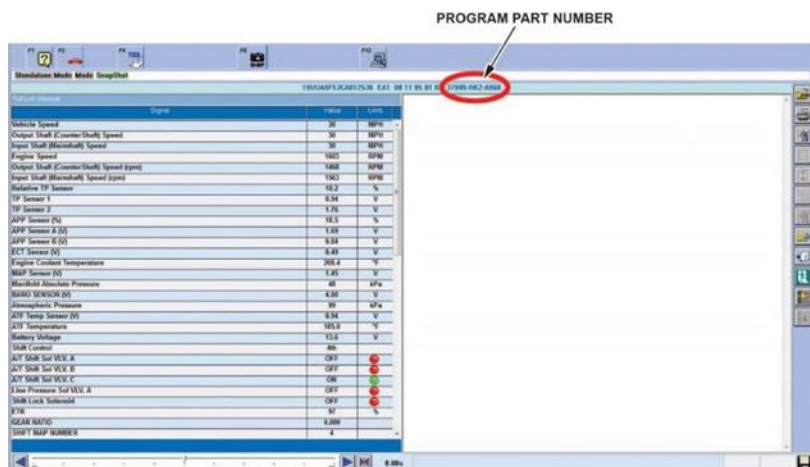
1. Connect the i-HDS, and go to the **AT Data List**. Check to see if the software has been updated by comparing the program P/N against the table below.

- If the program P/N is listed below (or later), the vehicle has been updated. Go to step 2.
- | | |

| 37805-R53-3050 | 37805-R53-3060 |

- If the program P/N is not listed, the vehicle has not been updated. Go to service bulletin 17-041, *2013–15 Crosstour V6: Judder from the Torque Converter Lock-Up Clutch*.
