CR154 – Panigale V4 Side Stand Update
Models: Panigale V4 2018 (all model versions)
Technical Service Bulletin SRV-TSB-18-009

Date: Thursday, May 11th, 2018

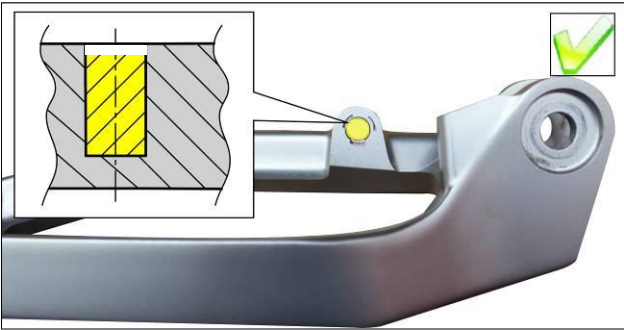
STEP 1: CHECK MAGNET ASSEMBLY ON SIDE STAND

<p>Magnet upper surface is positioned lower than the side stand surface</p> <p>↓</p> <p><u>The side stand is COMPLIANT</u></p>
STEP 2: CLINCH THE CAULKED AREAS

- 1) If the magnet is positioned below the side stand surface, this stand is COMPLIANT, and the caulked areas must then be clinched with a flat tipped punch to ensure magnet remain in position:

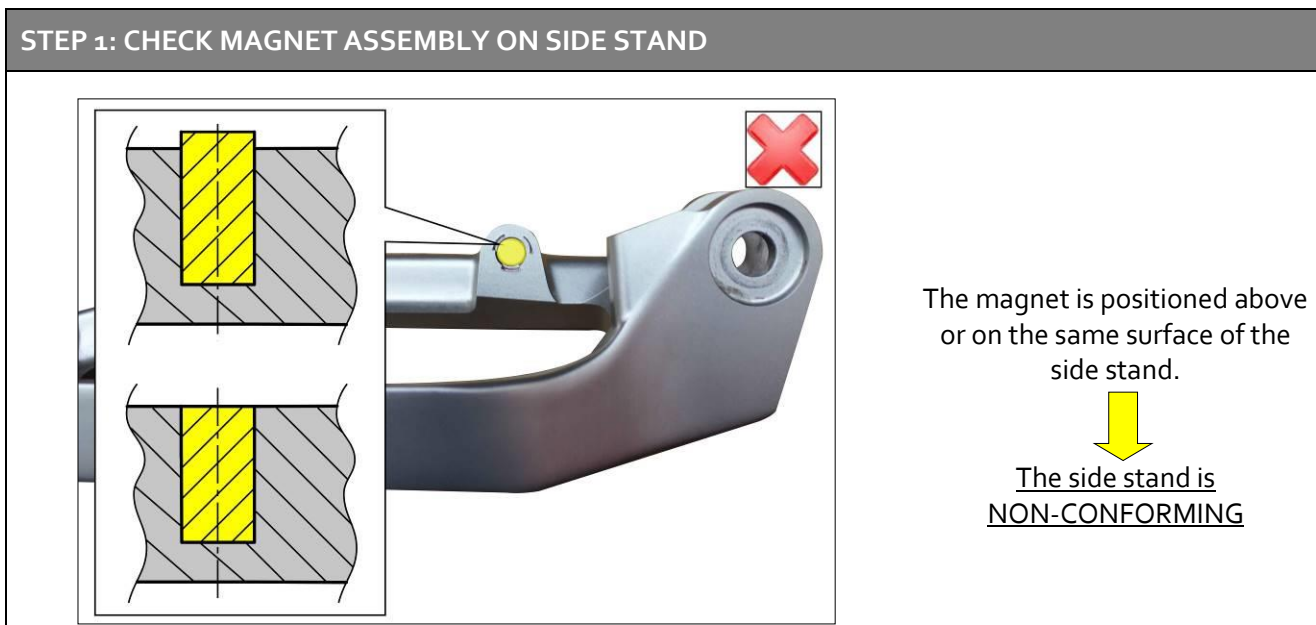
- 2) If the magnet is positioned above or on the same surface of the side stand, this stand is NOT COMPLIANT and must be replaced.

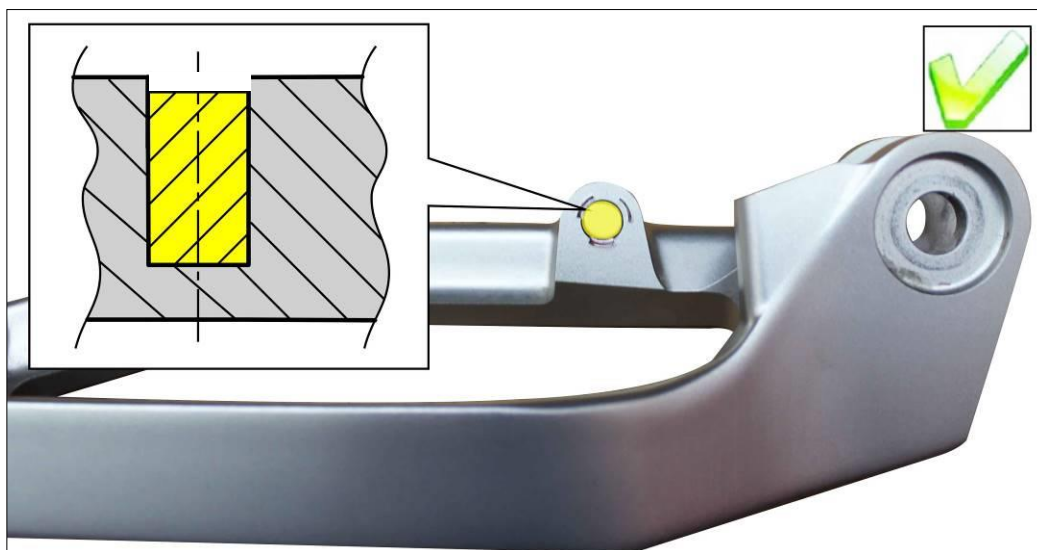
- 4) Position **side stand (3)** on a clean surface and check side stand sensor magnet position:
- a) If magnet upper surface is positioned under side stand surface, the side stand is COMPLIANT.

Using a flat-head tip, clinch the caulked areas with a 120° angle offset, taking care not to damage the magnet.

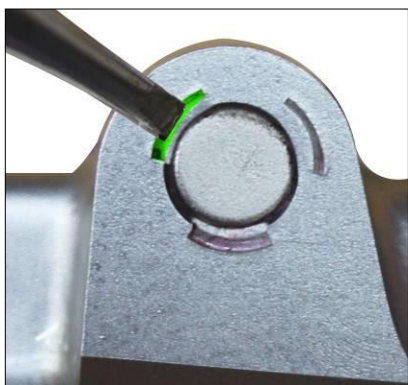
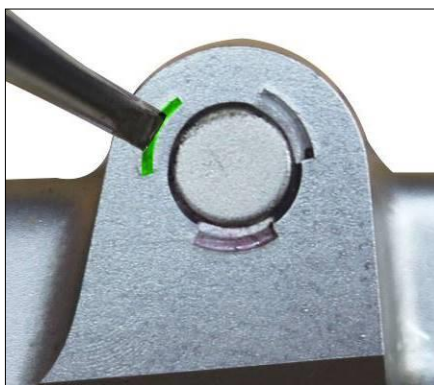
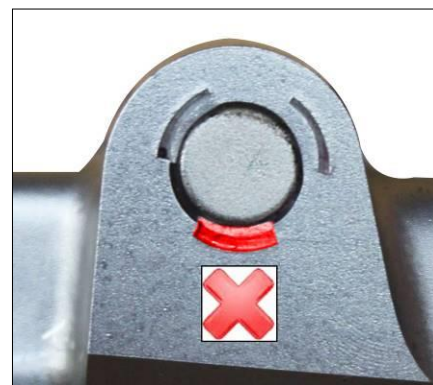
The caulked areas present close to the magnet, as shown in the figure or the right, must NOT be clinched in order to avoid possible damage to the magnet.

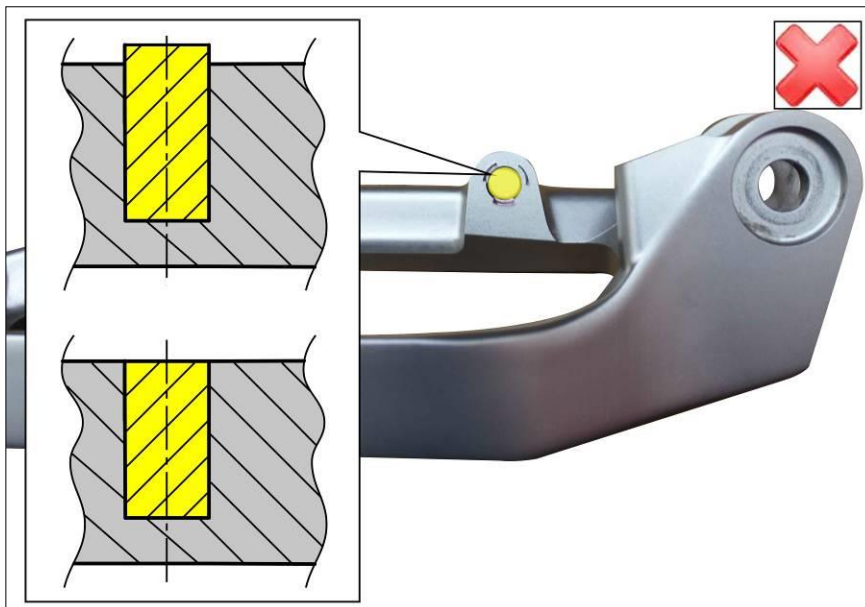
- b) If the magnet is positioned above or on the same surface of the side stand, this latter is NOT COMPLIANT and must be replaced.
