<b>HYUNDAI</b> <b>Technical Service Bulletin</b>	GROUP <b>CAMPAIGN</b>	NUMBER <b>18-01-014-1</b>
	DATE <b>MAY, 2018</b>	MODEL(S) <b>SONATA (LFa)</b>
<b>SUBJECT:</b> 2018 SONATA D-AUDIO SOFTWARE UPDATE FOR LCD OVERLAY (SERVICE CAMPAIGN T2W)

This bulletin supersedes TSB# 18-01-014 to include the Notice on the front page.

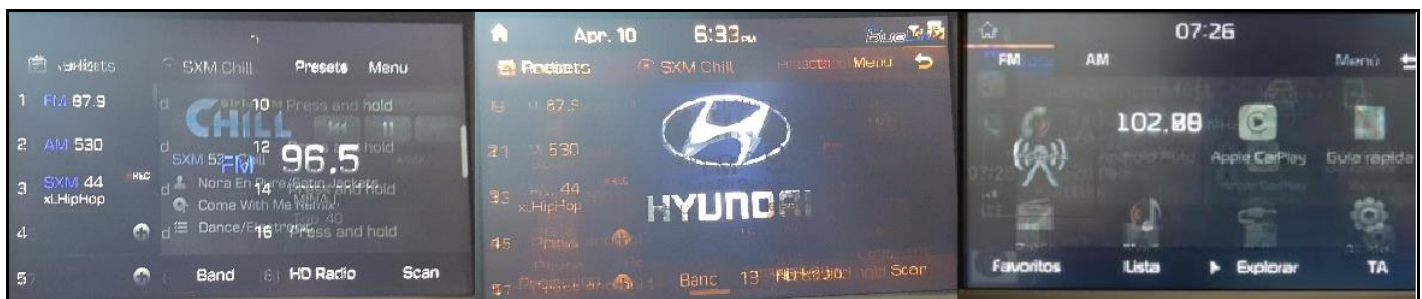
**[LCD Overlay / Display Overlapping Symptom]**

**Description:** This bulletin describes the procedure for updating the Display Audio (D-Audio) System Software for the 2018 Model Year Sonata (LFa). This update prevents the LCD Overlay/Display overlapping condition (previous screen images/icons showing on current screen).

If the symptom is already present, the S/W update will not resolve the concern.

- If the symptom is already present ➡ replace the (D-Audio) Head Unit.
- If the symptom is not present ➡ perform the following S/W update procedure.
