HYUNDAI Technical Service Bulletin	GROUP BODY ELECTRICAL	NUMBER 18-BE-007
	DATE MAY, 2018	MODEL(S) SEE BELOW FOR APPLICABLE MODELS
SUBJECT: CLOCK TIME INACCURACY (DISPLAY AUDIO)

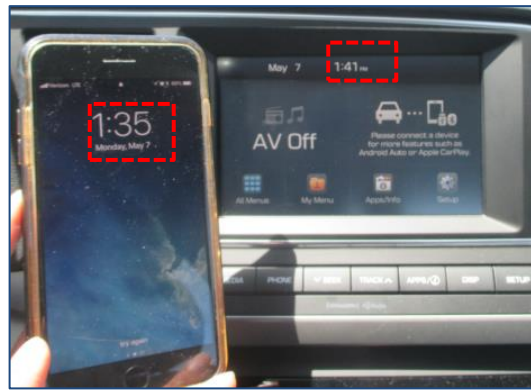
SYMPTOM(S)
Clock mismatch
