NUMBER: 12-232-18

SERVICE BULLETIN

APPLICABILITY: 2008-2016MY Impreza

SUBJECT: Front Seat Back Upholstery Hooks- Design

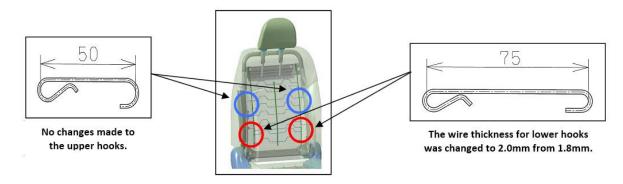
The part number for the hook set (HOOK FLAT MAT SET) is **64133FJ001**. The set consists of 2 upper and 2 lower hooks to repair 1 seat back assembly. The 4 hooks are replaced AS A SET.
