## **TECHNICAL SERVICE BULLETIN**

**SB-18-010 COE RELAY BLOCK (VACUUM RELAY  
CORROSION)**

**GROUP: 27-ELECTRICAL SYSTEMS  
BULLETIN NO: SB-18-010  
DATE: 4-16-2018  
REFERENCE: HMM-170707-J1**

**SUBJECT VEHICLES:** 13MY-17MY Cab Over Engine (COE) Trucks equipped with a J05 engine.

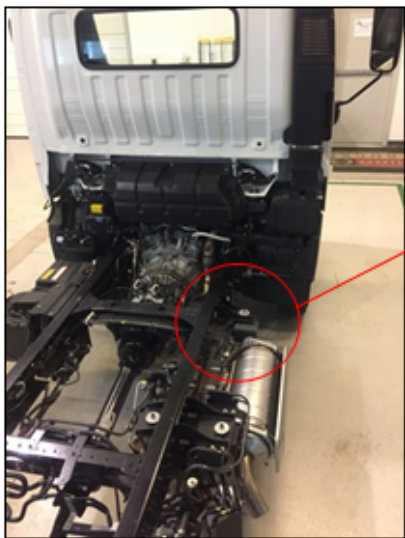
To enhance the waterproof performance of the relay block, the mounting position has been changed and the vent in the relay block cover has been removed.

Mounting Position Has Changed

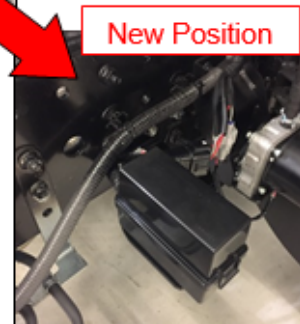
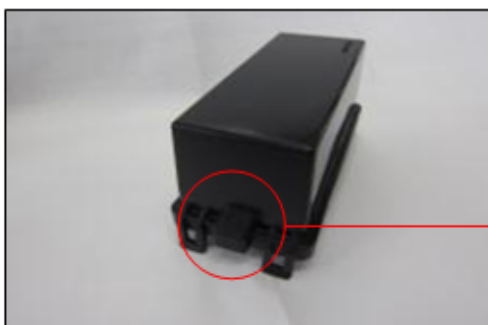
Relay Cover Vent Removed

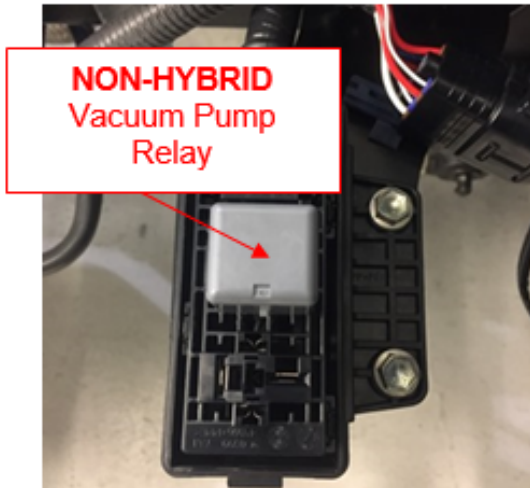
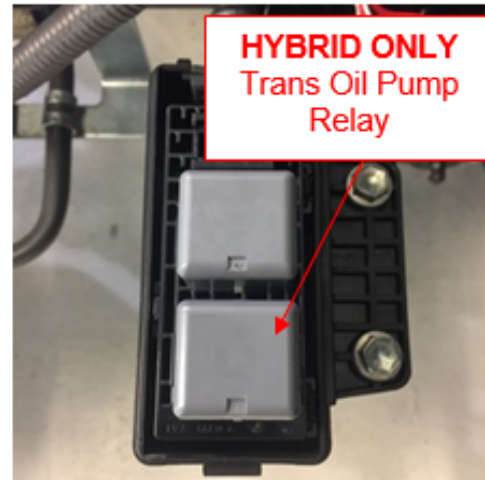
**NOTICE:** If corrosion is present on the old relays, DO NOT reuse these relays. Replacement of the relay or relays will be necessary. Discard the old relay(s).

8. Transfer the relays from the old relay block to the new relay block.
