FIELD SERVICE CAMPAIGN BULLETIN

Subject: **Field Service Campaign 18M1**
GHG14 Heavy Duty Engine Platform Vocational Application Programming

Field Service Campaign Bulletin 18M1

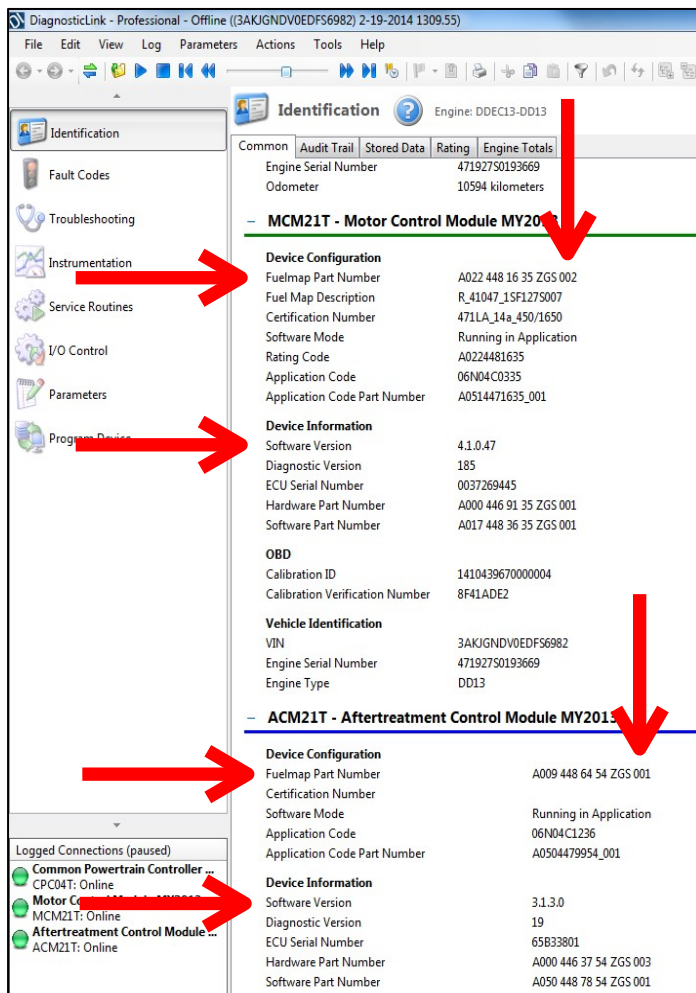
Figure 1 – DiagnosticLink® Identification Screen

6. Is the software level for the MCM, ACM, CPC, and if applicable the TCM, less than, equal to, or higher than the minimum software levels listed in step 5? All modules must meet the **MINIMUM** requirements. For example, in Figure 1, MCM software 4.1.0.47 and ACM software 3.1.3.0 are both less than the minimum levels of 4.7.0.0 and 5.57.0.0, and thus would require programming, regardless of fuel map ZGS version.
 - a. If less than the minimum software levels, proceed to step 8.
 - b. If equal to the minimum software levels, proceed to step 7.
 - c. If greater than the minimum software levels, no programming is necessary. Proceed to step 13.

5. On the Identification screen, check the current MCM, ACM, CPC, and if applicable the TCM, software and fuel map level. Listed below are the **MINIMUM** levels required. See Figure 1 for an example of the Identification screen for the MCM and ACM.
- a. MCM **4.7.0.0 software** and fuel map version **ZGS 003**, except for three ratings that are ZGS 004:
 - i. DD13 450/1450/1650 1-box, fuel map P/N: A0294487935 ZGS 004
 - ii. DD15AT 455/1550/1750 1-box, fuel map P/N: A0304480035 ZGS 004
 - iii. DD15AT 400/1750 1-box, fuel map P/N: A0304480335 ZGS 004
 - b. ACM **5.57.0.0 software** and fuel map version **ZGS 004**
 - c. CPC **R34 00 000A software**
 - d. If applicable, TCM **NAMT070700 software**

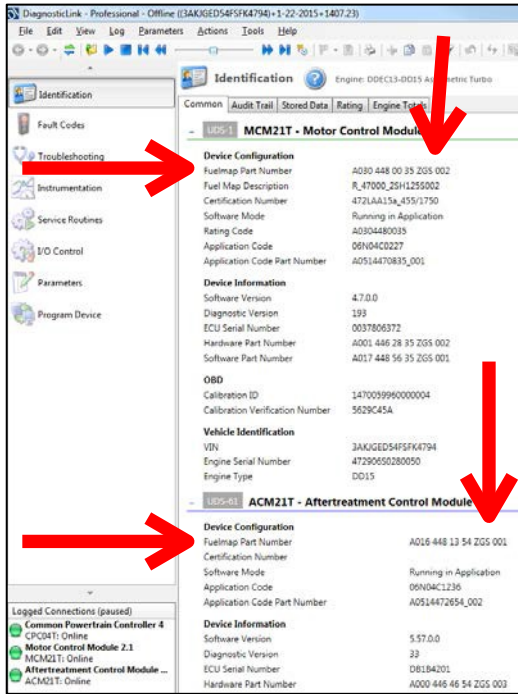
Figure 2 – DiagnosticLink® Identification Screen

7. Is the fuel map ZGS version level for the MCM and ACM less than, equal to, or higher than the fuel map ZGS revision levels listed in step 5? The MCM and ACM fuel map ZGS version levels must meet the **MINIMUM** requirements. For example, in Figure 2, both the MCM and ACM software levels meet the minimum required of MCM 4.7.0.0 and ACM 5.57.0.0, but the fuel map ZGS version levels of MCM 002 and ACM 001 are less than the minimum levels of MCM 003 (except for three ratings that are 004) and ACM 004, and thus would require programming.
 - a. If less than the minimum fuel map ZGS version levels, proceed to step 8.
 - b. If equal to, or greater than, the minimum fuel map ZGS version levels, no programming is necessary. Proceed to step 13.
