# SS 1033364 - New Cascadia Forward Chassis Harness Chafe

New Cascadia (P4) manufactured prior to 2/9/2018.

## Inspection / Correction Process for New Cascadia (P4) Forward Harness Chafing

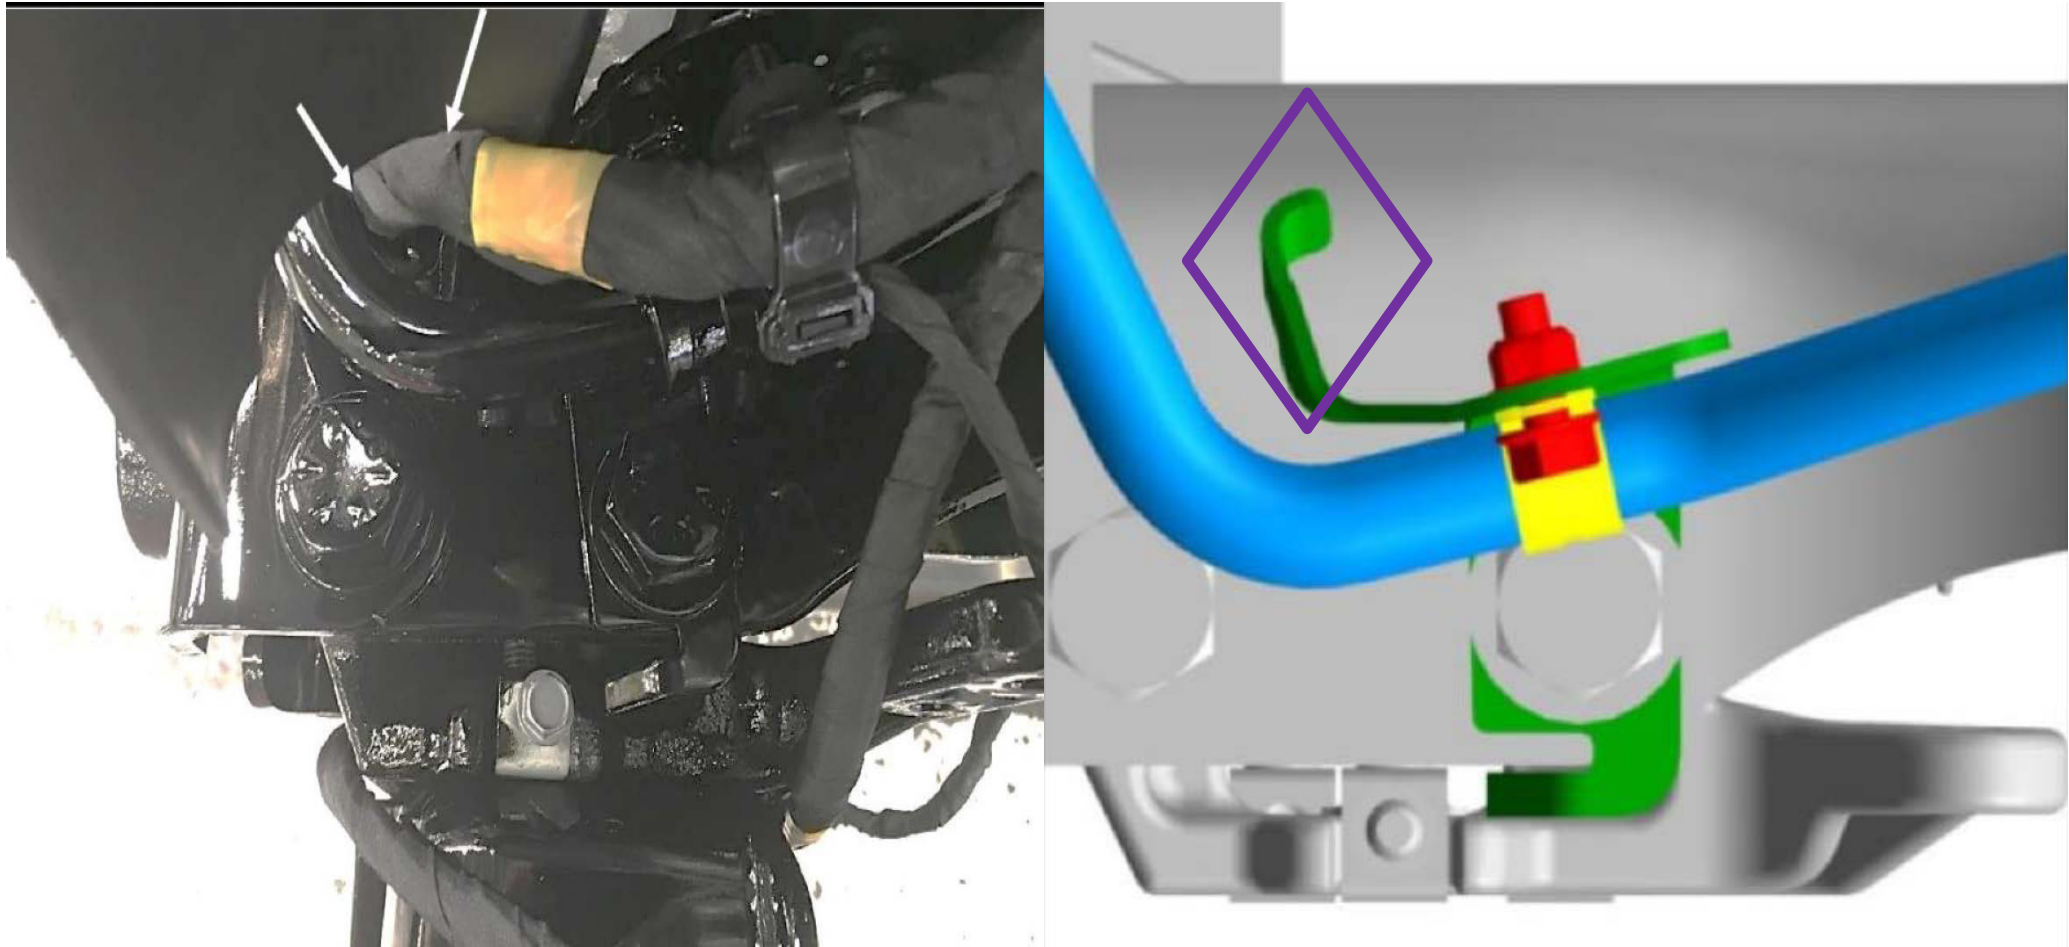
## Items 1 and 2 (Driver side shown, Passenger side similar)

Radiator baffle pictured below is before trimming (white arrows show chafe points). Trim baffle. Bend the purple diamond area of the green bracket (for both the driver and passenger sides of the vehicle), so it is parallel to the closing cross member. This will help separate the harness from rubbing on the tube at this junction. Inspect the entire area, adding butterfly tie straps (p/n TYC DCT110HIR) between the harness and tube as needed to maintain separation, and to prevent rubbing on the bracket.

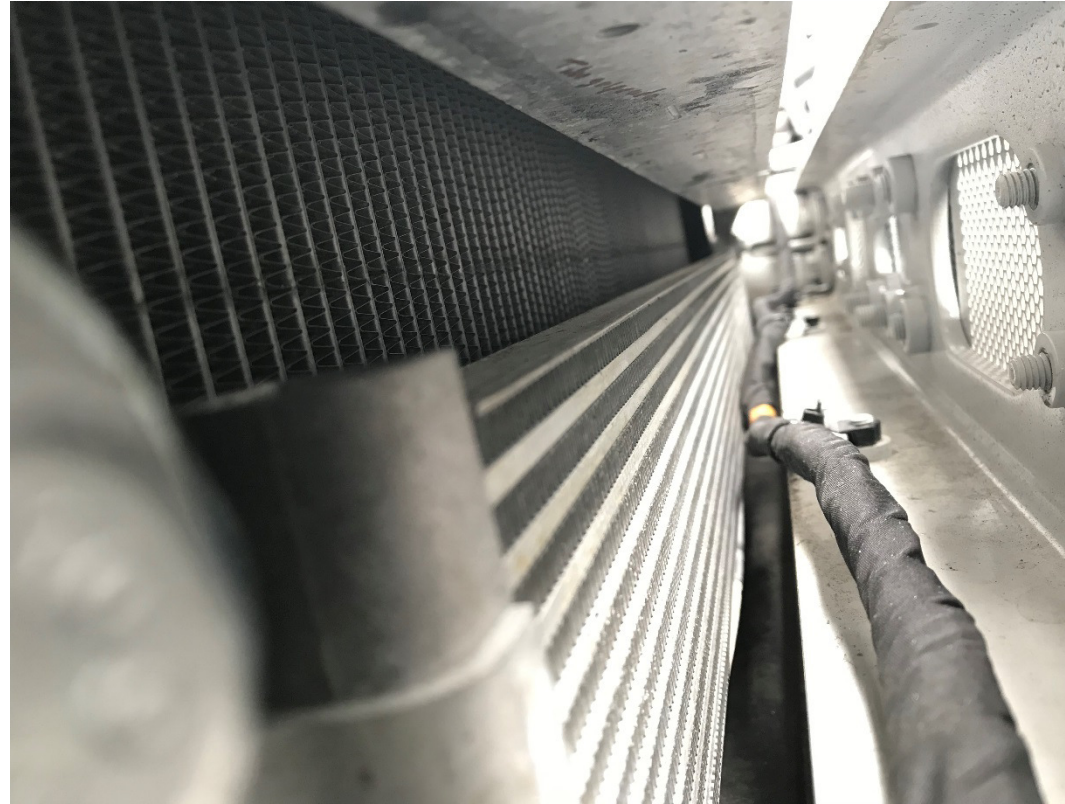
View from Passenger side

# Bad Cross Member Harness Routing (could result in wiring and cooler failure)
