H087NAS1

TECHNICAL BULLETIN

501-02: Front End Body Panels

Service Action: Hood Seal Freezing

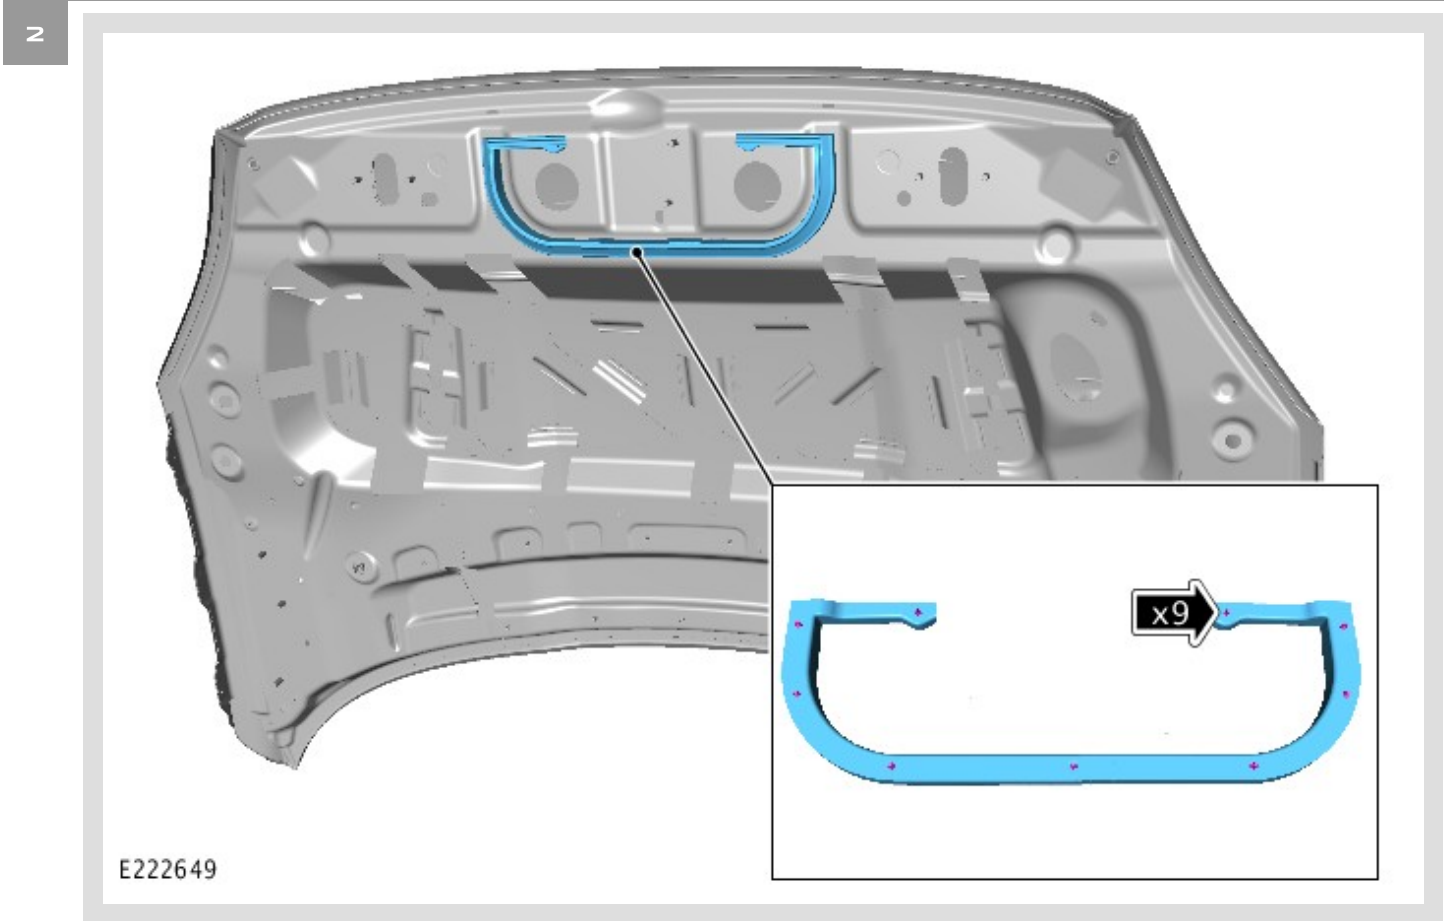
An issue has been identified on certain vehicles within the listed Affected Vehicle Range where the hood seal absorbs water and freezes to the lock panel. When the hood is opened, the seal can get damaged, unclipped, or lost.

Remove and discard the hood seal.
