JTB00458NAS2 TECHNICAL BULLETIN 15 MAR 2018

MODEL:	MODEL YEAR:	VIN:	ASSEMBLY PLANT:	APPLICABILITY:
XE (X760)	2017	921222- 937474	Solihull	Vehicles With: 8HP45 8-Speed Automatic Transmission RWD

JTB00458NAS2 - 'Rattle' Noise From The Front Of The Vehicle | TOPIx

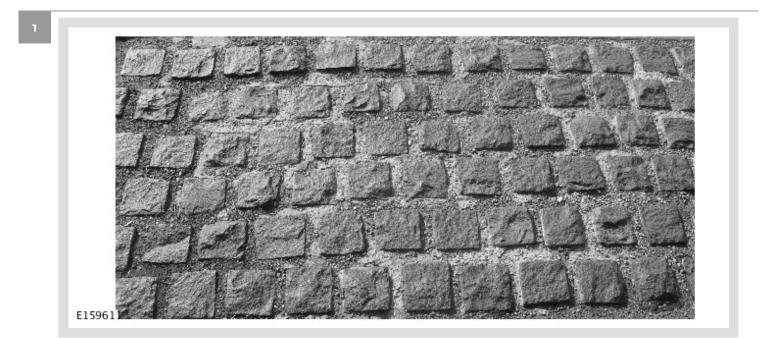
A 'rattle' noise may be evident from the front of the vehicle when driving between 10-25mph (16-40km/h) over cobblestones, damaged roads, and or other similar surfaces.

This may be caused by play within the bearings of the electric power steering gear.

Typical road surface that can generate the rattle sound.

Install a new electric power steering - steering gear (see TOPIx Workshop Manual section 211-02:
Power Steering - Steering Gear - Removal and Installation - Power Steering - Steering Gear).

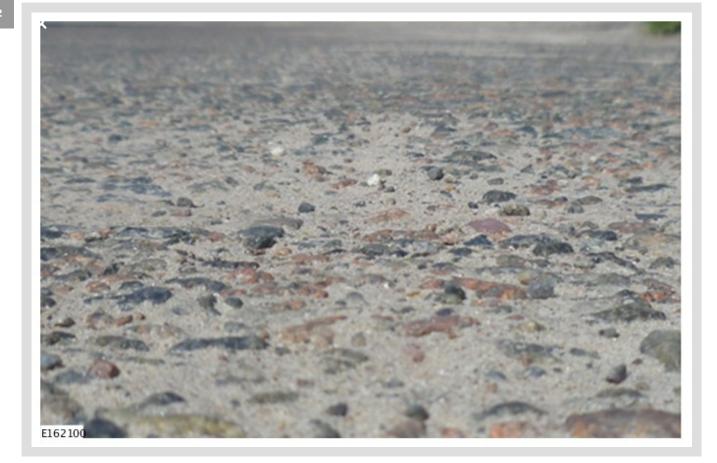
Typical road surface that can generate the rattle sound.
