## Hood Support, Repair GU7

### **FSB 821-026, Hood Support, Repair**

**(April 2018)**

Some GU7 trucks may experience broken hood support attachment points due to high impact during hood closing. To fix this issue install the kits using the procedure below.

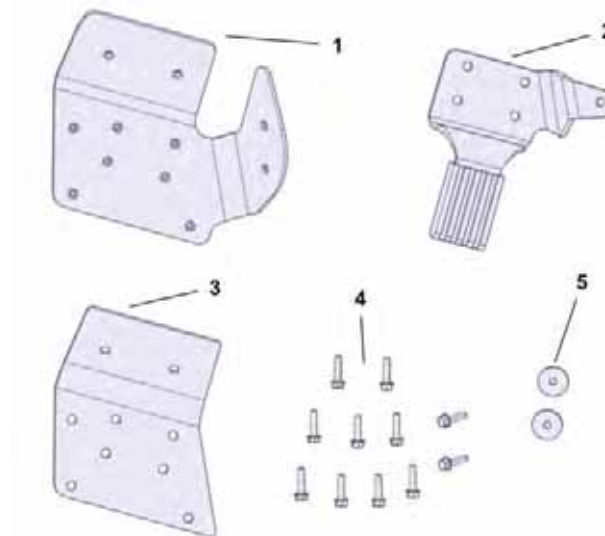
W8129103

**Note:** Parts shown in illustration are Left Hand side only.
